RE: Ms. Woodlee, Ms. Pelton, and Ms. Richardson

Pursuant to your request, I am setting forth my biomechanical opinions regarding the fatal bus accident on September 26, 2014 involving Ms. Katelynn Woodlee, Ms. Jaiden Pelton, and Ms. Megan Richardson. I am also providing a summary synopsis of my background and qualifications to render my opinions.

To perform a biomechanical analysis of the fatal bus incident involving Ms. Woodlee, Ms. Pelton, and Ms. Richardson on September 26, 2014.

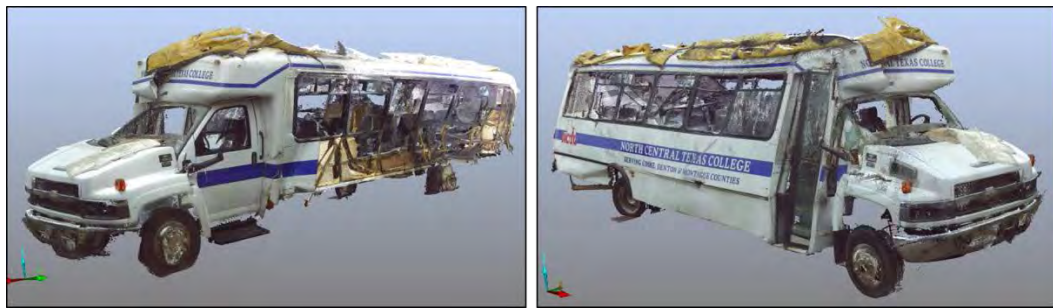
Figure 10 – 3D FARO Laser Image for the 2008 Champion bus

The damage assessment for the Champion bus was carried out using two different approaches: laser based measurements and basic measuring tools. Selected images from the 3D FARO Laser System are shown in Figure 10. Example photographs taken during my inspection, with exterior measurements suitable for photogrammetric analysis are shown in Figure 11.

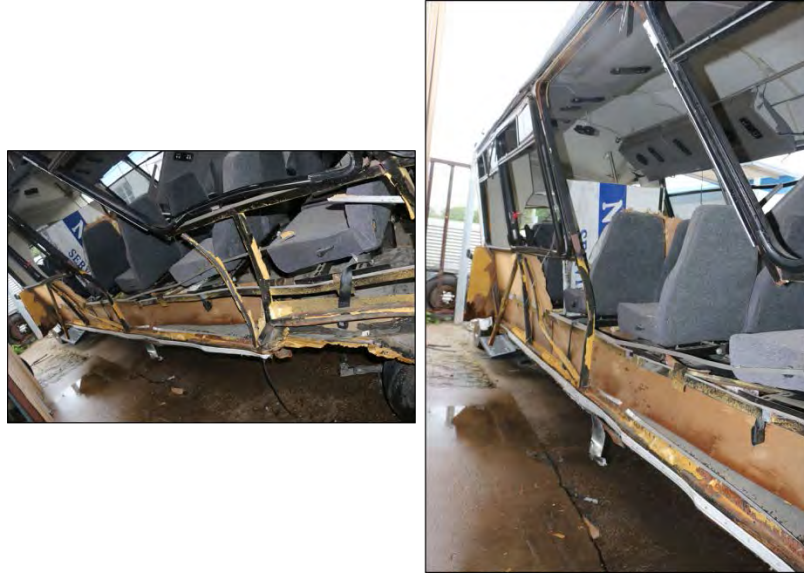
Most of the driver’s side outer panels and insulation were ripped away from the vehicle frame (Figure 12). The glass in all but one window on the driver’s and passenger’s side of the bus was broken or missing, creating large ejection openings (Figure 13). According to Mr. Syson’s report, (Materials Studied #27, Section VIII, H-O), welding joints between the seat and side structure of the bus appear to be weak, unreinforced, and did not extend below the floor, thus, reducing the integrity of the bus frame. The “unistrut” seat support channels were connected to the seats by flat plates (Figure 14). Only lap-belts were available to the passengers of the bus but were difficult to use due to difficult accessibility, entanglement, length, and significant wear (Figure 15). The rear cargo door did not stay closed during the impact, removing important diagonal bracing needed for the frame of the bus to remain square (Figure 16).

Figure 12 – Driver Side Damage and Intrusion

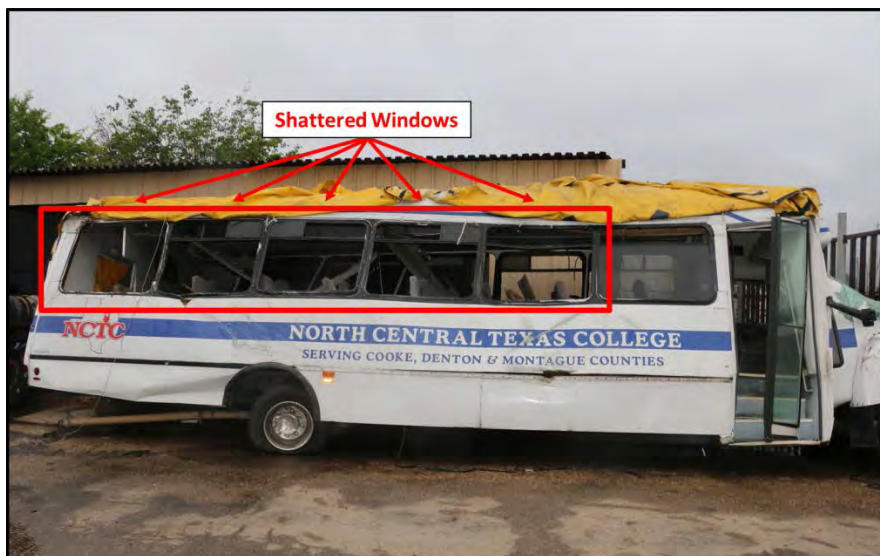
Figure 13 –Improperly Tempered Glass Displaced Driver's Side Windows

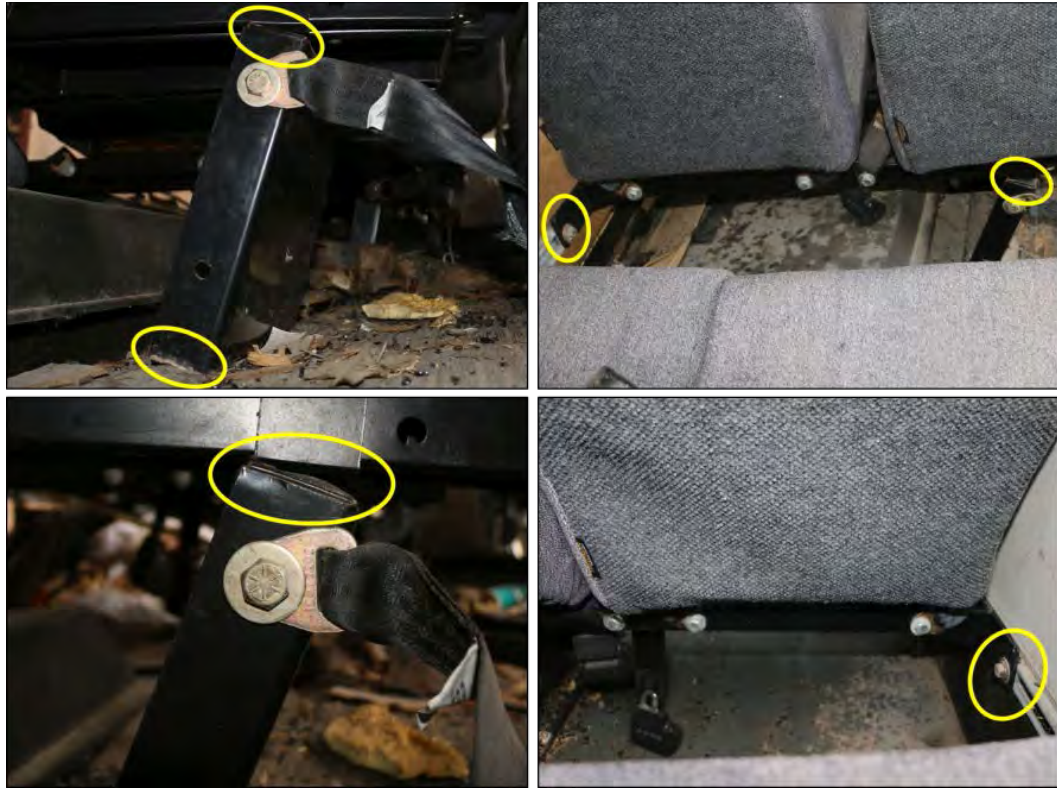
Figure 14 – Inadequately Secured “Unitstrut” Seat Support

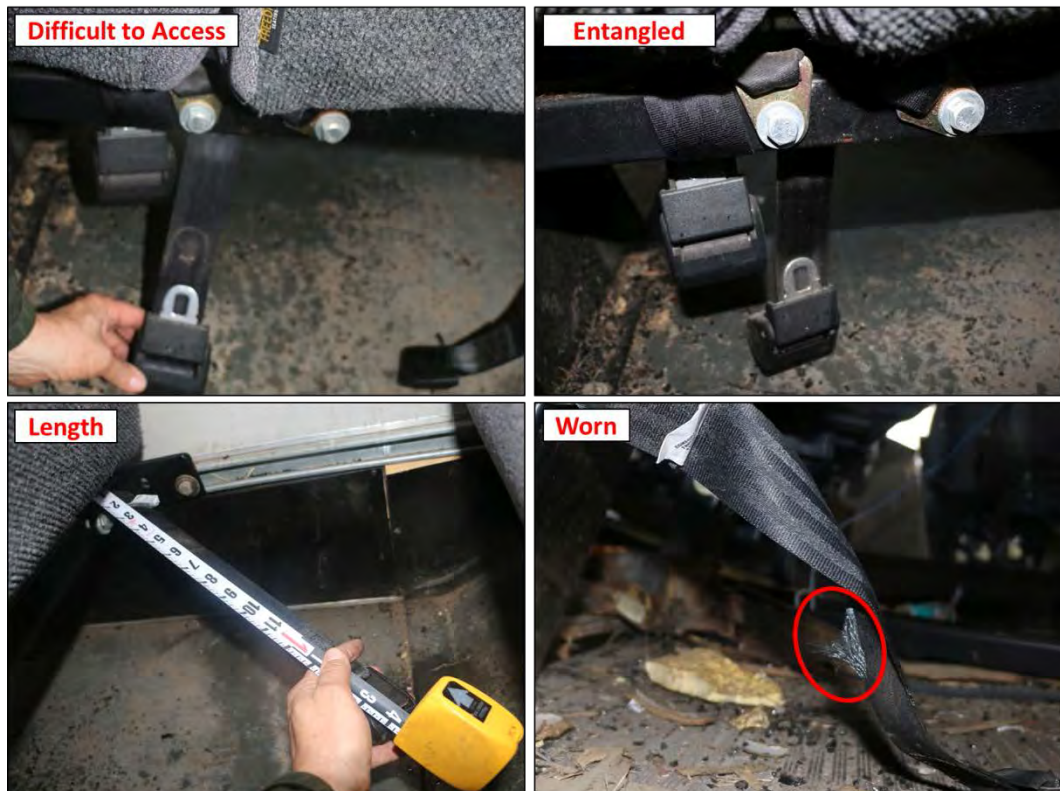
Figure 15 – Lap-Only Belts Were Difficult to Use, Tangled, Lacked Proper Length and Showed Wear

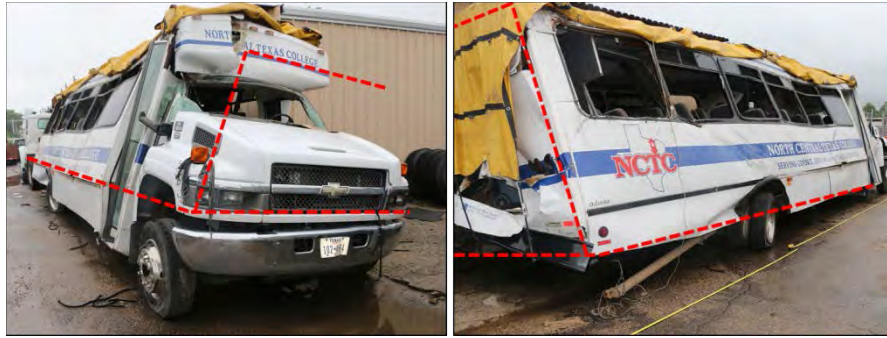
Figure 16 – Lack of Diagonal Bracing From Open Cargo Door

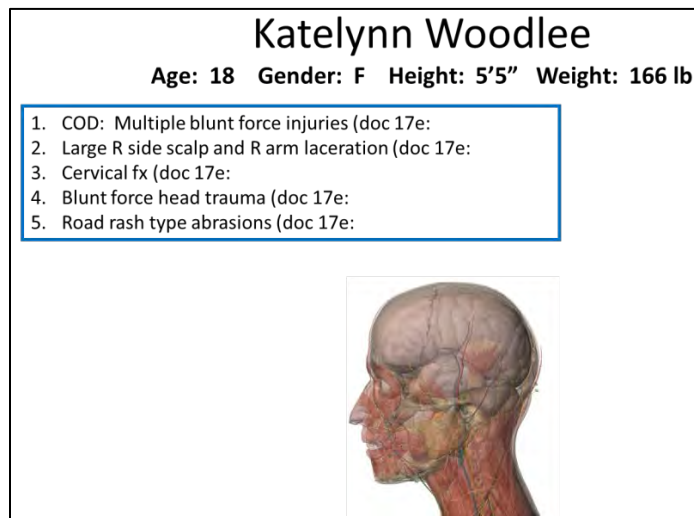
Figure 21 - Injury Pattern Analysis (Katelynn Woodlee)

Ms. Woodlee was sitting on the passenger side of the bus and most likely was not seriously injured during the initial side-swipe impact of the tractor-trailer. However, Ms. Woodlee's injuries are consistent with partial ejection and the tipped bus coming to rest on her head and shoulders.

Ms. Woodlee was seated upright in row 5 of the bus next to the window on the passenger's side. Her body motion would have been slightly forward and left as the bus was impacted. The impact between the passenger side of the bus and the ground forced her body motion back to the right and become partially ejected through the window she was seated against. As the Champion bus bounced, her head and right shoulder became trapped between the bus and ground.

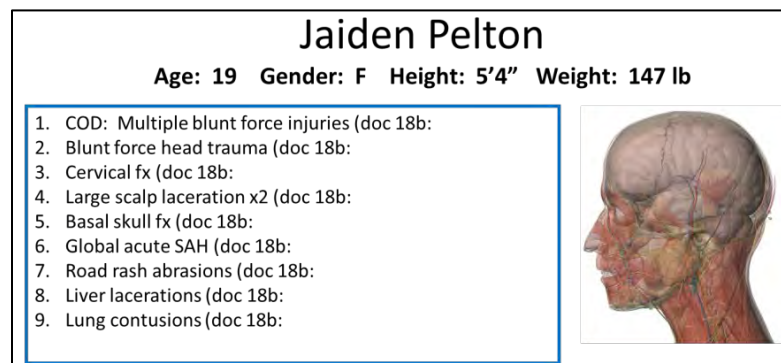
Figure 22 – Injury Pattern Analysis (Jaiden Pelton)

Most likely the sequence of events for Ms. Pelton and Ms. Richardson would be nearly identical. Although their exact seated position is not certain, interviews state they were located on the driver's side of the bus, lying down. Multiple blunt force injuries, cervical fractures, internal organ lacerations and contusions are indicative of contact with the intruding bus wall, and/or the tractor-truck itself, during the initial side-swipe impact. Fractures, lacerations and road rash abrasions are consistent with injuries received during ejection and subsequent sliding along a paved surface.

Ms. Pelton and Ms. Richardson's body motion would have been toward the Principle Direction of Force (PDOF), forwards and towards the driver side of the bus. As the bus was impacted, the sidewall was torn away, and their unrestrained bodies were ejected from the bus most likely contacting and sliding/rolling from the pavement to their final resting position 15-20 ft. north of the bus and west of the paved shoulder.
