INSPECTION OF CHAMPION DEFENDER BUS :

DRIVER SIDEWALL, FRAME (PART # 0414250)

PASSENGER SIDEWALL, FRAME (PART #0414249)

Re: Champion Defender bus accident, Davis, Oklahoma

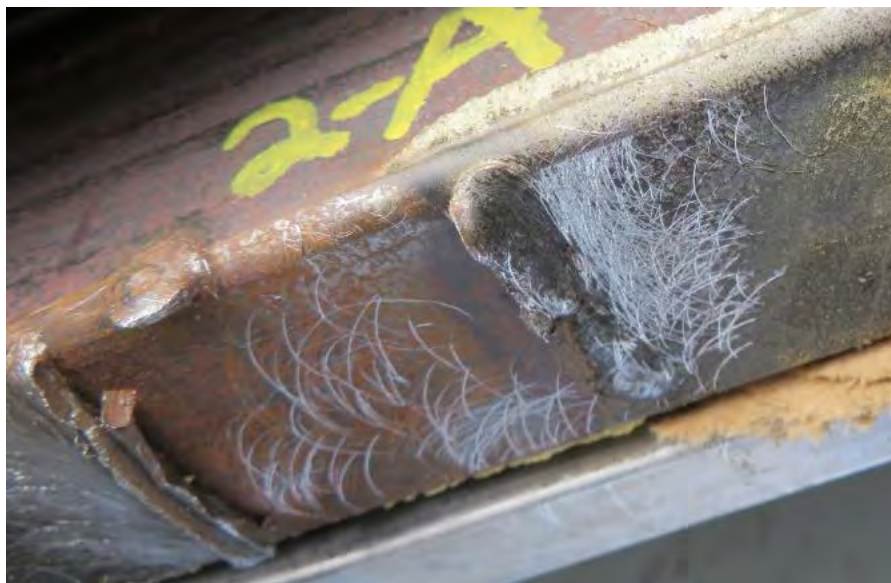
Figure (1) Incomplete Fusion of Joint 2-A

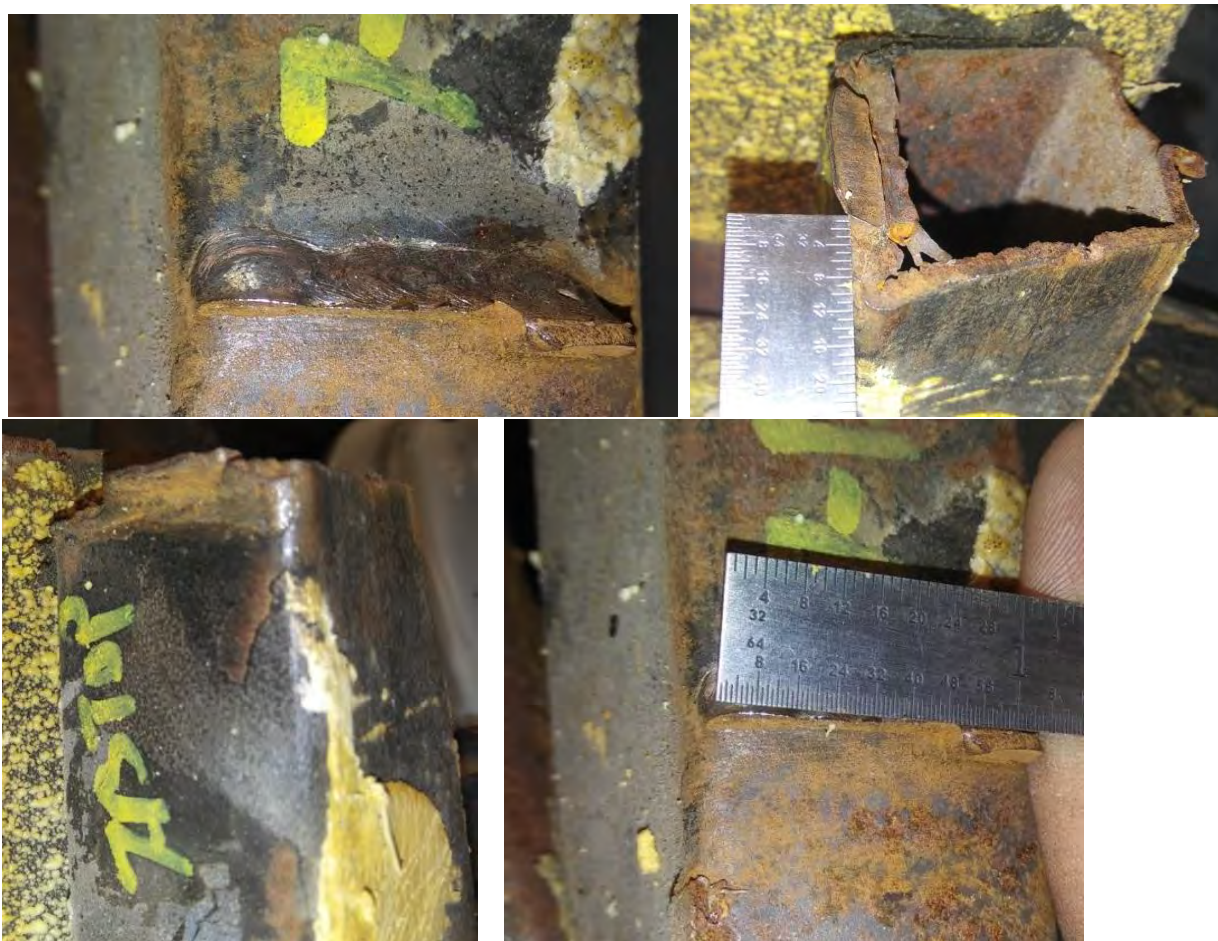
Figure (2) Incomplete Fusion of Joint 7-B

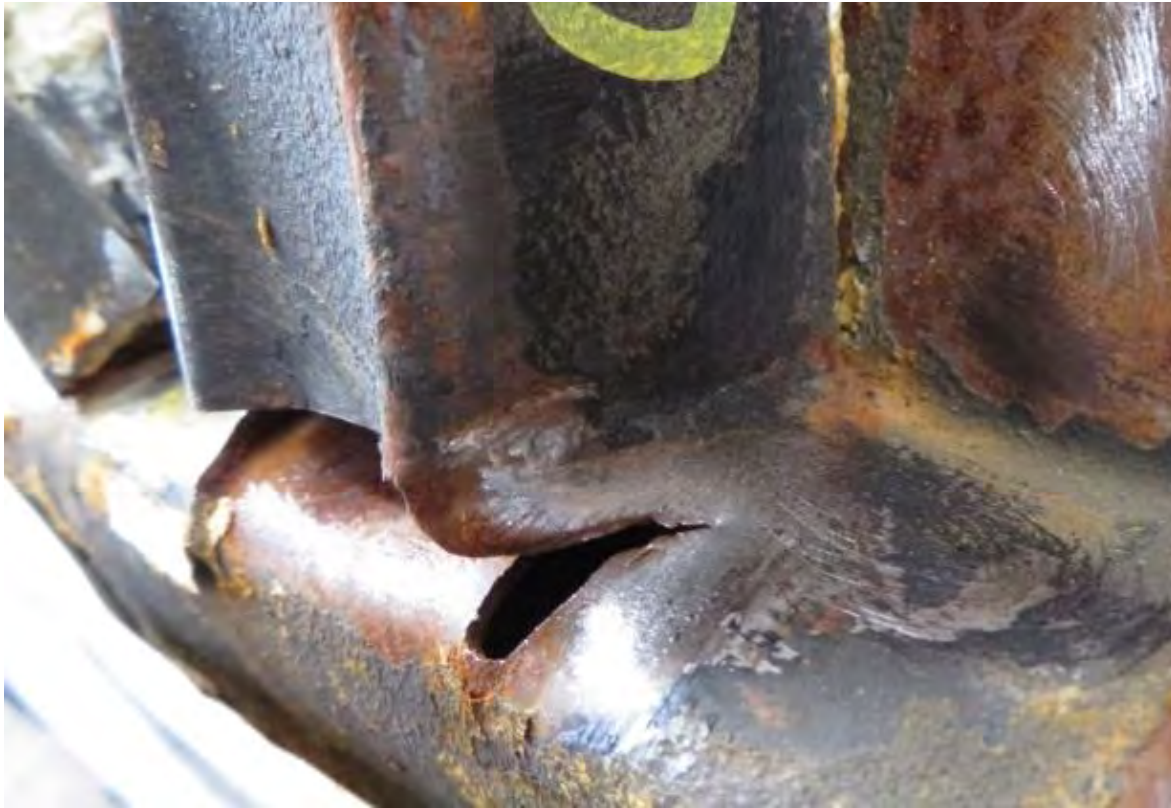
Ms. Ewing also stated that “the collision was so severe and violent that there was even base metal tearing in the tube itself.” Ms. Ewing’s conclusion is misleading because it omits the fact that the majority of tubular tearing occurred in the Heat Affected Zone (HAZ) of the base metal, and the weld interface. Common fatigue spots when welding processes are not proofed, documented and controlled. See Figure (3). AWS requires that all welding be controlled by a WPS (Welding Procedure Specification), which will control the amount of Joules heat input ingested into the base metal, changing the molecular structure, and resulting in a change in the mechanical properties of the parent metal. Manufacturers are required to proof their processes and demonstrate weld soundness by methods of destructive and non-destructive examination to ensure sound weld quality. Ms. Ewing mentioned visual inspection and macro-etch testing – these are two ways to test the soundness of a weld and should be applied prior to fabrication. No such test results have been furnished.

Figure (3) Tearing in the Heat Affected Zone

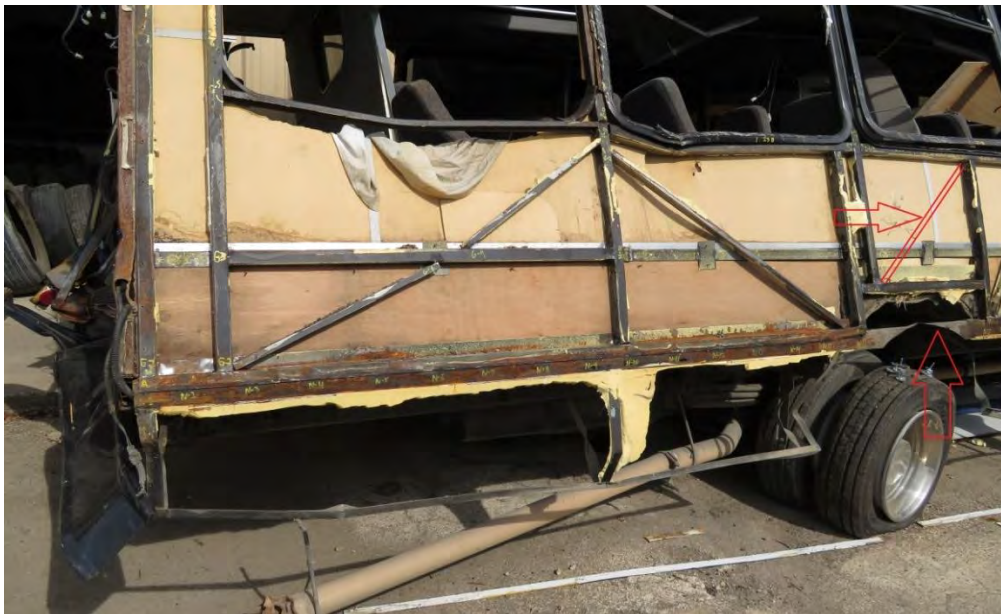
Figure (5) Missing structural members missing and cut

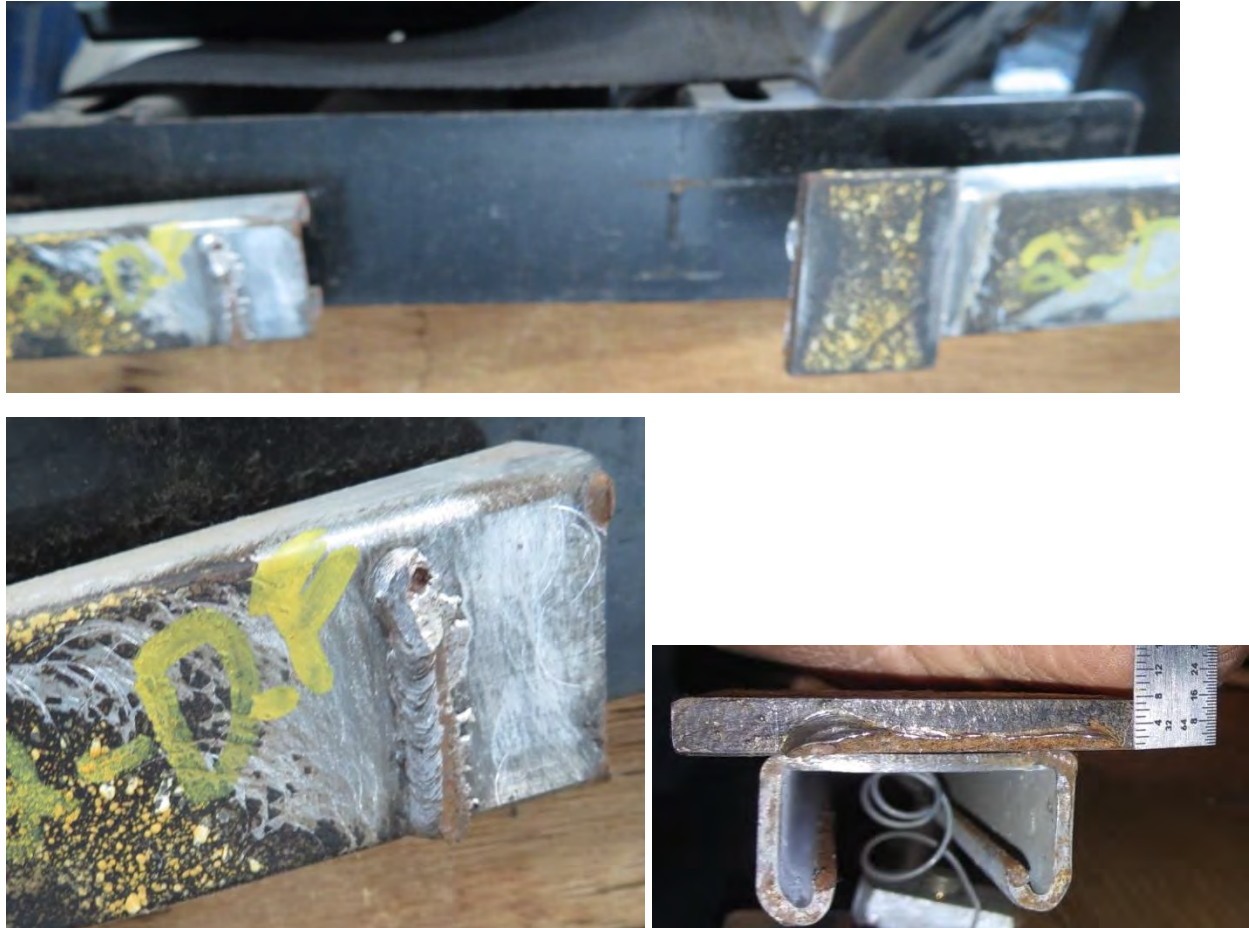
to join the spliced sections is not listed, dimensioned or specified on the Champion Defender Bus manufacturing drawings. As is seen in Figure 8, the lack of fusion rendered these spliced sections unsatisfactory to an AWS Acceptance Criteria. When welding non-coated, versus coated, material (this Channel is Zinc coated or 'galvanized'), D8.8M/2014 specification requires that "the filler metal shall conform to the requirements of the appropriate AWS filler metal specifications. Filler metals used to weld zinc coated steel shall be evaluated for their compatibility with zinc coatings."

Figure (6) Spliced C Channel Seat Track Back Weld Failure

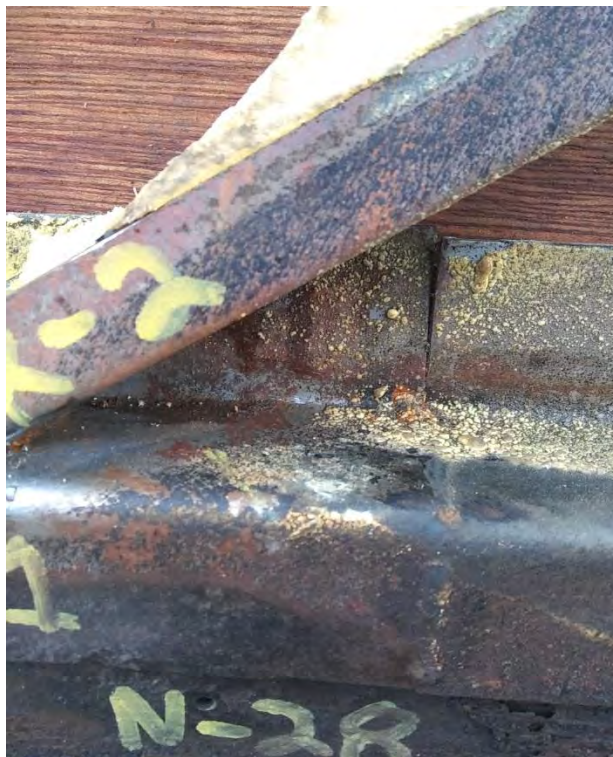
Figure (1)

Passenger Side: Section L2(P) Item D & E, Z sidewall 16GA x 96.00 and Z sidewall 16GA x 74.00 vertical section of joint not welded (Figure 1)

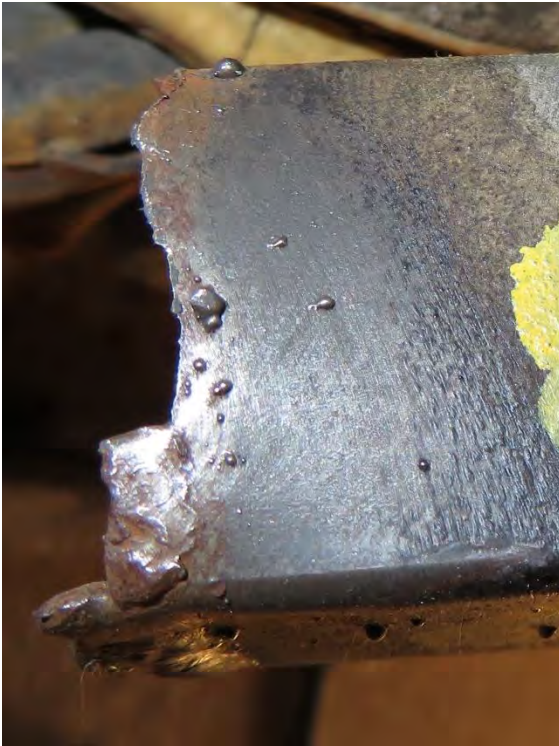
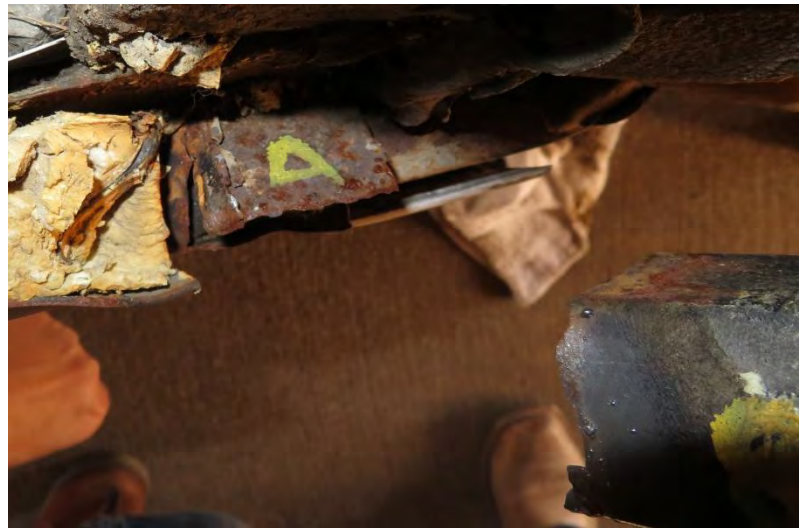
7-C: Tubing ripped away from weld toes

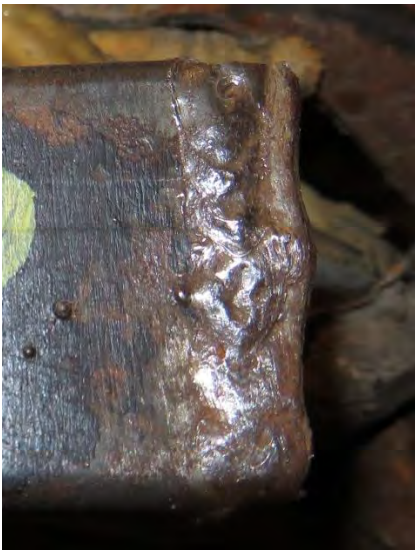
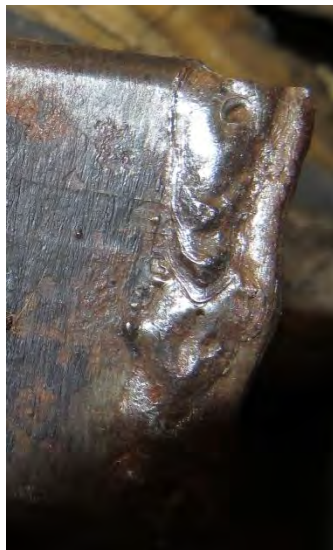
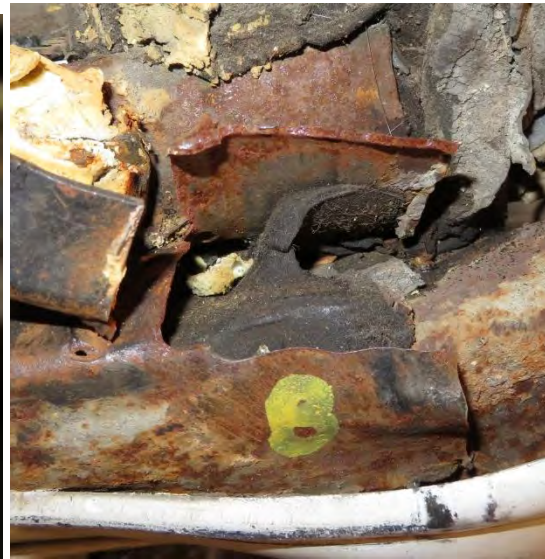
8-CA: Failure in the overlap region of the weld.

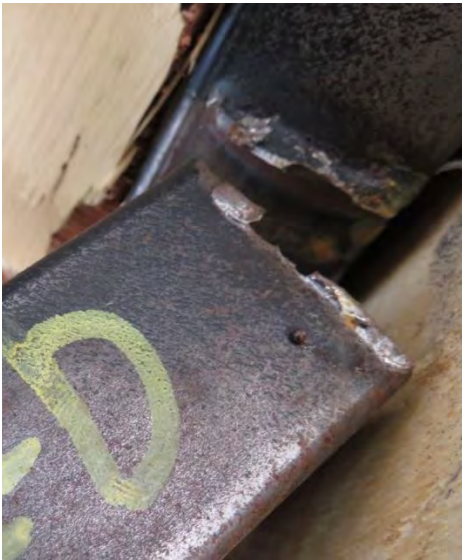
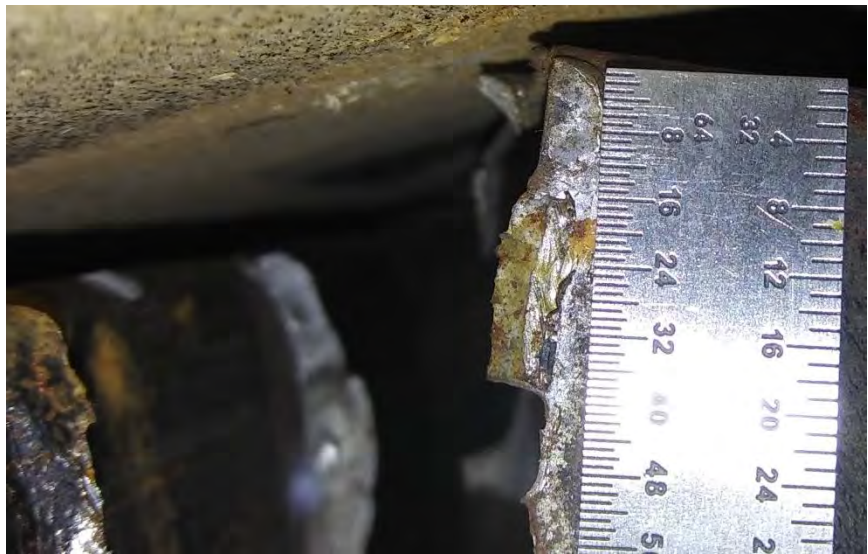
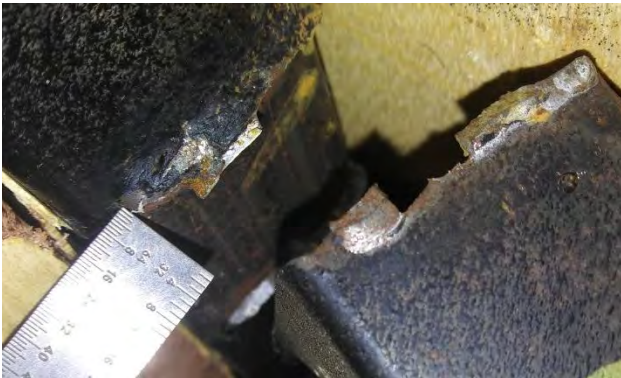
8-CB: 5.1.2 Craters, possible failure in HAZ (Heat Affected Zone)

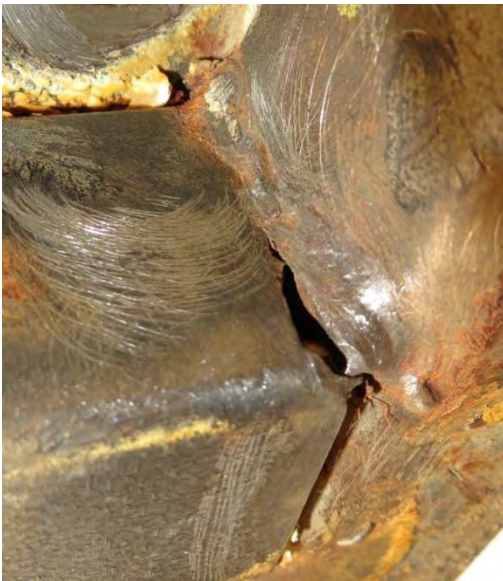
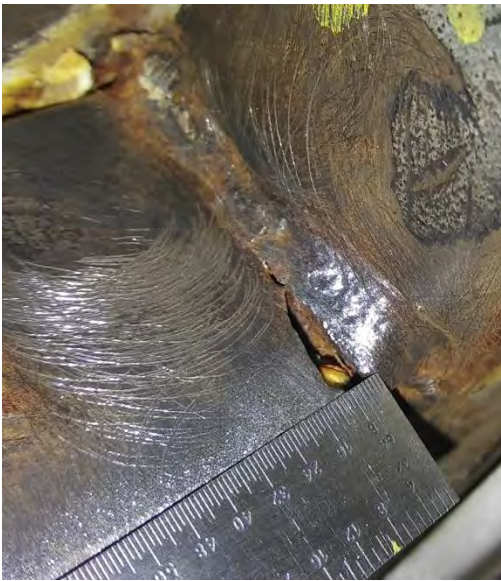
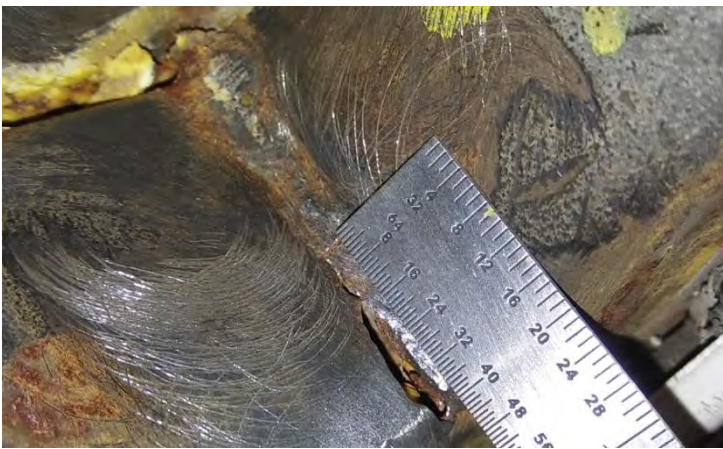
2-E: 5.1.10 Overlap₂. 5.1.2 Craters₁

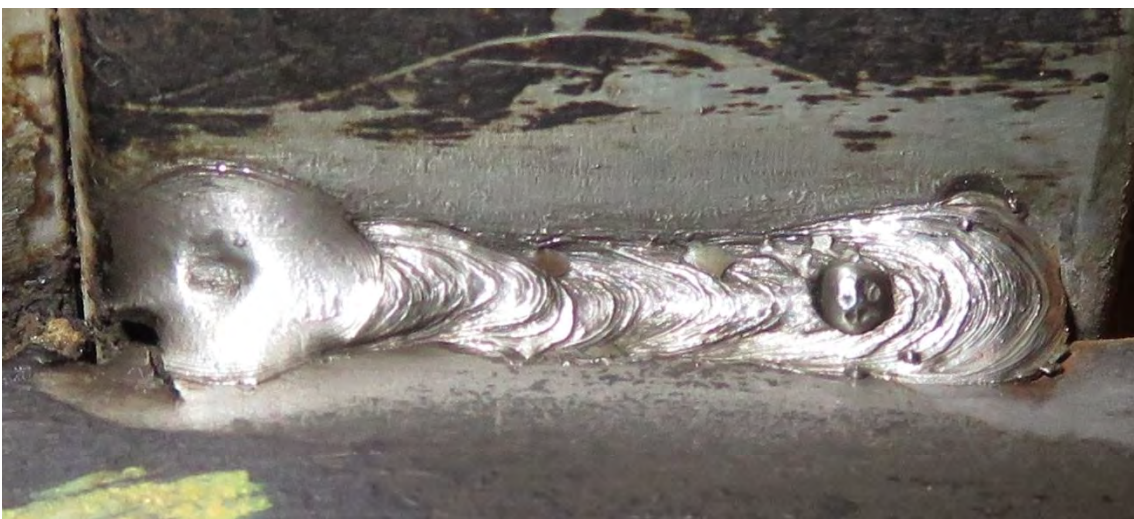
3-E: Loss of HSS due to suspect corrosion -Height $11/64''$, width $45/64''$, 5.1.2 Craters₁,

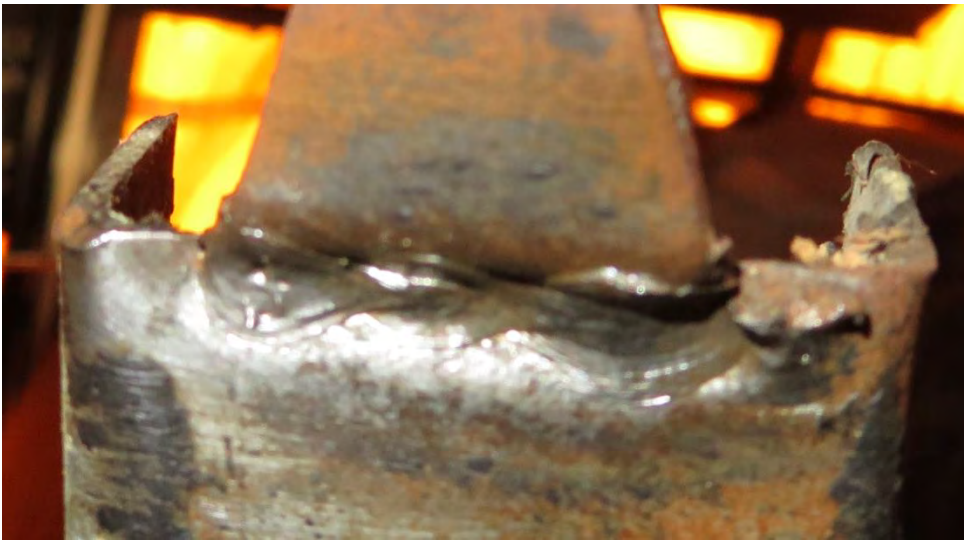
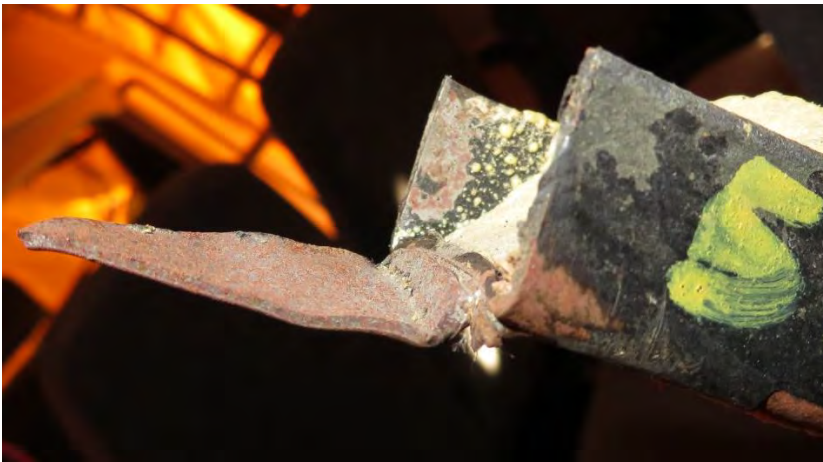
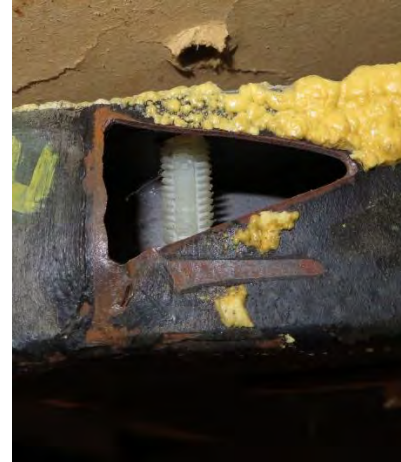
4-E: Incomplete fusion - Ref Table 1: Common Types of Discontinuities₄, 5.1.2 Craters₁, 5.1.10 Overlap₂, 5.1.3 Cracks₉,

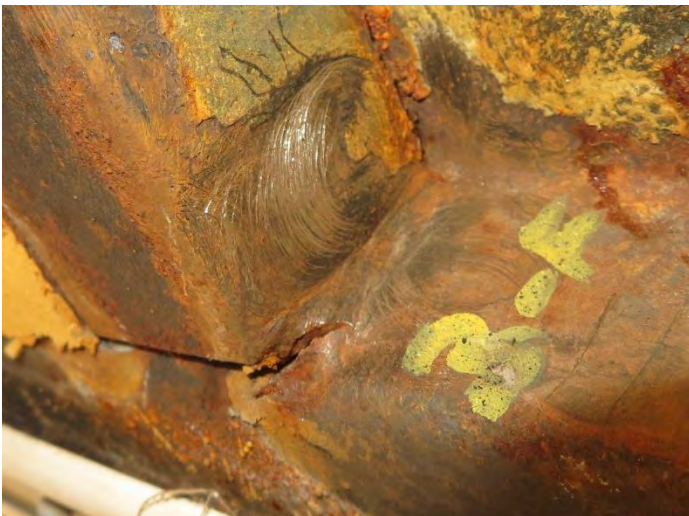
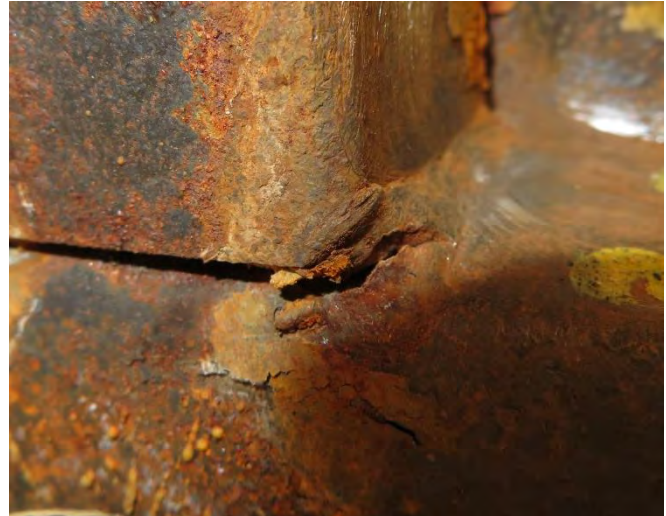
2-F: 5/32" Incomplete fusion - Ref Table 1: Common Types of Discontinuities₄, 5.1.2 Craters₁,

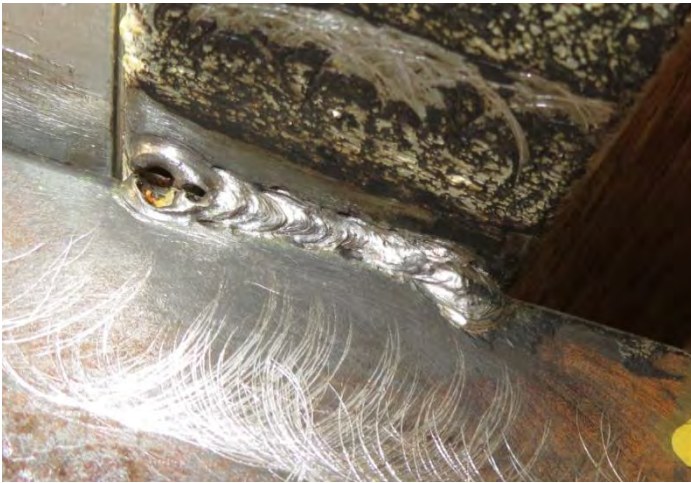
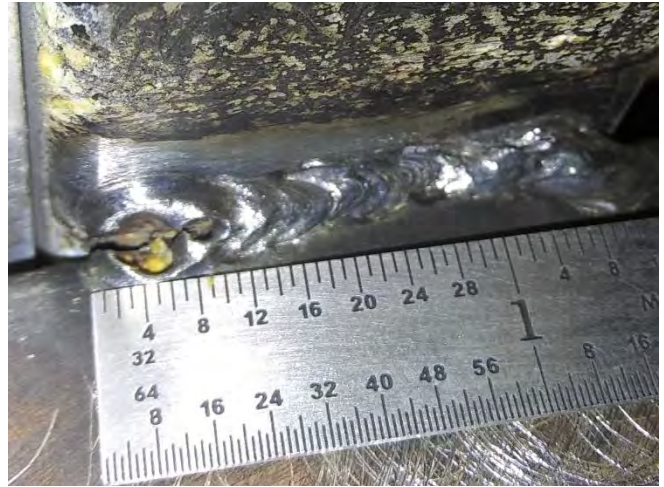
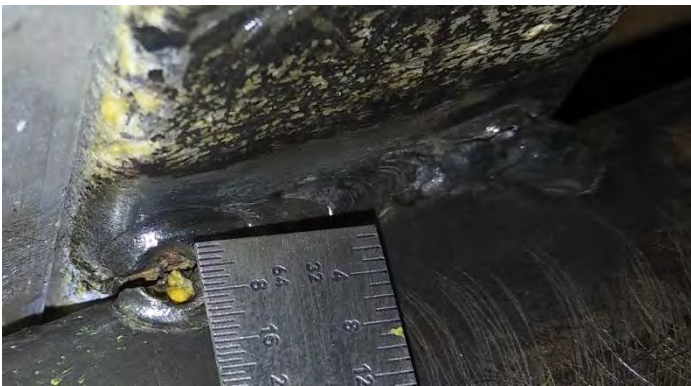
3-F: 5.1.3 Cracks₉ - crack is located in Crater (5.1.2 Craters₁), 5.1.10 Overlap₂, 5.1.12 Combination of Discontinuities₃ applies but is over-ruled due to sub-clause 5.1.3 Cracks.

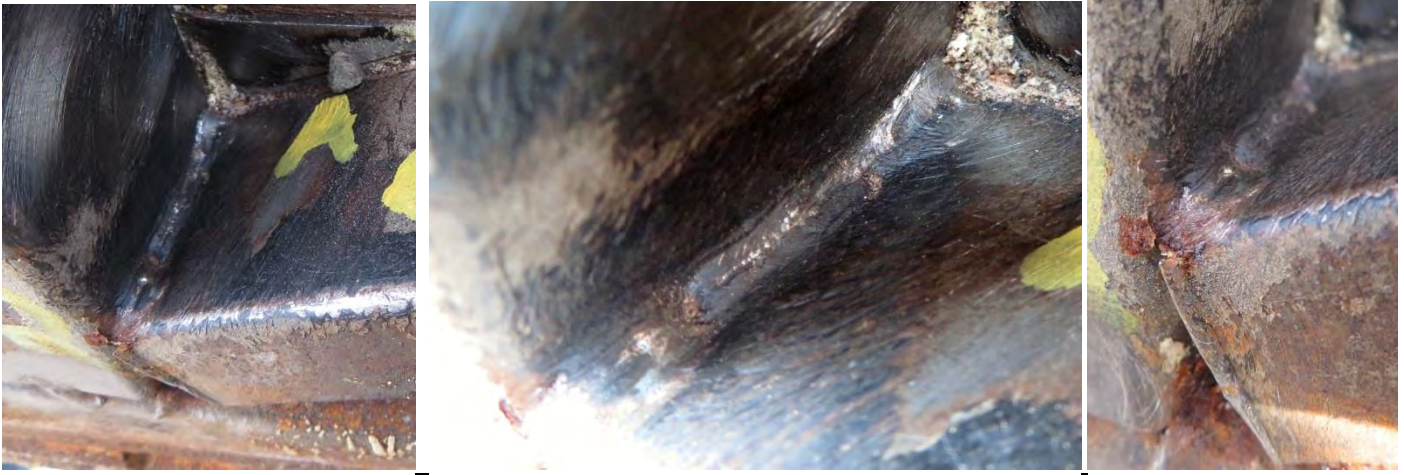
G-3B: 5.1.10 Overlap₂, 5.1.2 Craters₁

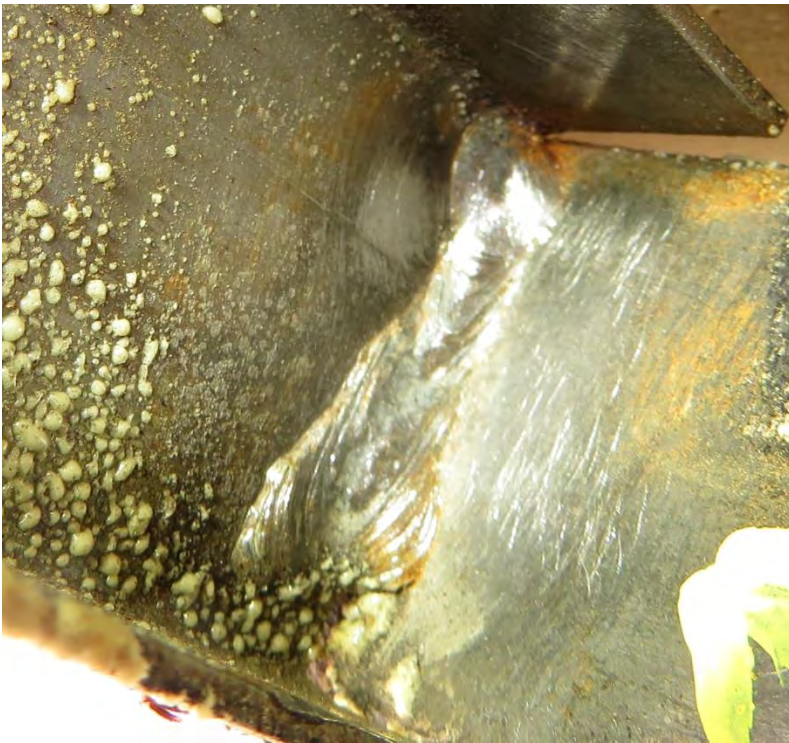
G-4A: 2 x 5.1.2 Craters₁, 5.1.3 Cracks₉ - crack is located in Crater.

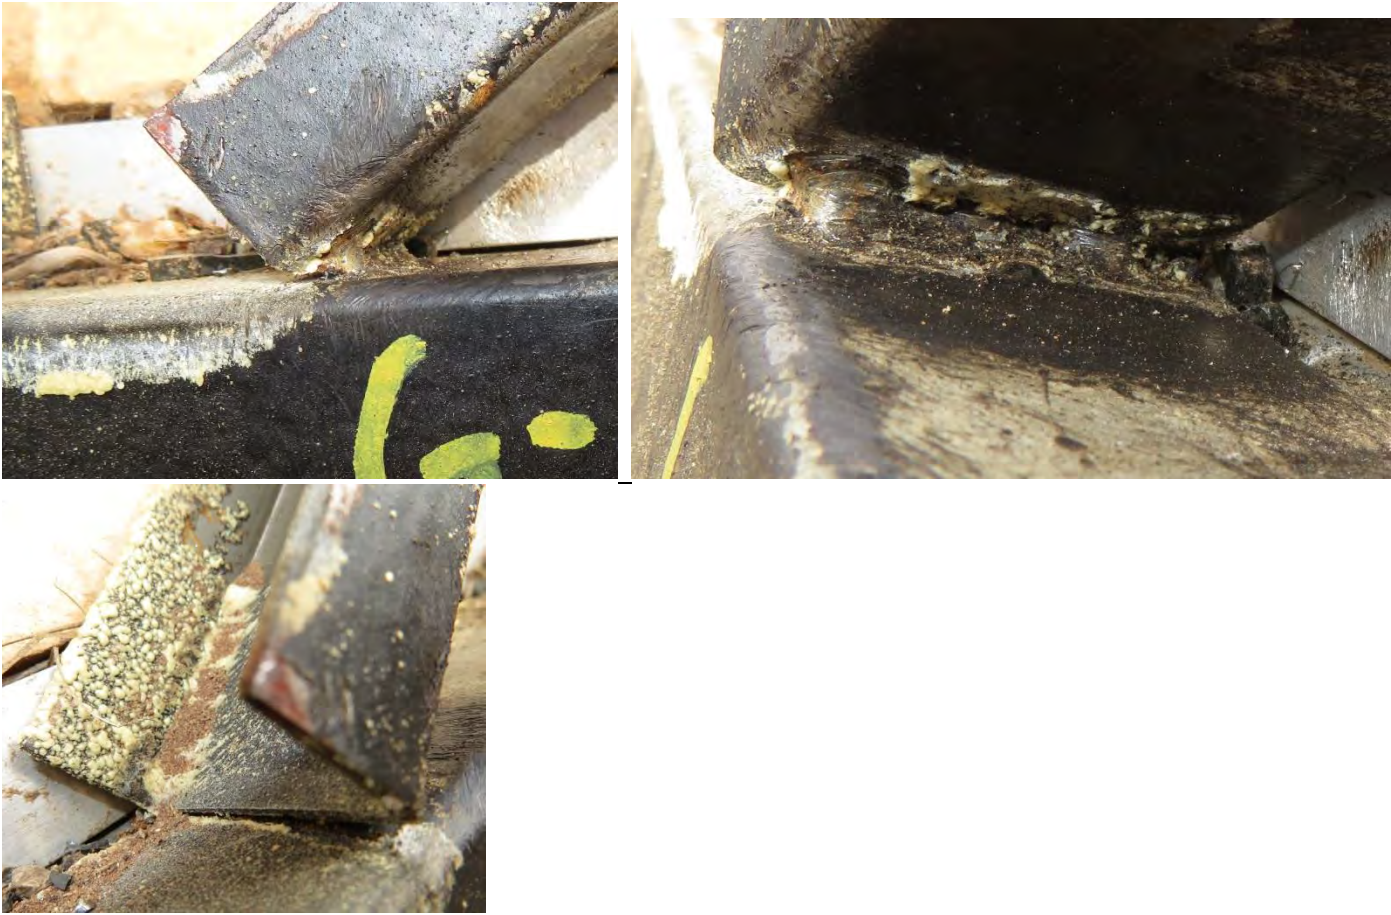
G-8: 1/8" Incomplete Fusion - Ref Table 1: Common Types of Discontinuities₄, 2 x 5.1.2 Craters₁.

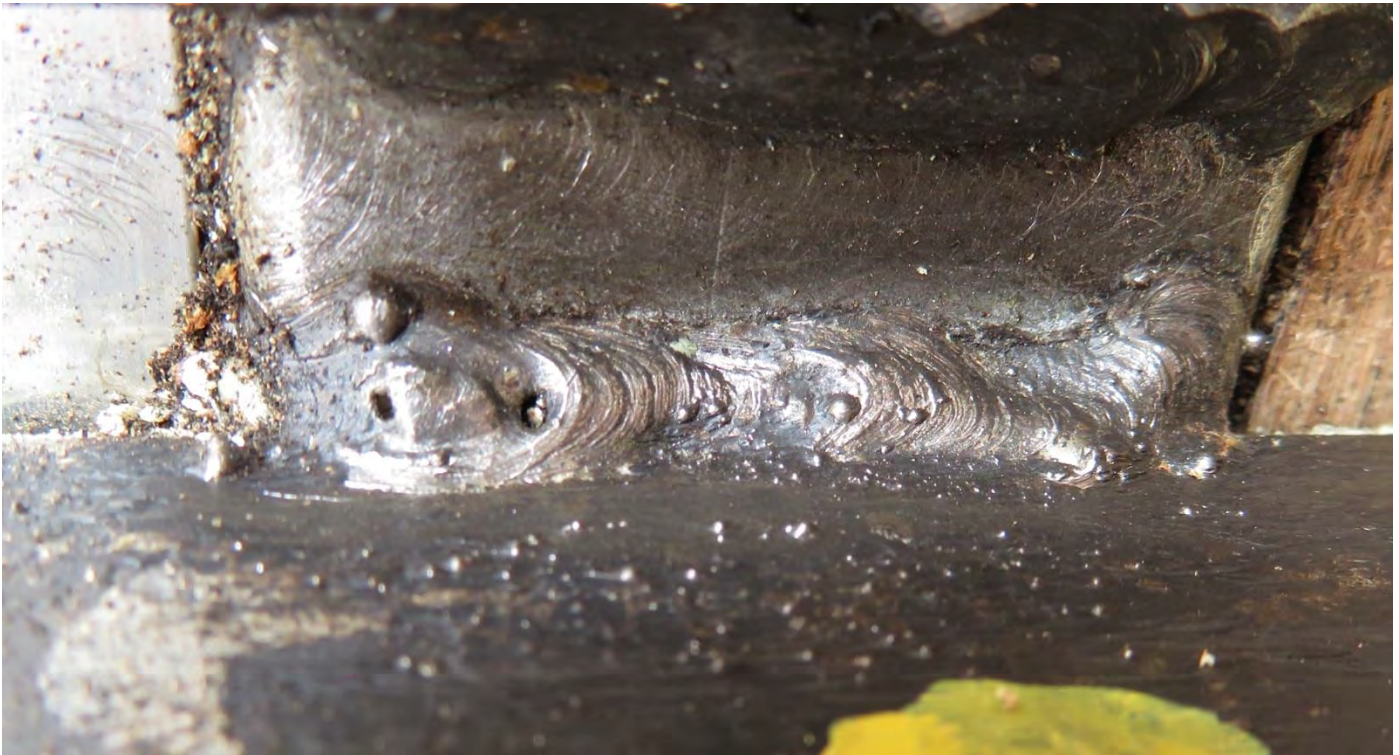
H-9: 5.1.2 Craters₁, 5.1.7 Meltback₁₁, 1/8" Incomplete Fusion - Ref Table 1: Common Types of Discontinuities₄.

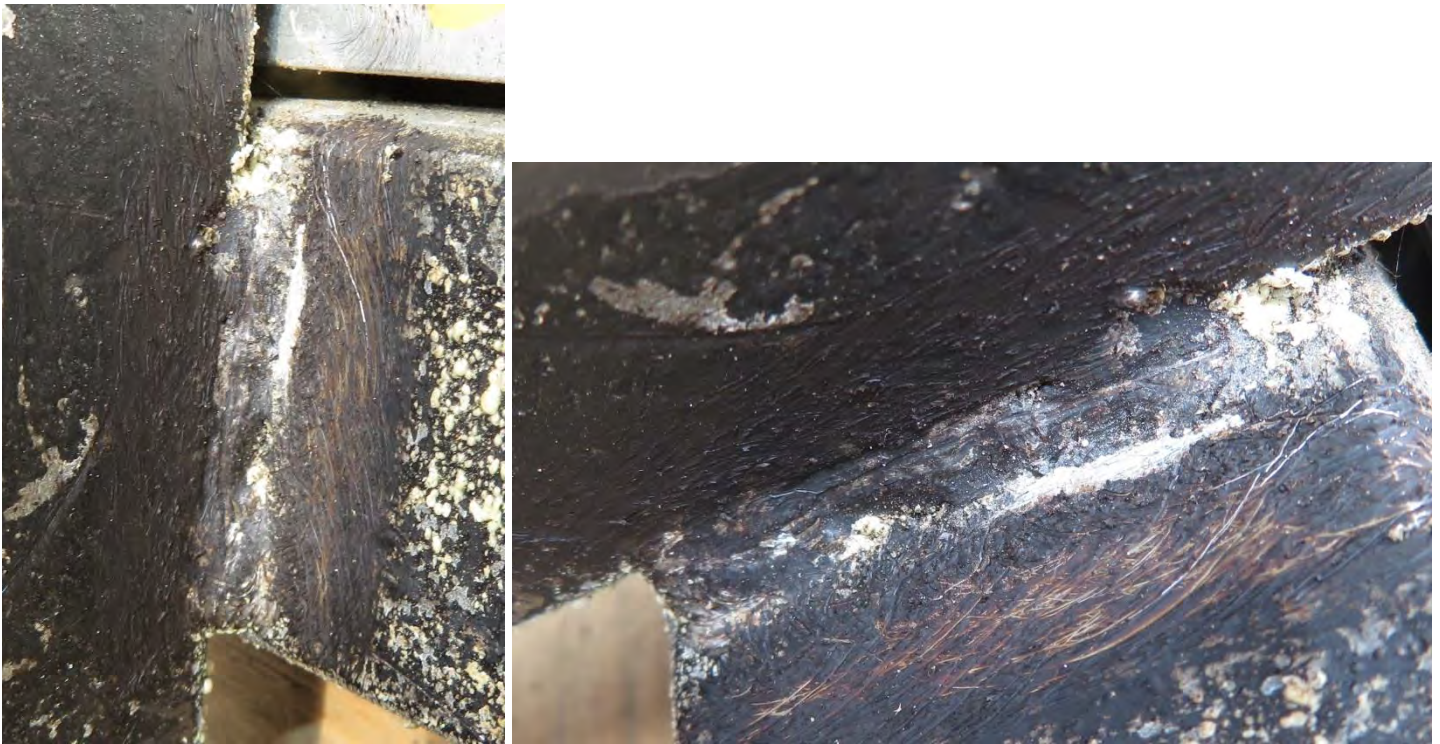
I-1: 5.1.2 Craters₁,

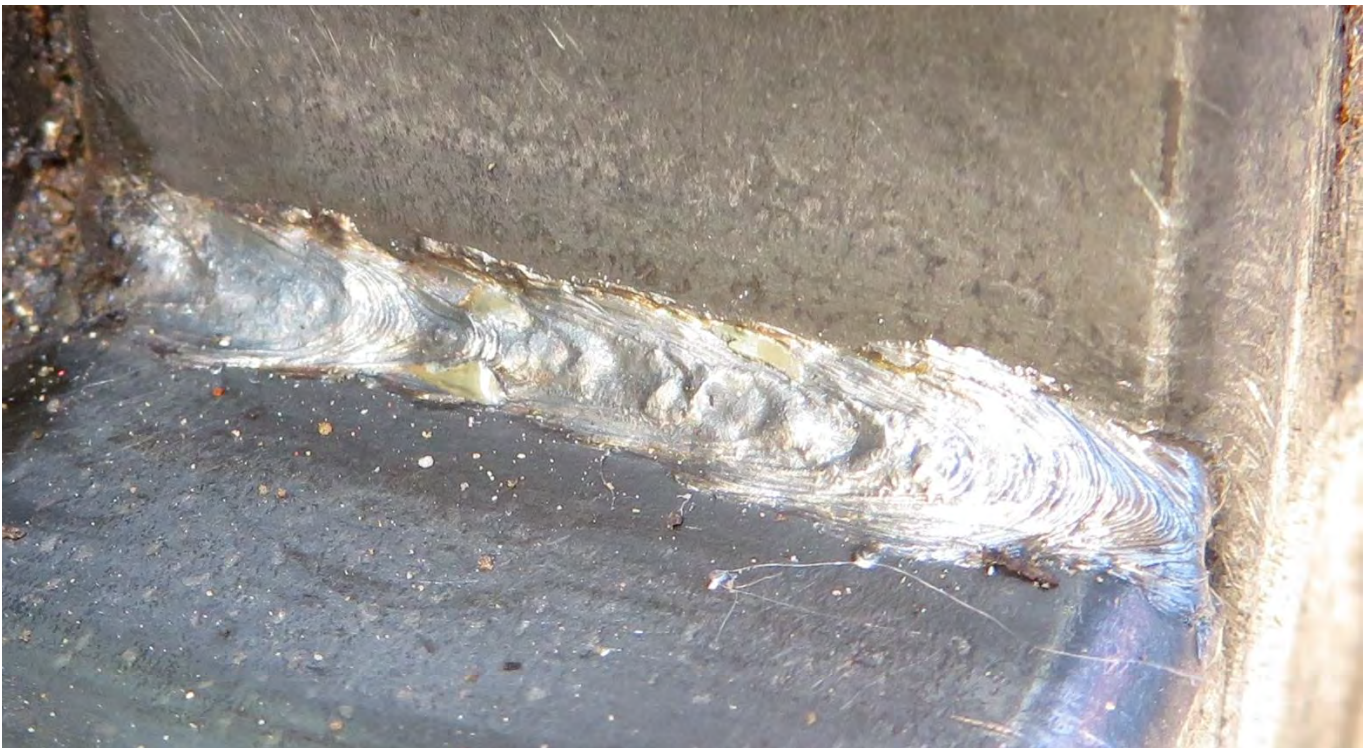
I-2: 1/8" Incomplete Fusion - Ref Table 1: Common Types of Discontinuities₄, 5.1.1 Undercut₁₀ T = 0.0625". 0.2T = 0.0125" (= permissible depth of undercut in this weld). Actual depth of undercut in this weld is 0.031 (1/32"). Length of undercut is 3/16".

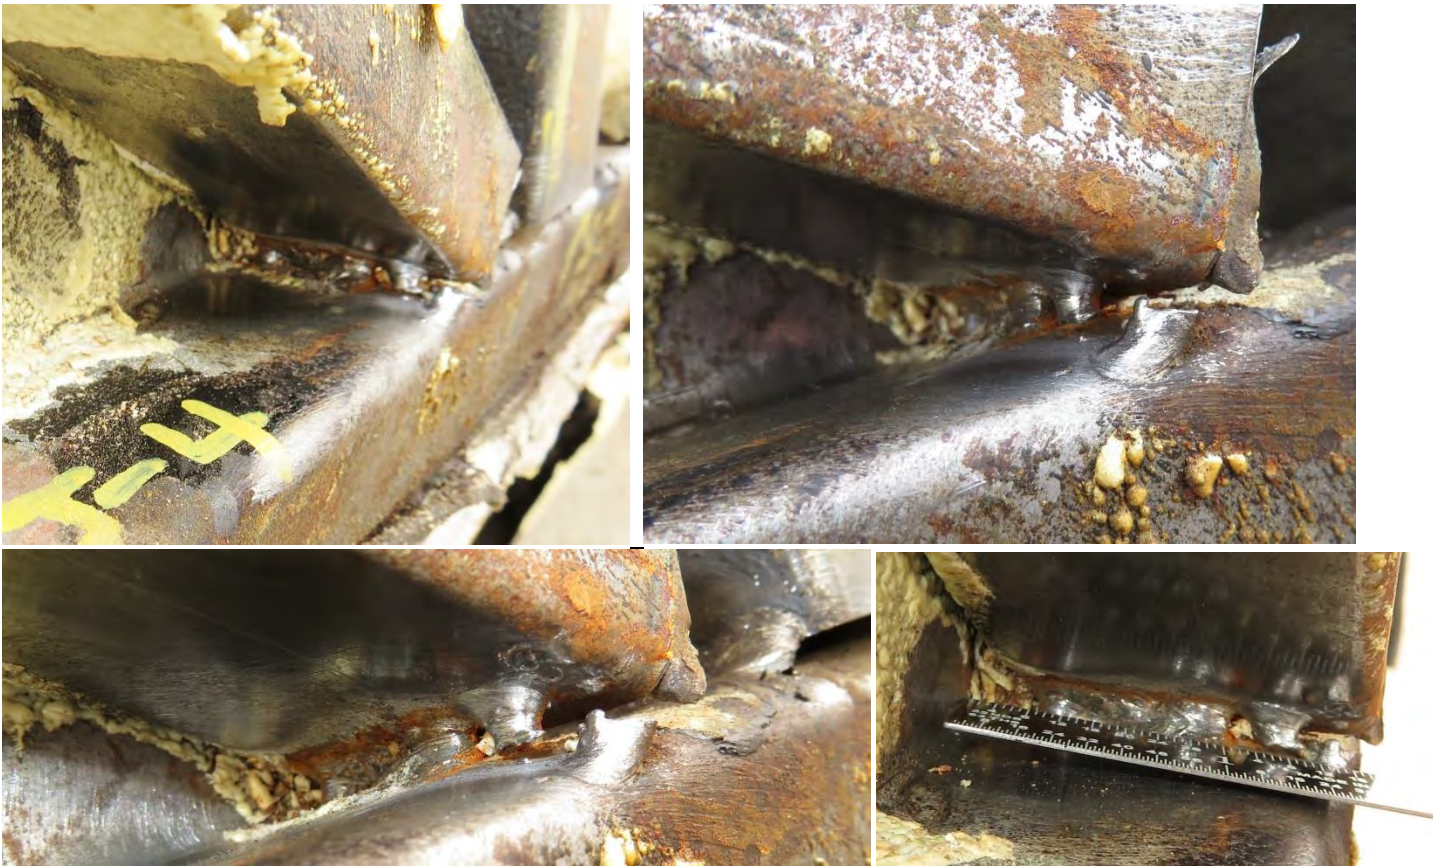
J-3A & B: Refer to Macro-etch Report

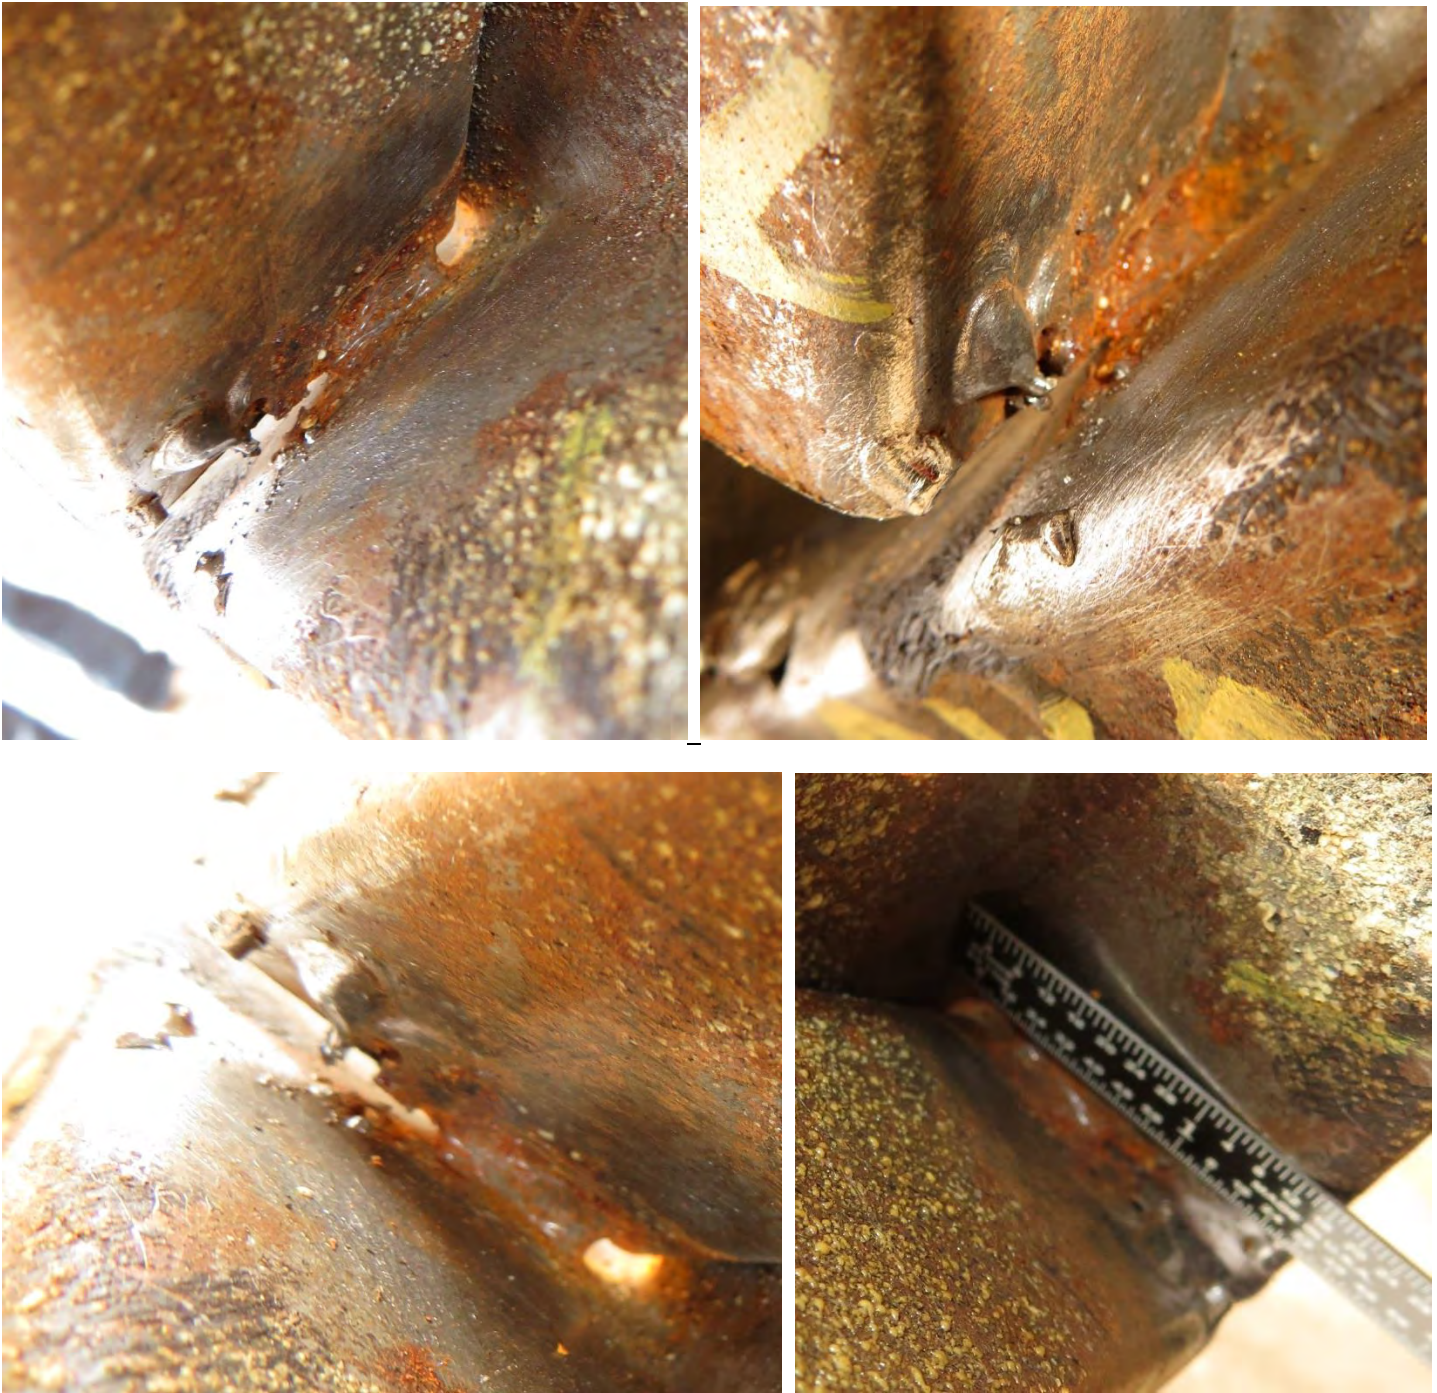
K-1: HAZ (Heat Affected Zone) / toe of weld tearing 1/4"
