INSPECTION OF CHAMPION DEFENDER BUS :

DRIVER SIDEWALL, FRAME (PART # 0414250)

PASSENGER SIDEWALL, FRAME (PART #0414249)

Re: Champion Defender bus accident, Davis, Oklahoma

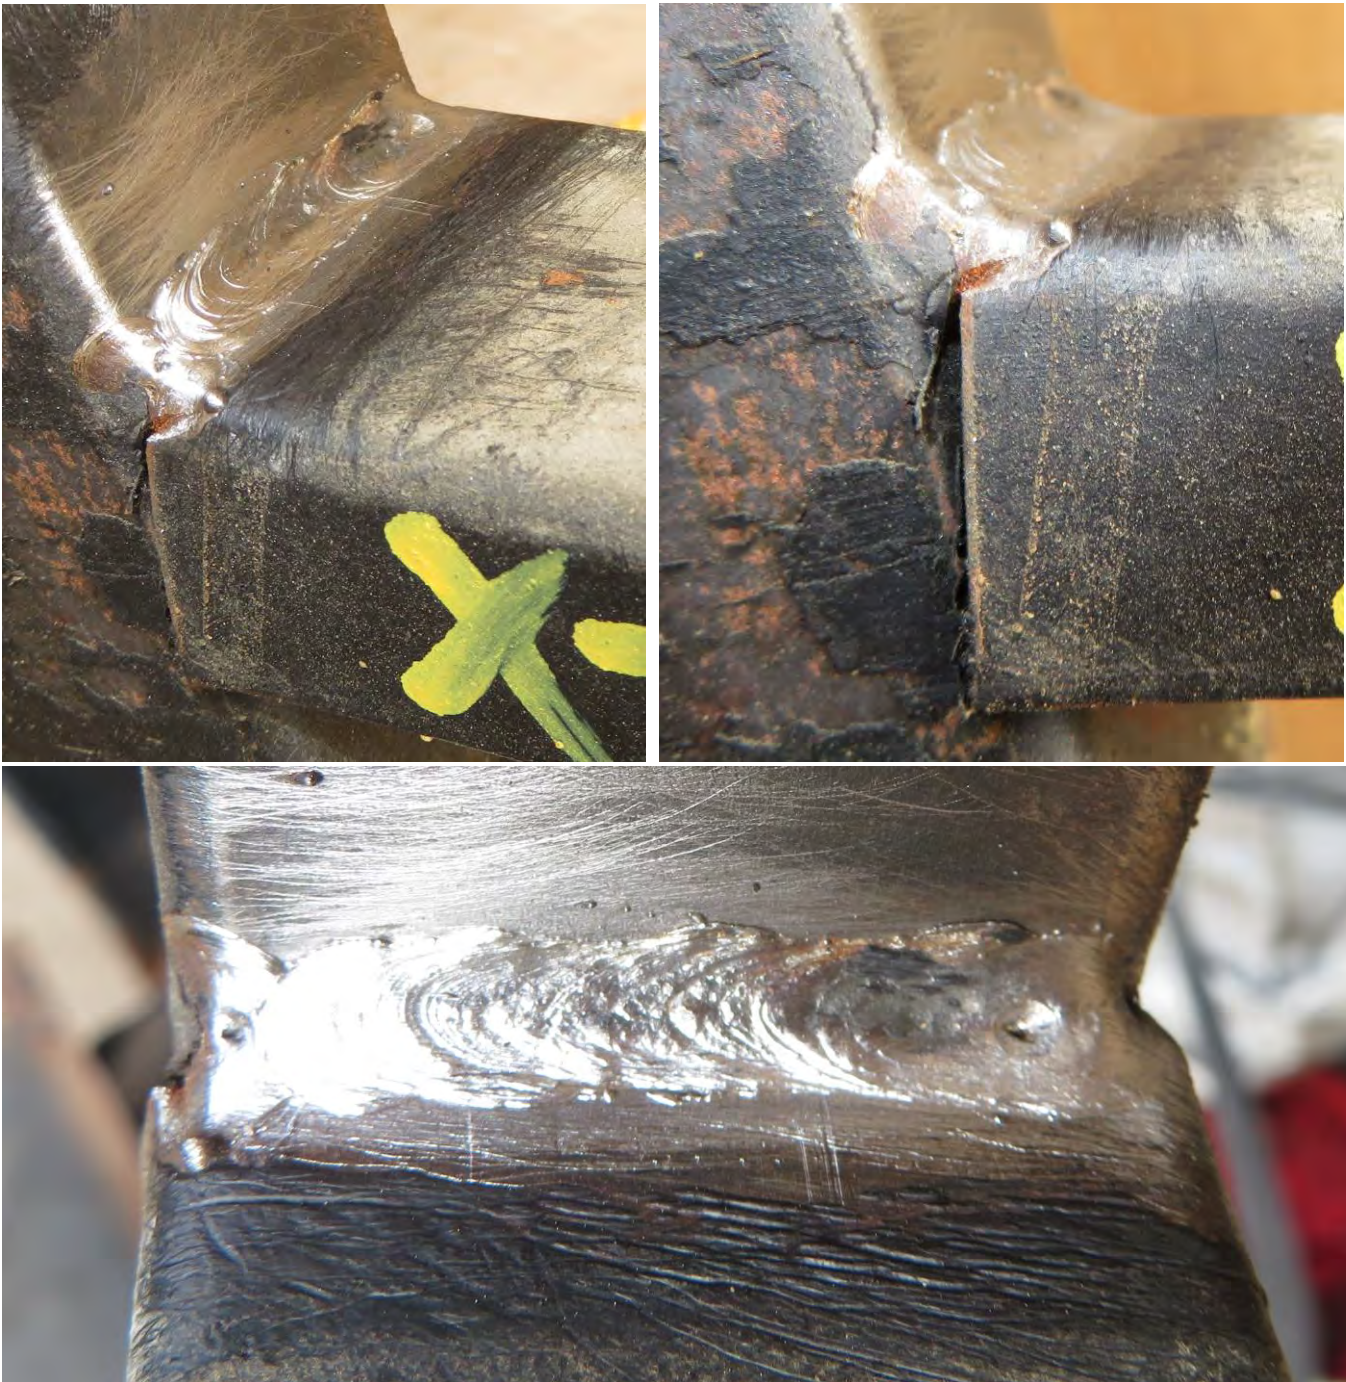
X-10: 5.1.2 Craters₁,

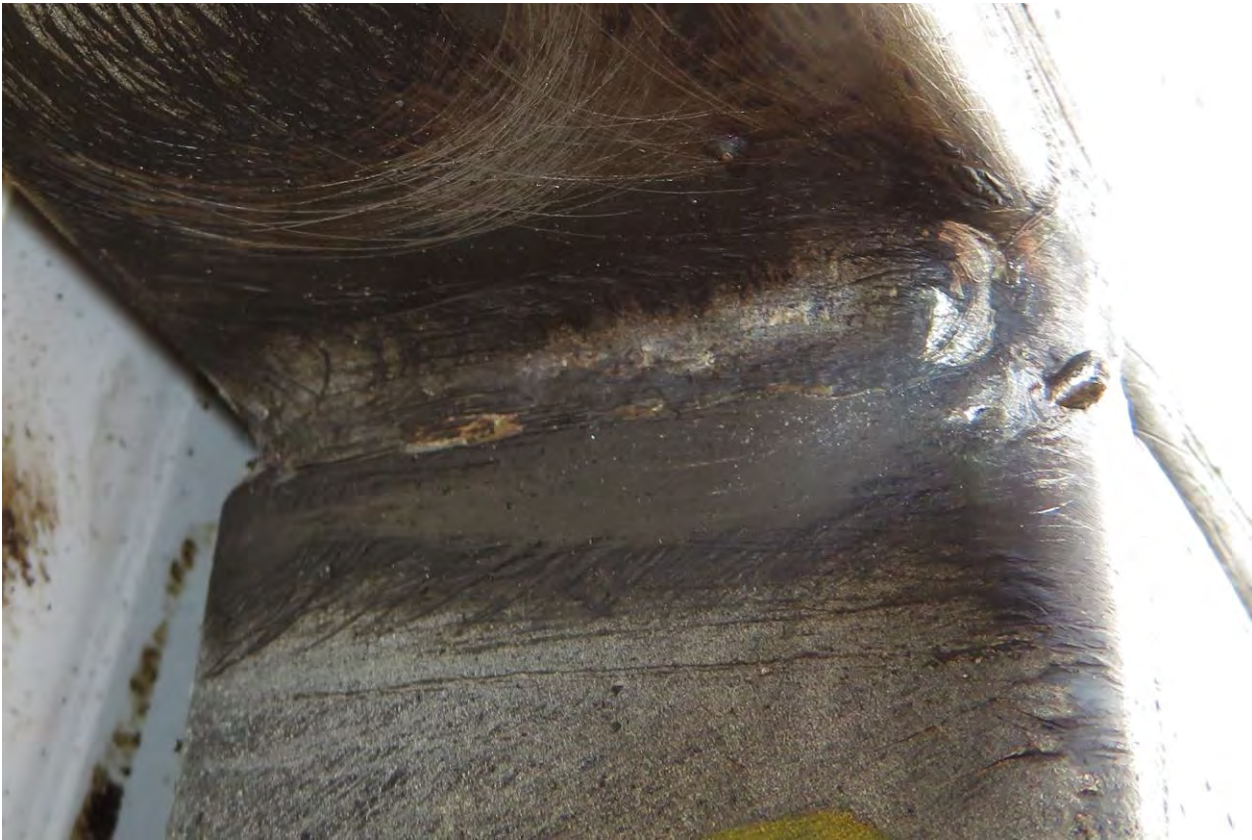
X-18A: OK
