Neil Hannemann  
Automotive Engineer  
26811 NE Highland Meadows Drive  
Vancouver, WA 98682

Re: **Seebachan v. John Eagle et. al.**

I have studied the crash safety performance of the 2010 Honda Fit in which Matthew and Marcia Seebachan were seriously injured. I inspected the vehicle on May 15, 2015 and again on July 28, 2015. I inspected the removed fuel tank on July 28, 2015. I have also reviewed the police report and photographs from the accident scene. Based on my inspection, research, education, training and experience as well as my own engineering judgment, I have formed opinions regarding the safety performance of the subject vehicle in this crash. Prior to stating my opinions, here is a brief outline of portions of my education, training and experience with crashworthiness and vehicle design analysis that applies to the particular disciplines required to effectively render an opinion in this case.

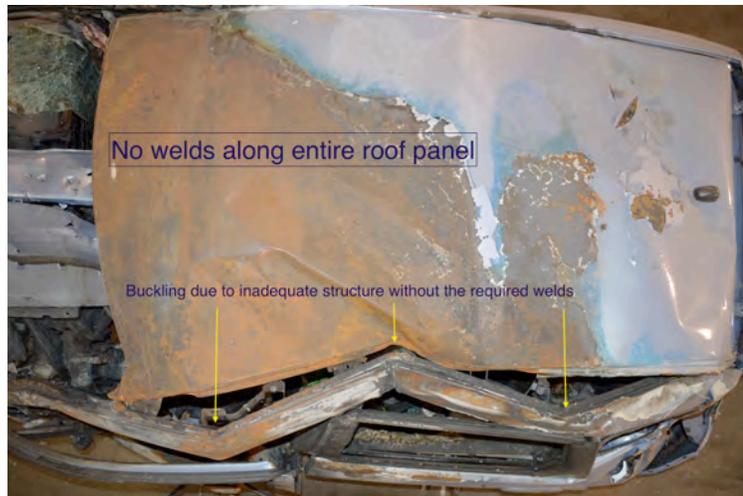
3. The roof panel, which was replaced, was not welded on as part of the repair procedure. John Eagle Collision was responsible for welding the roof on and they failed to perform the necessary welding. Figure 3 shows the failure of the roof in the area where there should be spot-welding. It can be seen that no welds are present. The buckling of the cant rail is due to the lack of welding of the roof panel, which was designed to be welded on and acting as a shear panel for sharing crash loads.

Figure 3 – Defectively repaired Honda Fit roof

- C. The roof was defectively attached to the vehicle structure by John Eagle Collision Center. It is effectively disconnected from the structure and did not provide the necessary contribution to the overall vehicle structure. There are no welds at the flange between the roof and the cant rail.

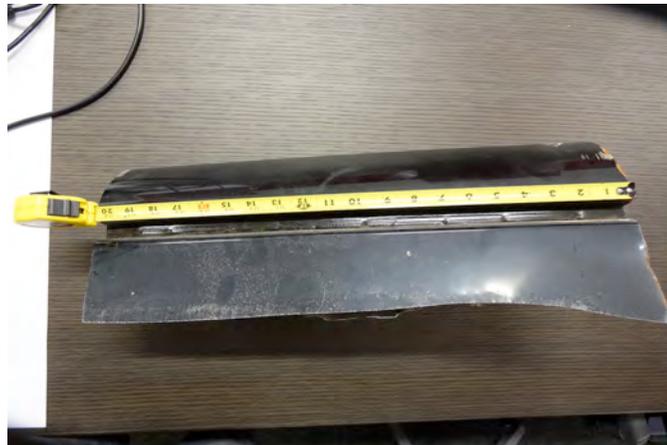
4. A section of the roof structure of an exemplar 2010 Honda Fit was obtained and inspected. The spot welding that Honda performed in the manufacturing of the Honda Fit can be seen in this section of the roof structure as shown below in Figure 4.

Figure 4 – Original Honda spot welding

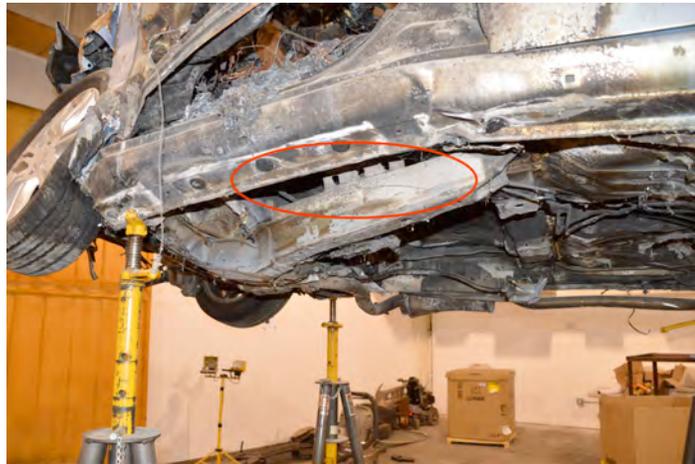
5. The affect on the upper structure is seen as the roof cant rail has buckled in three locations along its length. There is a corresponding affect on the underbody structure of the vehicle. When the upper structure cannot carry the loads that it was designed for due to the roof panel welds having been omitted during repair, the loads on the underbody are increased. These increased loads, which the Honda Fit was not designed for, caused failures of the underbody that were not intended.

6. A further consequence of the omission of the required roof welding was that the entire structure of the Honda Fit, which relies on a properly welded roof structure, was compromised and could not perform as intended. This affected both the upper and lower structure. Figures 4 and 5 show the failures of the lower structure. Both of the lower frame rails have failed and become disconnected from the vehicle body. The left side structure failure compromised the fuel tank.

Figure 4 – Failures of the lower structure

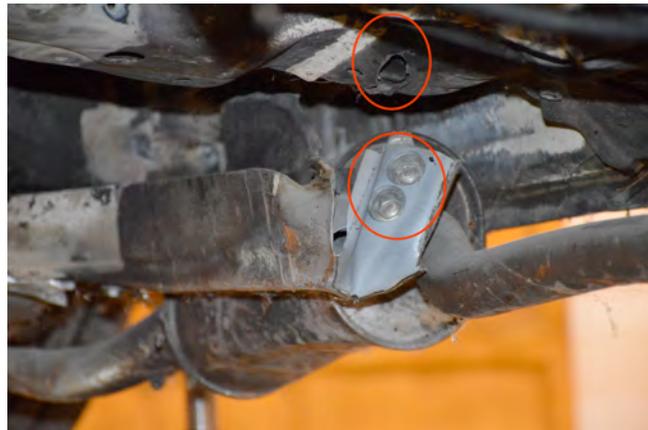
Figure 5 – Failures of the lower structure

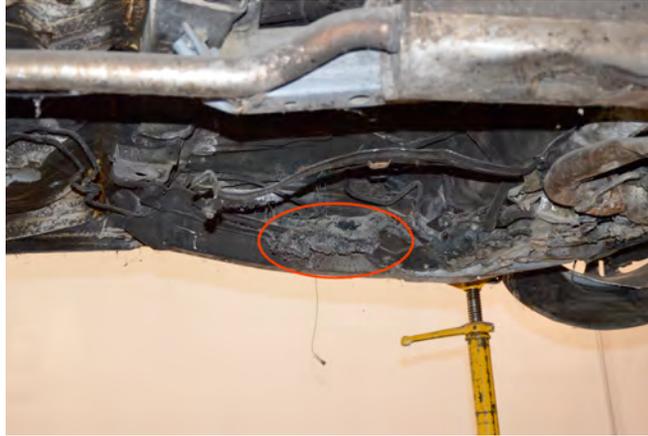
7. There is fuel tank material deposited on the left side structure (, 6 and 7). This structure failed for the structural reasons described above and is the direct cause of a compromise to the fuel tank, allowing fuel to escape.

Figure 6 – Fuel tank material on failed structure

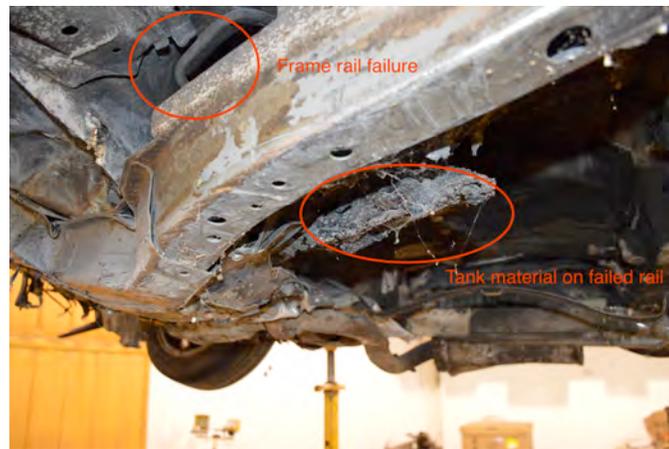
Figure 7 – Fuel tank material adjacent to failed structure

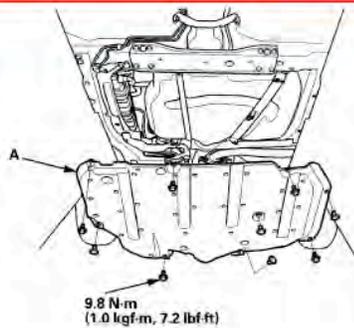
1. The 2010 Honda Fit fuel tank design included four items that were intended to protect the fuel tank. A fuel tank guard, and fuel tank protector and, depending on if the vehicle is an automatic or manual transaxle, a fuel tank cover or a floor under cover. Figure 8 is a page from the 2010 Honda Fit service manual that describes these features as part of the fuel tank replacement procedure.
2. The item referred to as a fuel tank cover or floor under cover was missing from the vehicle at the time of my inspection. I could find no evidence that the tank cover or floor under cover was present at the time of the collision and the subsequent fire.
3. Removal of the fuel tank cover or floor under cover would compromise the protection that it provides to the fuel tank.

5. Except LX (A/T model): Remove the fuel tank cover (A).
