Truck-Tractor Semitrailer  
Median Crossover Collision  
With Medium-Size Bus on Interstate 35  
Davis, Oklahoma  
September 26, 2014

NTSB/HAR-15/03  
PB2016-100022

# Highway Accident Report

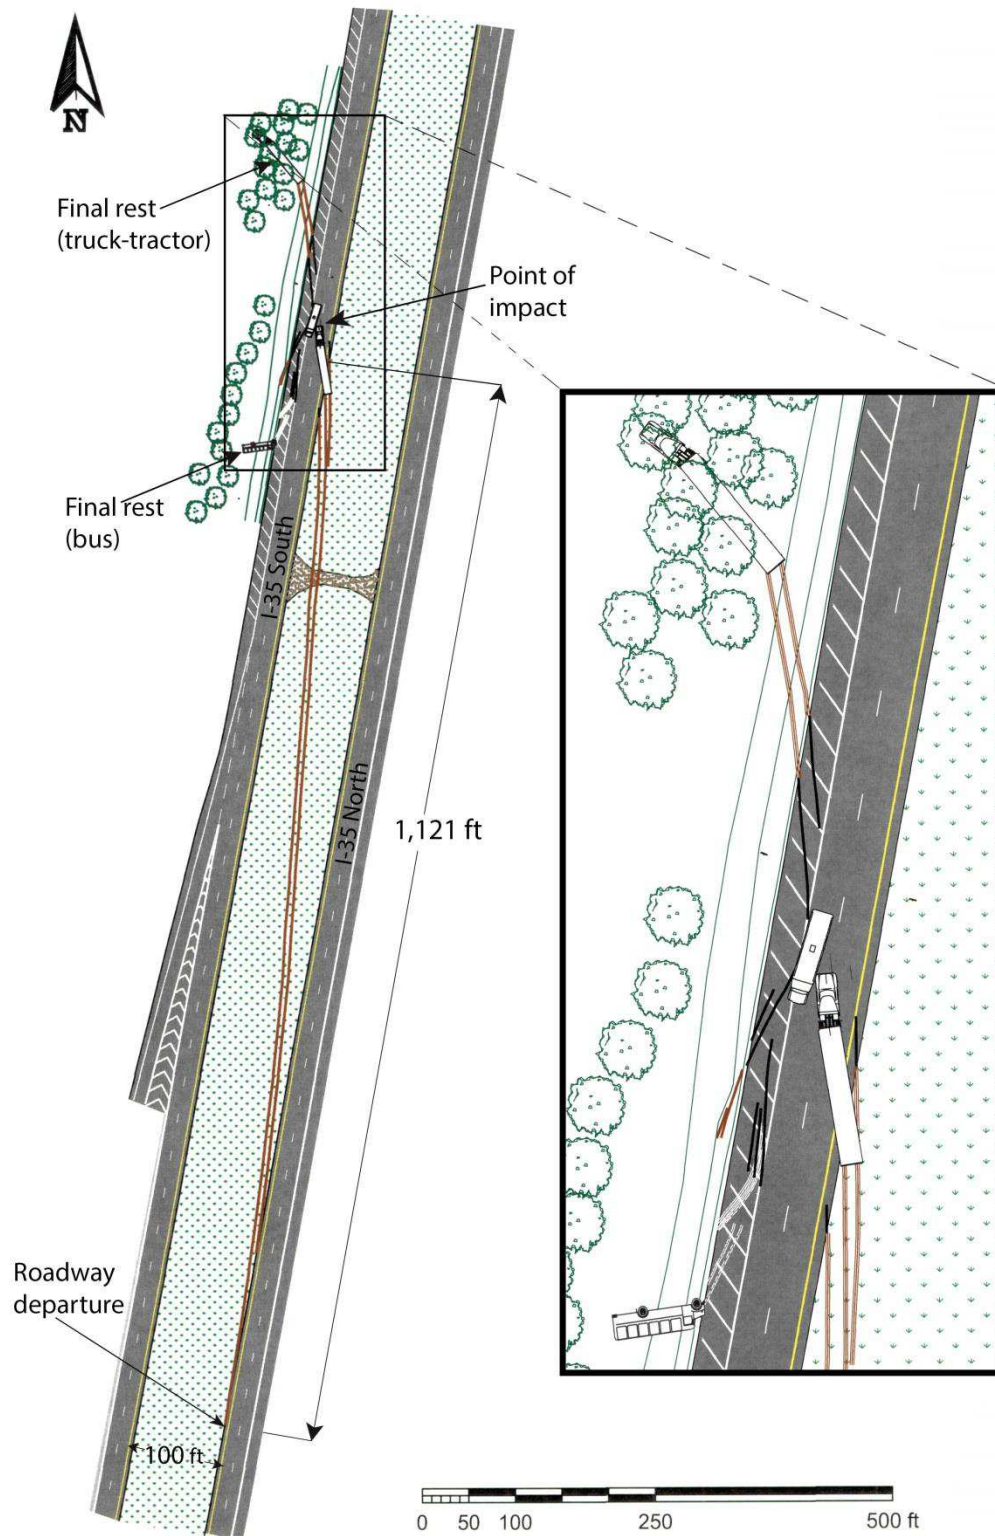
After negotiating a slight rightward curve near milepost 47, the truck-tractor departed the left lane and entered the 100-foot-wide depressed earthen median at an approximate 2 degree angle (see figure 3). The truck-tractor continued through the median at an estimated speed of 72–73 mph, traveling more than 1,100 feet. It then entered the southbound lanes of I-35 at an approximate 9 degree angle and collided with the bus. As a result of the collision, four bus passengers were fully or partially ejected and died. The remaining passengers and both drivers were injured.

**Figure 3.** Crash scene diagram showing location of roadway departure, point of impact, and final rest positions for truck-tractor and bus.

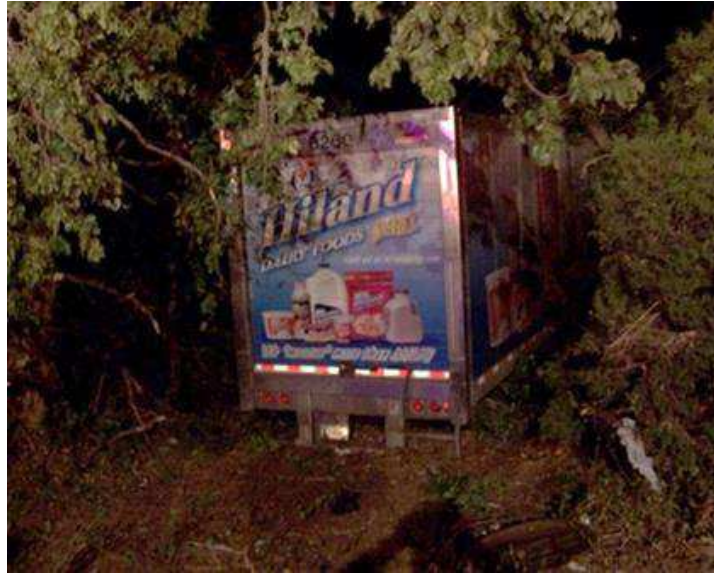
**Figure 4.** At-rest position of truck-tractor in wooded area. (Source: Oklahoma Highway Patrol)

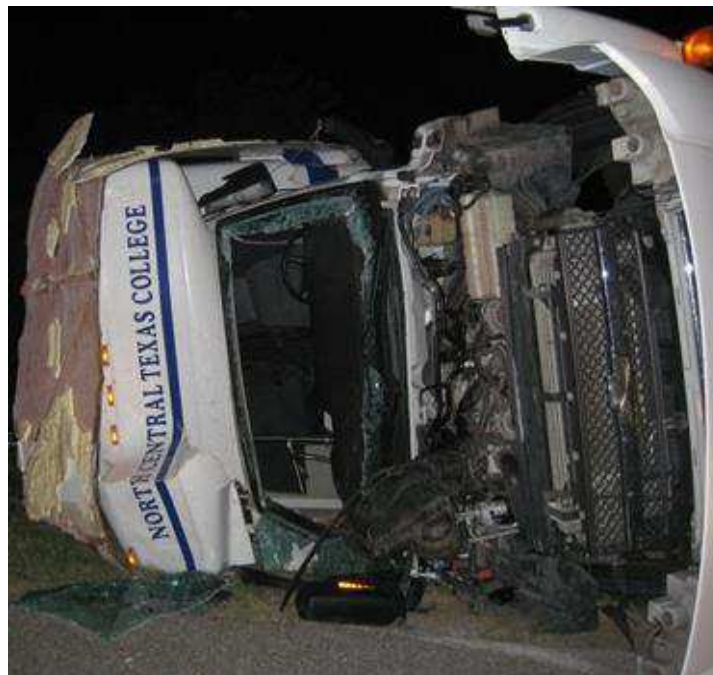
Following the collision, the truck-tractor continued off the roadway into a wooded area, and the bus rolled one-quarter turn onto its passenger side, blocking the loading door as a point of egress (see figures 4 and 5). The bus driver reported that he exited the bus after kicking out the windshield. The 11 survivors egressed through the emergency roof hatch either under their own power or with help from the bus driver and bystanders.

**Figure 5.** At-rest position of bus just off roadway. (Source: Oklahoma Highway Patrol)

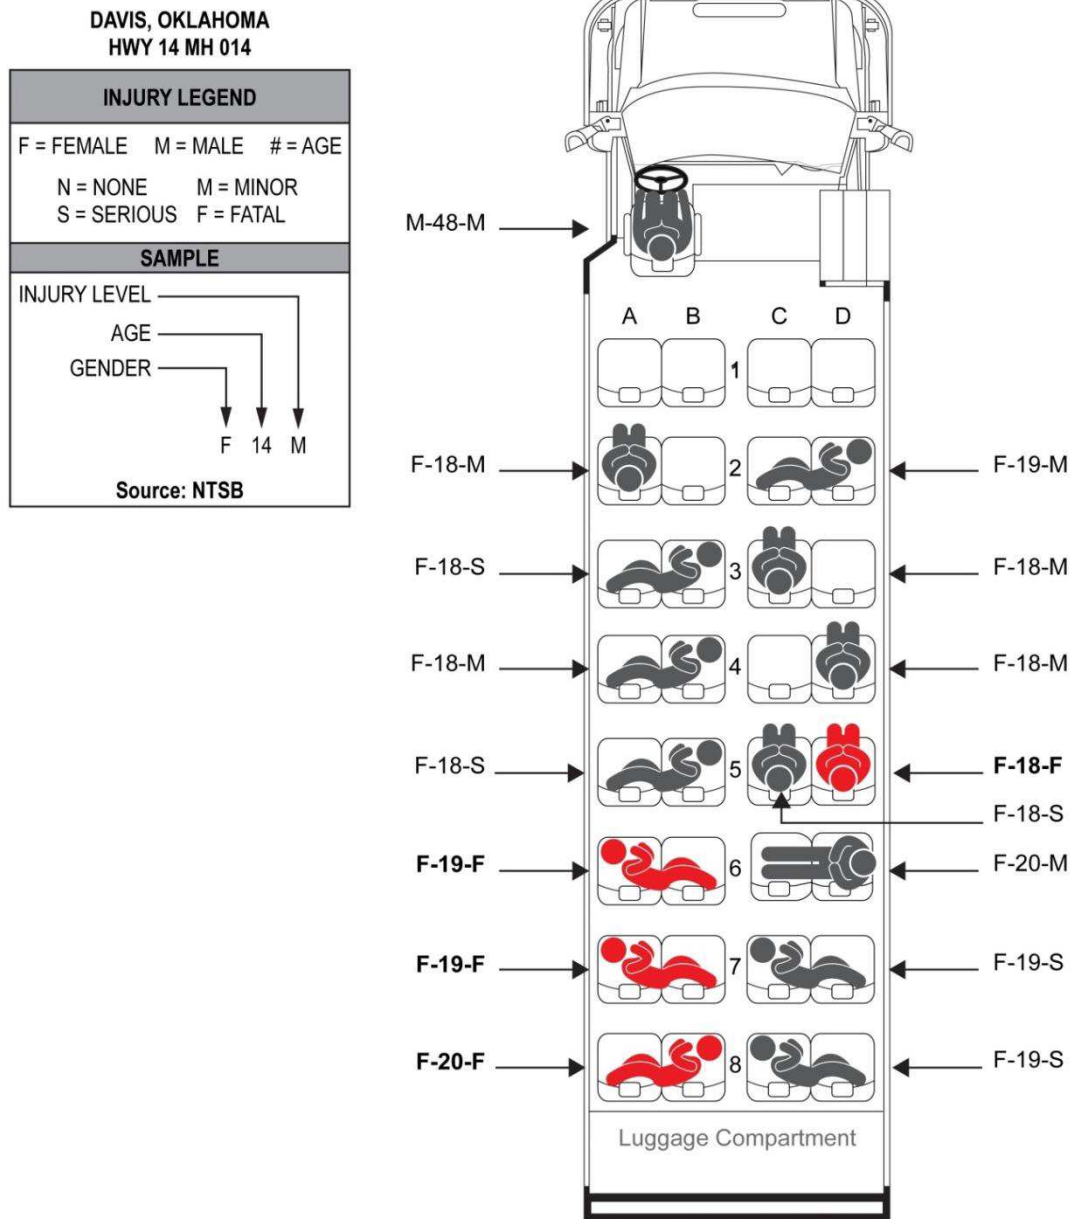
**Figure 6.** Bus seating chart, showing gender, age, and injury classification of occupants. Note: The exact positions of the three fatally injured passengers on the driver side are unknown, but according to interviews, they were lying down.

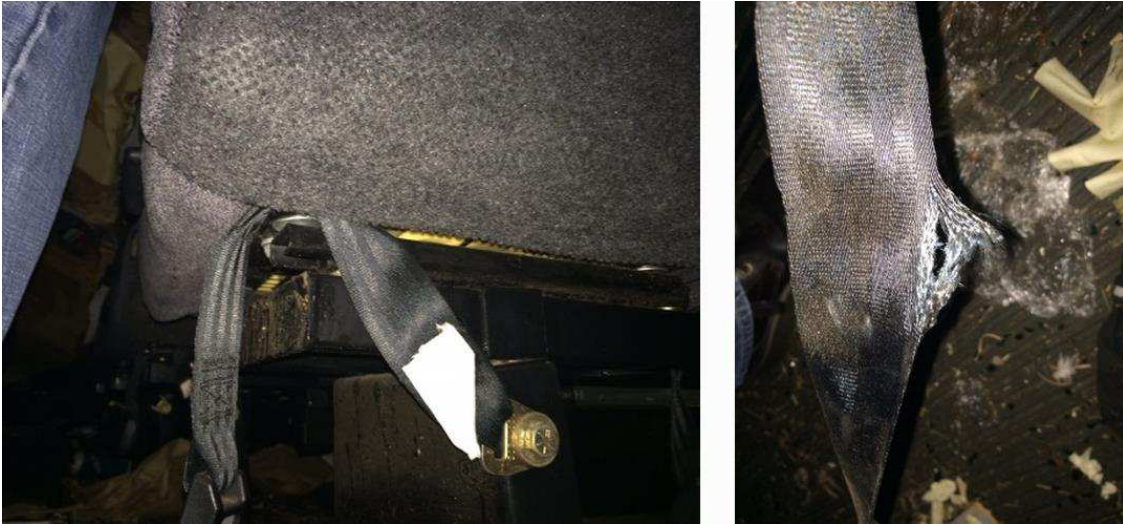
NTSB examination of the passenger seat belts revealed their worn condition and inaccessibility. The passenger seats—manufactured by Freedman Seating Company—included a side-slide seat option for those positions adjacent to the aisle. This option enables the occupant to adjust the seat so that it transitions laterally 3 inches into the aisle. The lap belts were an aftermarket item, installed by National Bus Sales. NTSB investigators found that many of the belts were wrapped around the seat bases and were inaccessible. Other belts were trapped above and around the side-slide seat track (see figure 7, left). Further, the seat belt webbing on the aisle seats in rows 4 and 6 on the driver side was abraded and slightly torn (see figure 7, right). As a result of these findings, on July 20, 2015, the NTSB issued recommendations to the National Highway Traffic Safety Administration (NHTSA) pertaining to the effects of side-slide seats on seat belt load capacity and egress.<sup>10</sup>

**Figure 7.** Seat belt webbing pinched above side-slide seat track (left) and torn seat belt webbing on side-slide seat (right).

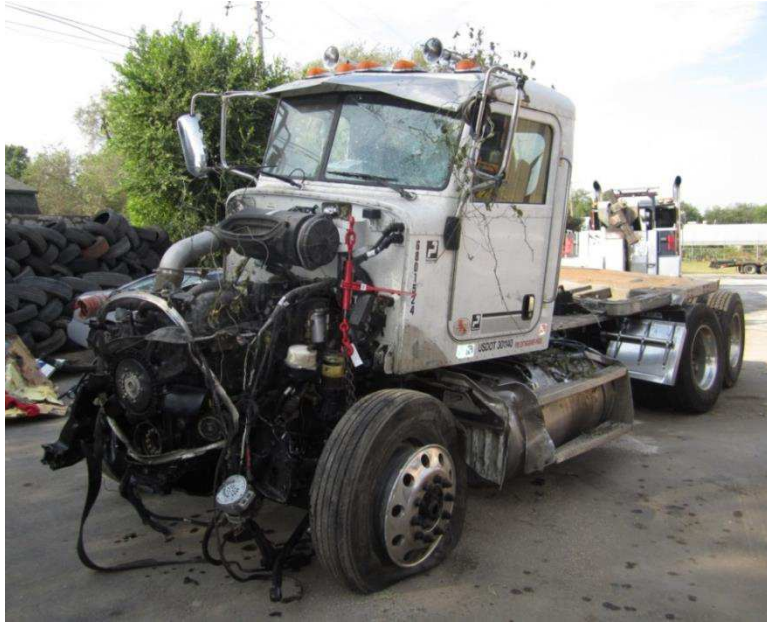
**1.5.1.2 Damage.** The truck's hood, front bumper, fenders, grille, and radiator were all displaced from the vehicle. All of the truck engine mounts were broken, and the oil pan was peeled rearward. The right and the left bumper mounts were broken. The forward portion of the left frame rail, with the attached steering gear, was bent outward to an angle of about 90 degrees (see figure 8).

**Figure 8.** Truck-tractor postcrash, showing extensive damage overall.

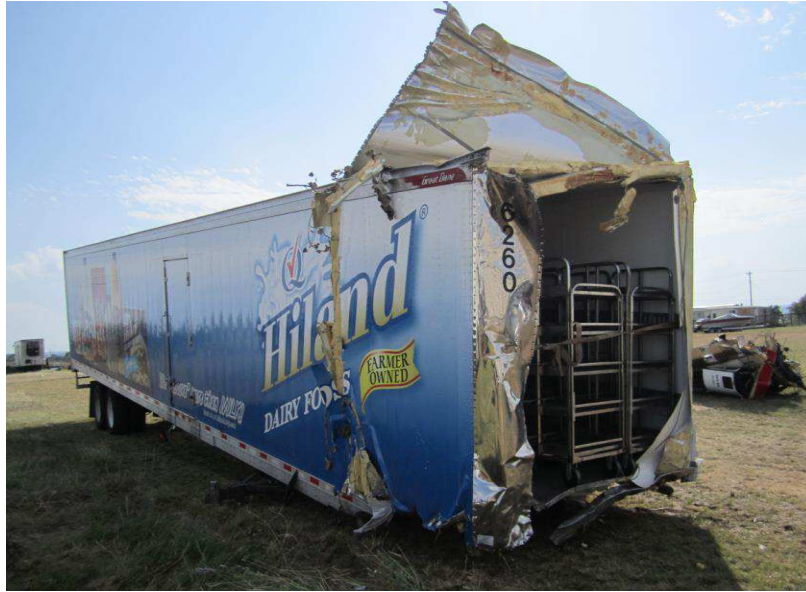
The front wall of the semitrailer, along with the attached refrigeration unit, was torn away at the left and right corners. This portion of the semitrailer was found in the woods near the final rest position of the combination vehicle. The roof was peeled rearward from the front of the semitrailer, about 1 foot on the left side and 6 feet on the right side (see figure 9). The fuel tank for the refrigeration unit, located just behind the landing gear area, was ruptured and crushed upward and to the rear.<sup>11</sup> At the time of the crash, the semitrailer was empty except for the racks designed to hold dairy products.

**Figure 9.** Semitrailer postcrash, showing damage to front end and roof.

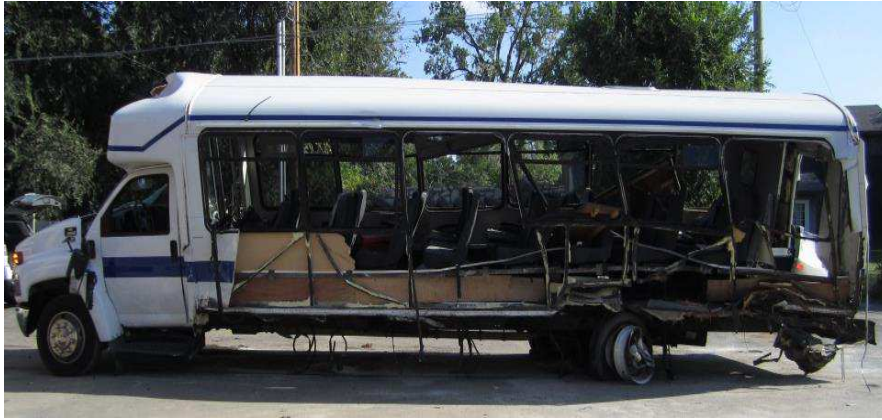
**1.5.2.2 Damage.** All of the large windows on the driver side of the bus were broken and displaced, and the bus driver had kicked out the windshield. The roof hatch had been removed for the egress of bus occupants. The outer body panels and insulation on the driver side of the bus were torn away, starting at row 1 and extending to the rear of the passenger seating area (see figure 10). An area of increased intrusion extended inward on the driver side of the bus, starting

at the end of the left rear wheel and continuing to the rear of the vehicle. The left end of the rear axle was displaced rearward about 22 inches.

**Figure 10.** Driver side of bus postcrash, with all main windows broken out and outer body panels missing.

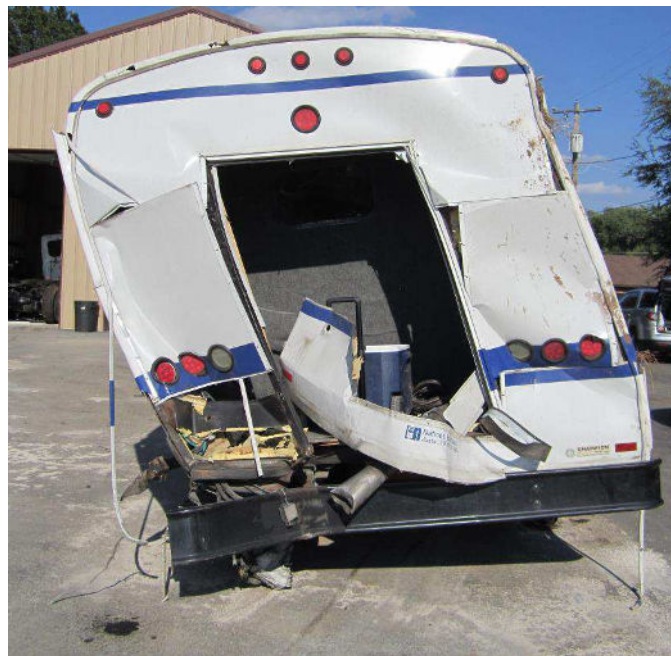
As shown in figure 11, the rear cargo door frame was skewed toward the driver side of the bus. The vertical members of the door frame were leaning to the left by 17 to 22 degrees. The rear cargo area door was separated from the vehicle. All of the large windows on the passenger side of the bus were broken out except for the most forward window.

**Figure 11.** Rear view of bus postcrash, showing extent of frame damage.

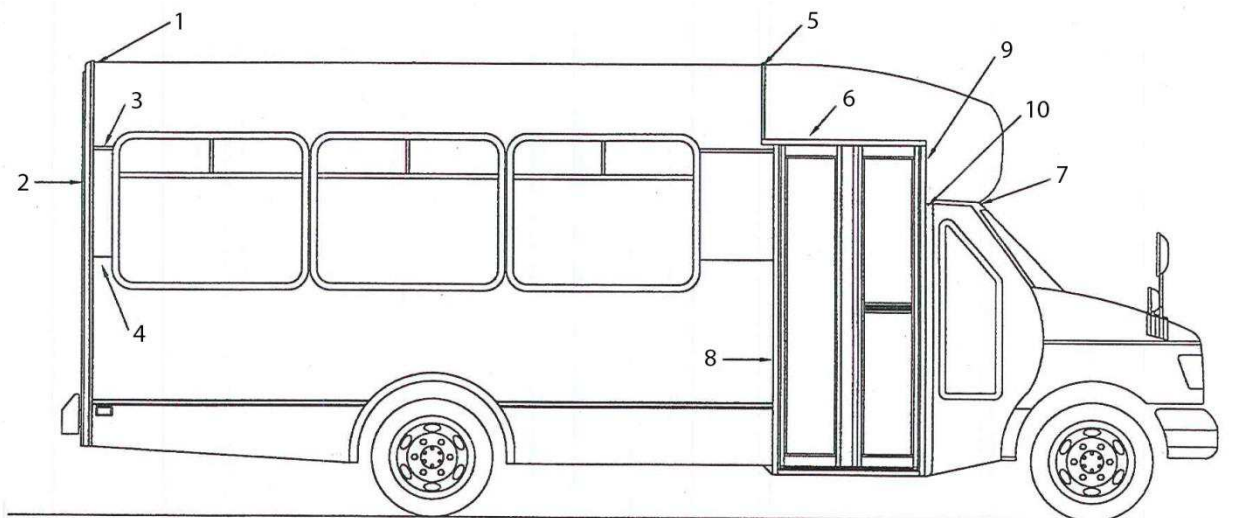
Based on the test results, one of the weakest areas of the bus was the juncture between the sides and the lower roof (no. 4 in figure 12). The strength of this area was less than 10 percent of the strength of the weakest body panel. The accident bus had joint failures in the area between the side and the lower roof; additionally, there was separation between the side panel and the lower roof panel (see figure 13, on which a broken joint and displaced panel are circled). The accident bus series does not meet the school bus joint strength standard.

**Figure 12.** Locations of 10 test samples taken from Champion bus body at selected joints. (Source: Progressive Engineering, Inc.)

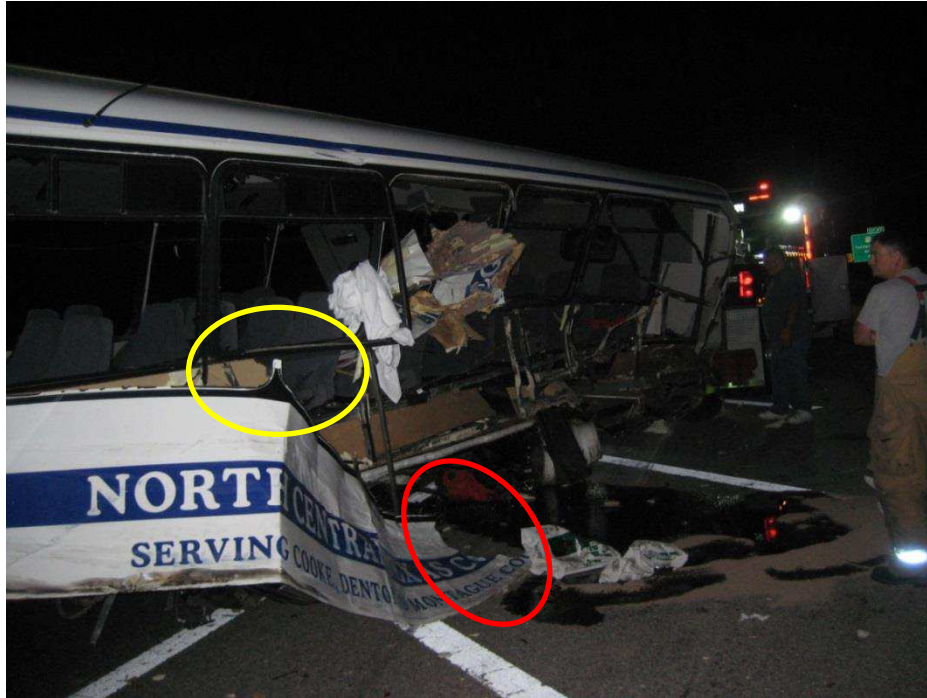
**Figure 13.** Damage to sidewall support structures on driver side of bus, with yellow circle highlighting broken joint and red circle highlighting panel tearing. (Source: Oklahoma Highway Patrol)

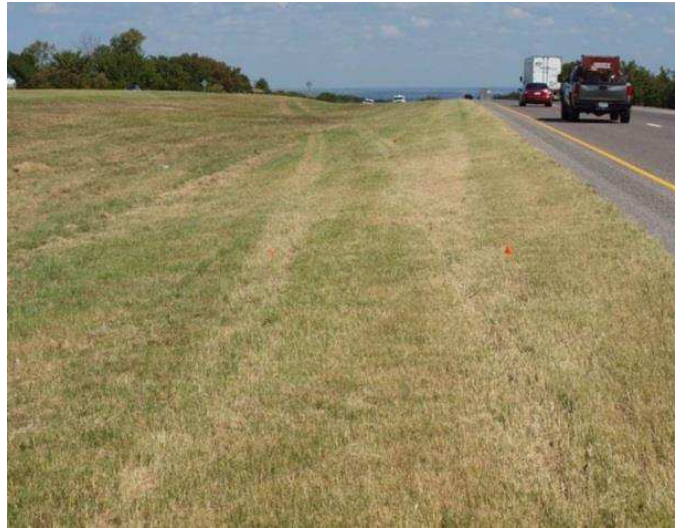
**1.8.1.3 Truck-Tractor Roadway Departure.** Evidence at the crash site indicated that the truck-tractor departed the left lane at a 1.9 degree angle, traversed 1,121 feet from the edge of the northbound lanes across the median, and entered the edge of the southbound lanes at an angle of 8.9 degrees. Figure 14 shows the tire marks from the combination vehicle.

**Figure 14.** Tire marks alongside I-35 northbound, showing path followed by truck-tractor as it crossed 100-foot-wide median and entered southbound lanes.

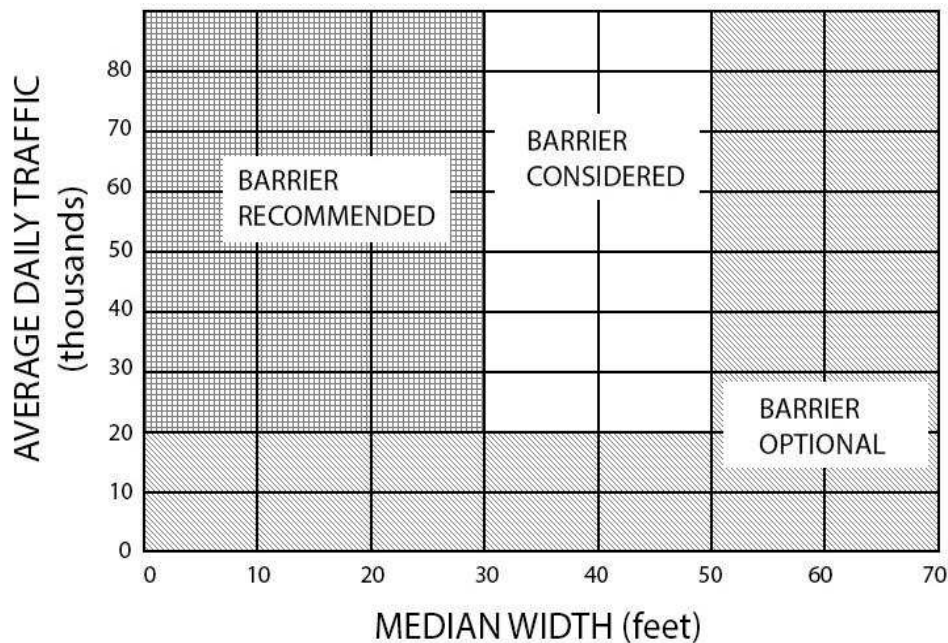
history of median crossover crashes or high heavy vehicle volume. However, the RDG does not formally define these factors or the thresholds beyond which a median barrier should be considered.

**Figure 15.** Guidelines for determining whether to install median barriers on high-speed, fully controlled-access roadways (adapted from AASHTO 2011, figure 6.1.)

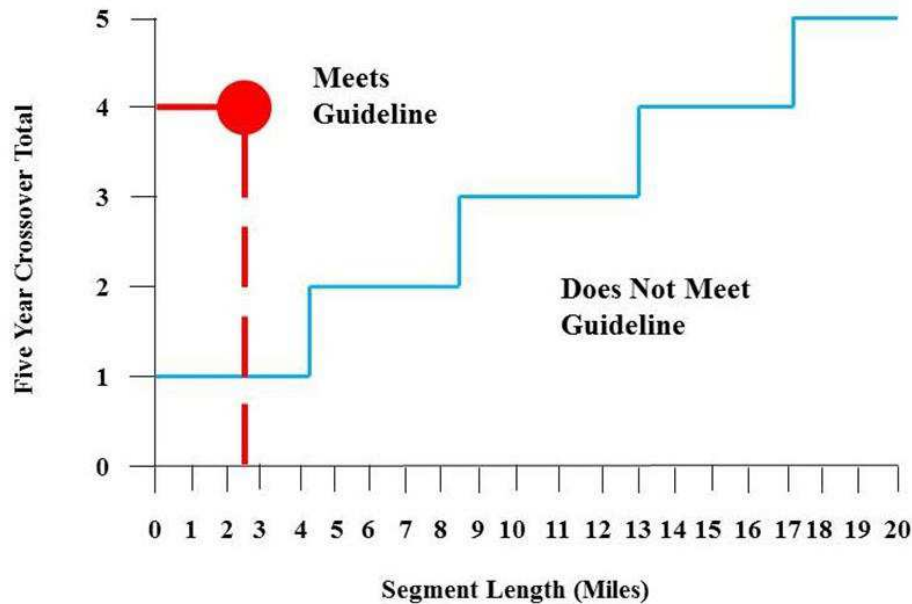
**Figure 16.** Suitability plot for median cable barrier at crash site, based on ODOT guideline no. 2 (crash rate and AADT).

ODOT acknowledged that this section of I-35 met the criteria of guideline no. 2. ODOT plans to install about 8 miles of longitudinal median cable barrier along I-35 in Carter and Murray Counties, starting at milepost 44 and extending to milepost 52 (the crash occurred near milepost 47). Construction of the barrier began in November 2015, with anticipated completion in January 2016.
