RE: Ms. Woodlee, Ms. Pelton, and Ms. Richardson

Pursuant to your request, I am setting forth my biomechanical opinions regarding the fatal bus accident on September 26, 2014 involving Ms. Katelynn Woodlee, Ms. Jaiden Pelton, and Ms. Megan Richardson. I am also providing a summary synopsis of my background and qualifications to render my opinions.

To perform a biomechanical analysis of the fatal bus incident involving Ms. Woodlee, Ms. Pelton, and Ms. Richardson on September 26, 2014.

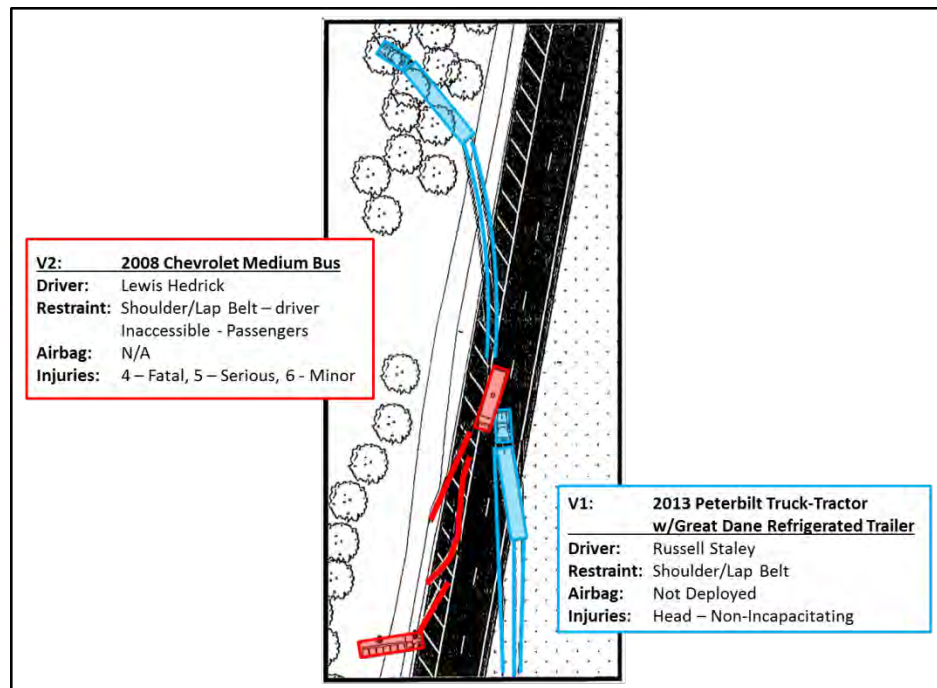
Figure 2 – Accident Diagram (Colors and Labels Added)

“Unit 1 was northbound on interstate 35. Unit 2 was southbound on interstate 35. Unit 1 departed the roadway to the left, crossed the grass median and entered the southbound lanes. Unit 1 struck Unit 2 in the south bound lanes. Unit continued across the southbound lanes and came to rest off the west side of the roadway. Unit 2 departed the roadway to the right and overturned a quarter time coming to rest on the passenger side.”

The officer's diagram is shown in Figure 2 (colors and labels added). The location of the incident was located on Google Earth using road names from the crash report and reference markers from scene photographs (Figure 3). Select photos (bus in original position and in righted position) taken at the scene of the accident are shown in Figures 4 and 5, with Reference “A” circled. The tractor-trailer is shown in its original position at the scene and as it was photographed post-incident (Figure 5). In Figure 6, the Google Earth image of the incident area is shown at street level with Reference “A” from Figure 4 circled. Figure 6 is a seating chart, modified from the chart provided in the NTSB report (Materials Studied #13, Page 6) with seating position provided from the Oklahoma Department of Public Safety Report (Materials Studied #11, Page 335).

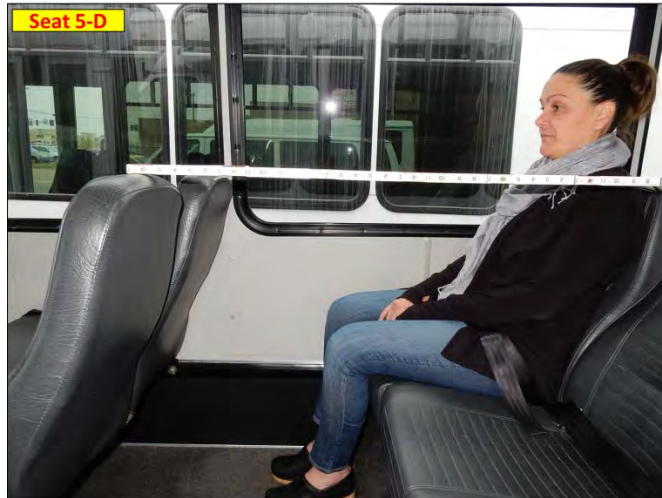
Figure 18 – Surrogate Fit in Exemplar Bus, Seat 5-D (Katelynn Woodlee)

One surrogate similar in height and weight to all three was utilized to represent each girl in the different seats. The objective of the surrogate fit (Figure 18-20) was to relate geometrical dimensions of the 2008 Champion bus to each girl.
