Neil Hannemann  
Automotive Engineer  
26811 NE Highland Meadows Drive  
Vancouver, WA 98682

Re: **Seebachan v. John Eagle et. al.**

I have studied the crash safety performance of the 2010 Honda Fit in which Matthew and Marcia Seebachan were seriously injured. I inspected the vehicle on May 15, 2015 and again on July 28, 2015. I inspected the removed fuel tank on July 28, 2015. I have also reviewed the police report and photographs from the accident scene. Based on my inspection, research, education, training and experience as well as my own engineering judgment, I have formed opinions regarding the safety performance of the subject vehicle in this crash. Prior to stating my opinions, here is a brief outline of portions of my education, training and experience with crashworthiness and vehicle design analysis that applies to the particular disciplines required to effectively render an opinion in this case.

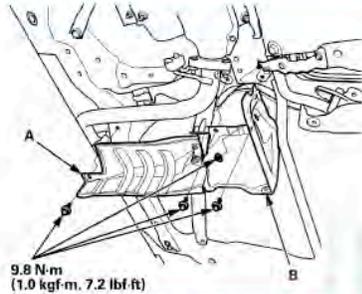
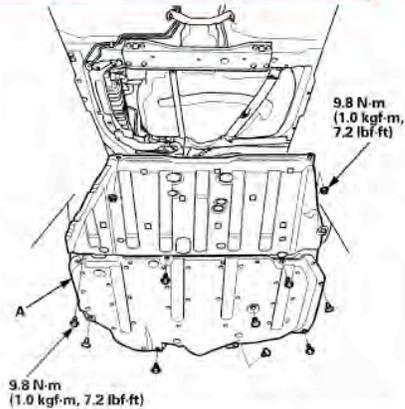
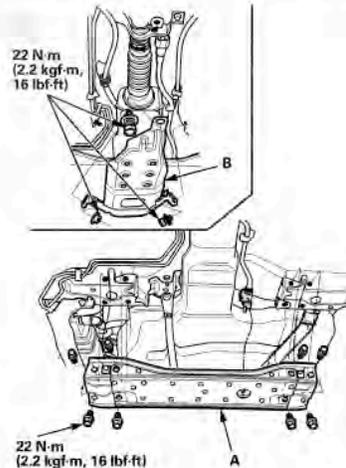
Figure 8 – Excerpt from Honda Fit service manual

1. The 2010 Honda Fit fuel tank design included four items that were intended to protect the fuel tank. A fuel tank guard, and fuel tank protector and, depending on if the vehicle is an automatic or manual transaxle, a fuel tank cover or a floor under cover. Figure 8 is a page from the 2010 Honda Fit service manual that describes these features as part of the fuel tank replacement procedure.
2. The item referred to as a fuel tank cover or floor under cover was missing from the vehicle at the time of my inspection. I could find no evidence that the tank cover or floor under cover was present at the time of the collision and the subsequent fire.
3. Removal of the fuel tank cover or floor under cover would compromise the protection that it provides to the fuel tank.

4. At the time of this report, I have not seen evidence that would indicate who removed the fuel tank cover or when it was removed. Regardless of who removed it, the selling dealership, Huffines Kia, should have noted that the fuel tank cover was missing during any inspection that they performed. The actual inspection form for the subject vehicle was not provided to me, only a blank inspection form. This form has, as one of the points, an inspection for frame damage (excerpt of the form shown below as Figure 9.) The frame damage point is contained in a red box in Figure 9. While performing the inspection for frame damage, the unused attachment points for the fuel tank cover should have been noted, and investigated to determine that the fuel tank cover was indeed missing.

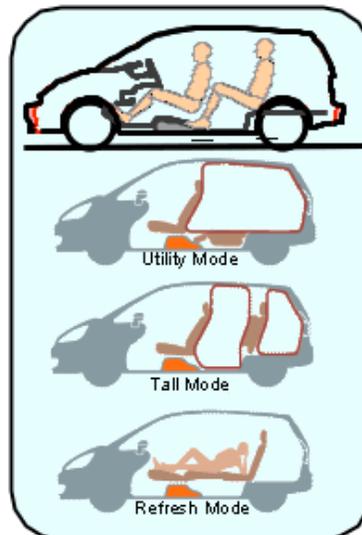
Figure 10 – Honda Fit fuel tank location and seating modes

2. One of the features of the Fit was a forward fuel tank location to allow the rear seat to fold into an area where a fuel tank is typically packaged. This locates the fuel tank directly under the front driver and passenger. Figure 10 shows the various seating modes and the tank location. The Utility mode and the Tall mode are 2 modes that benefit from the unique tank location. This was a decision made by Honda in order to gain a marketing benefit for this vehicle featuring a lower load floor and increased cargo volume.
