INSPECTION OF CHAMPION DEFENDER BUS :

DRIVER SIDEWALL, FRAME (PART # 0414250)

PASSENGER SIDEWALL, FRAME (PART #0414249)

Re: Champion Defender bus accident, Davis, Oklahoma

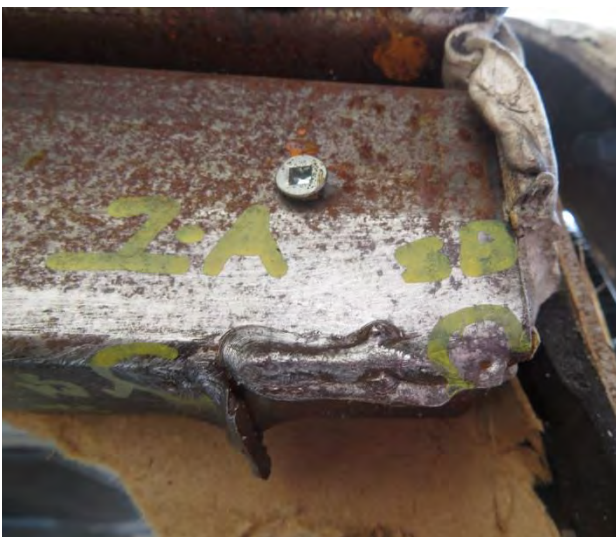
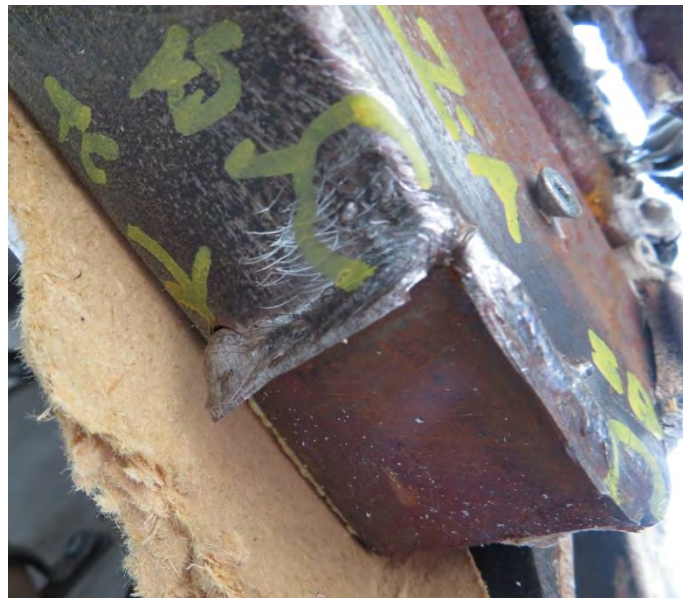
1-A: 5.1.2 Craters₁ 1/16", 5.1.10 Overlap₂, Incomplete fusion to corner-- Ref Table 1: Common Types of Discontinuities₄.

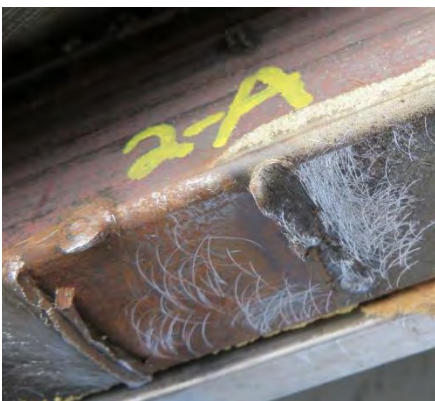
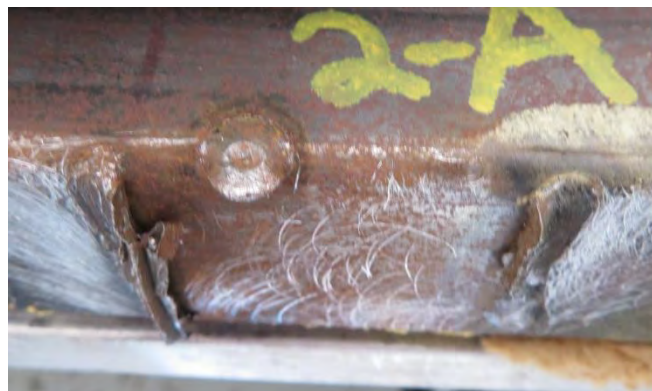
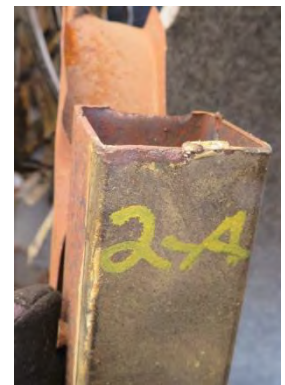
2-A: 24/32" Incomplete Fusion - Ref Table 1: Common Types of Discontinuities₄, clause 4.5

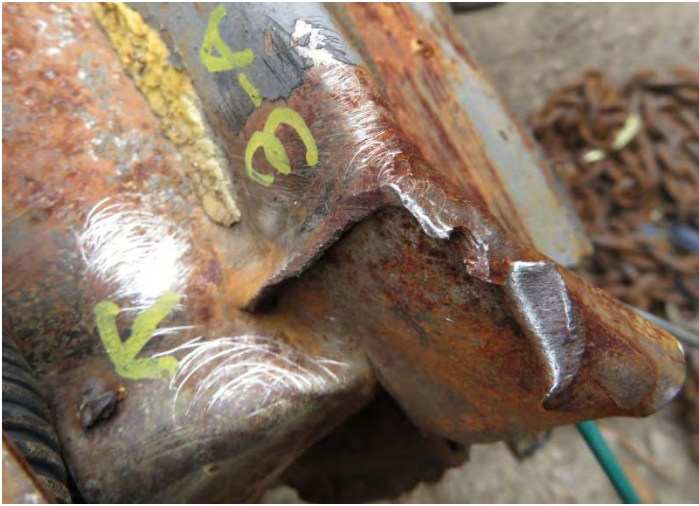
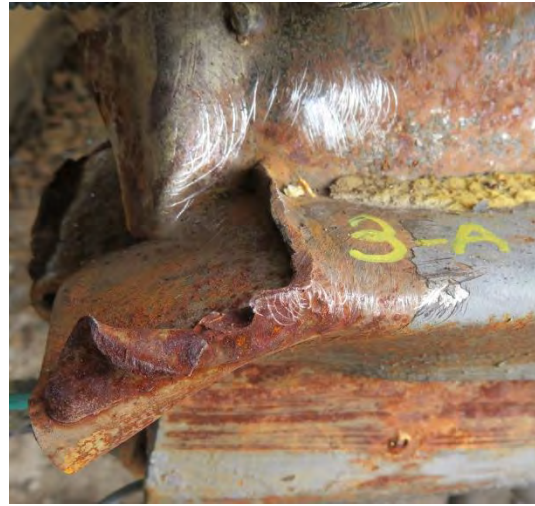
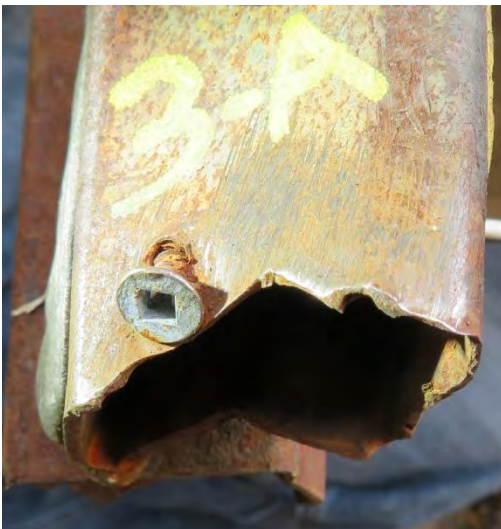
3-A: Sheared at Heat Affected Zone (HAZ), above the top weld toe. (not a rejectable discontinuity)

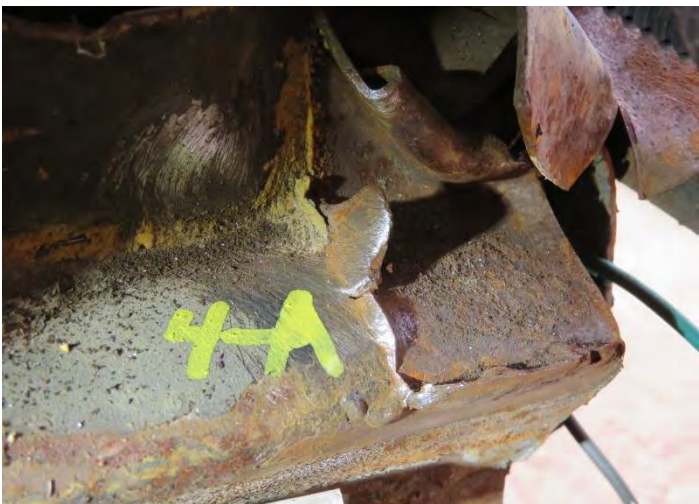
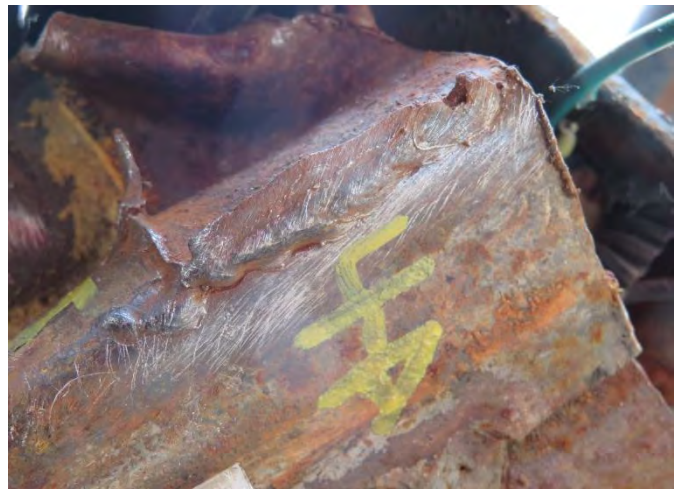
4-A: 4.17 Table 1 Weld Reinforcement⁵, 5.1.10 Overlap₂, Incomplete fusion to corner- Ref Table 1: Common Types of Discontinuities₄.

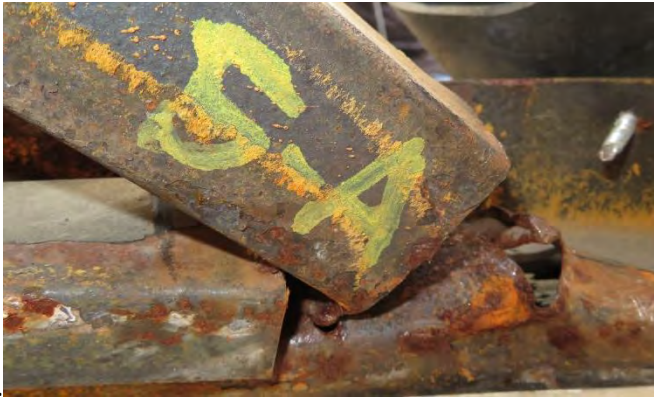
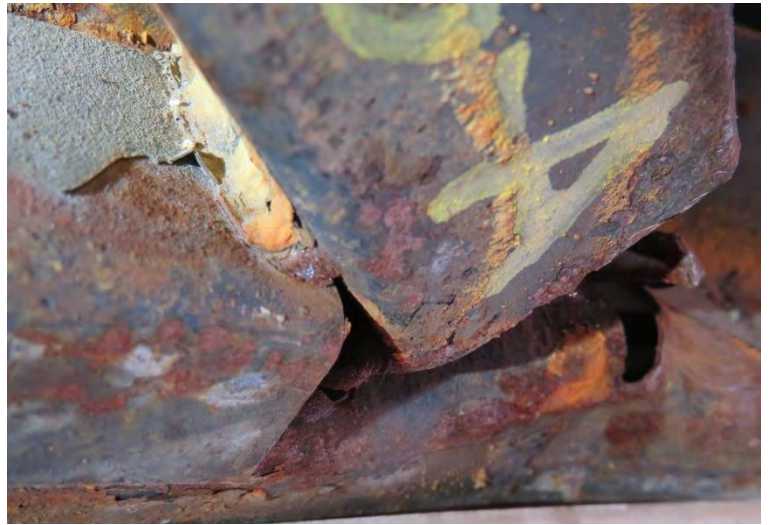
5-A: 1/8" Incomplete fusion - Ref Table 1: Common Types of Discontinuities₄.

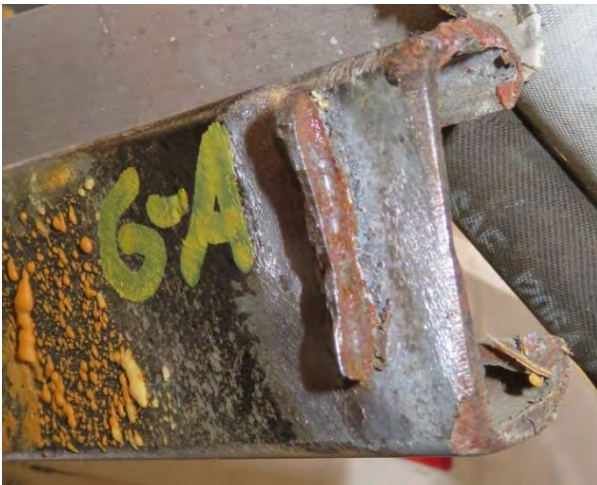
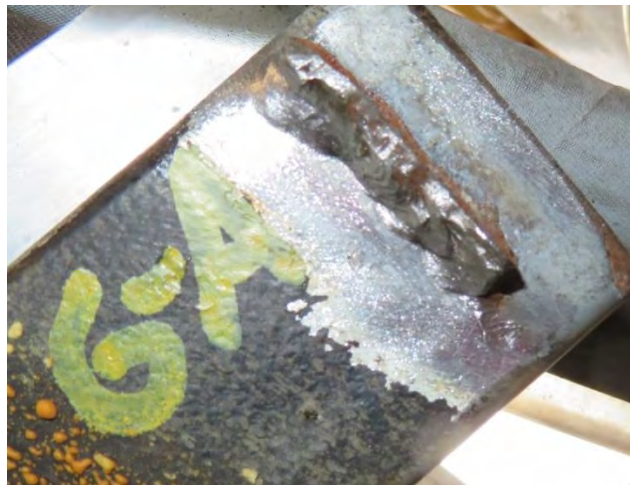
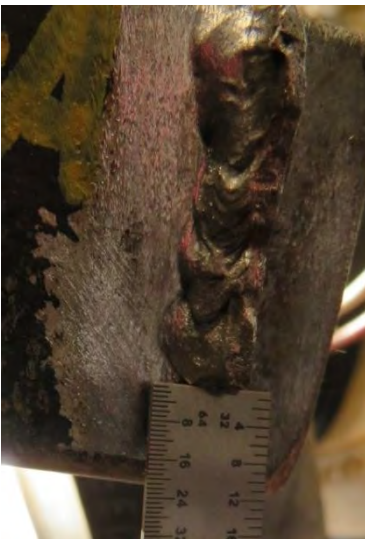
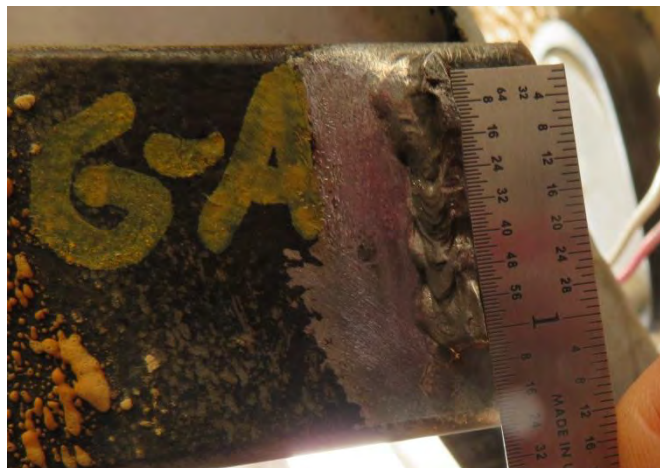
6-A: 5.1.2 Craters₁, 5.1.10 Overlap₂. Incomplete fusion - Ref Table 1: Common Types of Discontinuities₄.

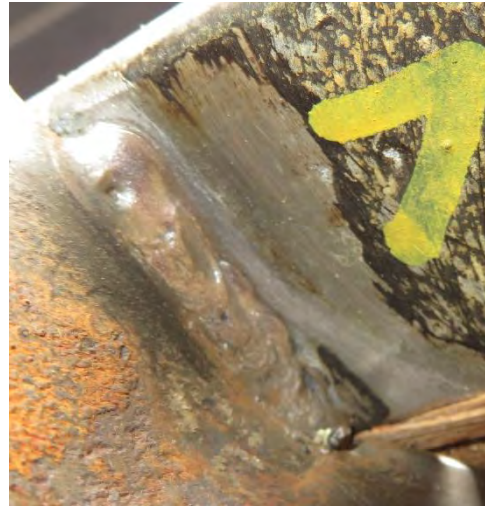
7-A: 1/8" 5.1.2 Craters₁, 1/8", Incomplete fusion - Ref Table 1: Common Types of Discontinuities₄.

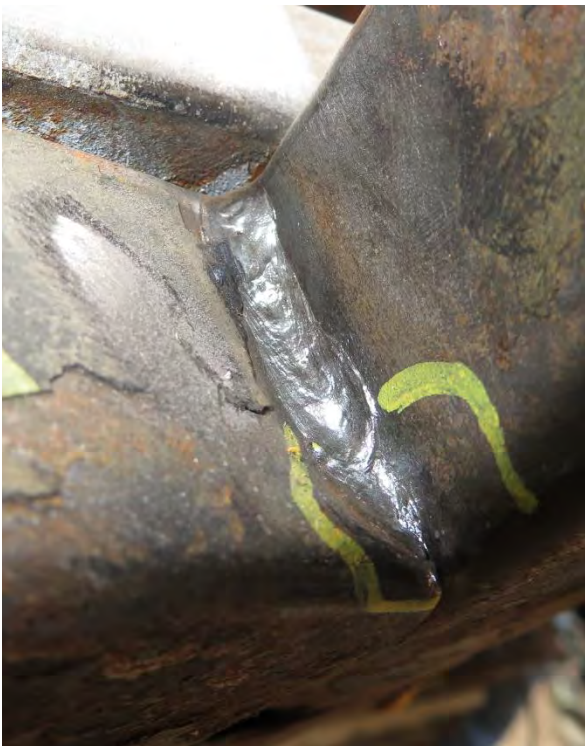
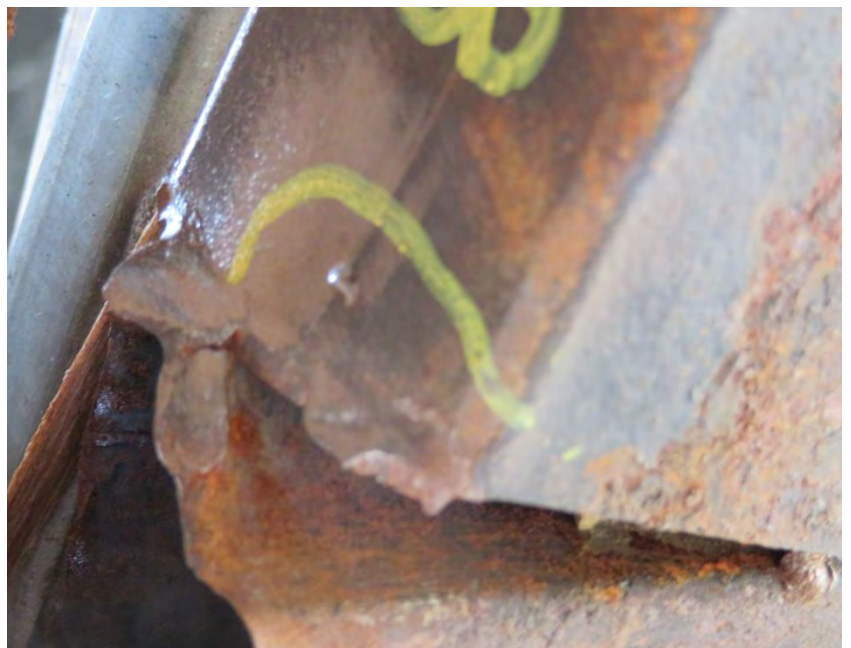
8-A: 12/32" Incomplete fusion (top weld) & 3/4" Incomplete fusion (bottom weld) - Ref Table 1: Common Types of Discontinuities₄, 5.1.2 Craters₁.

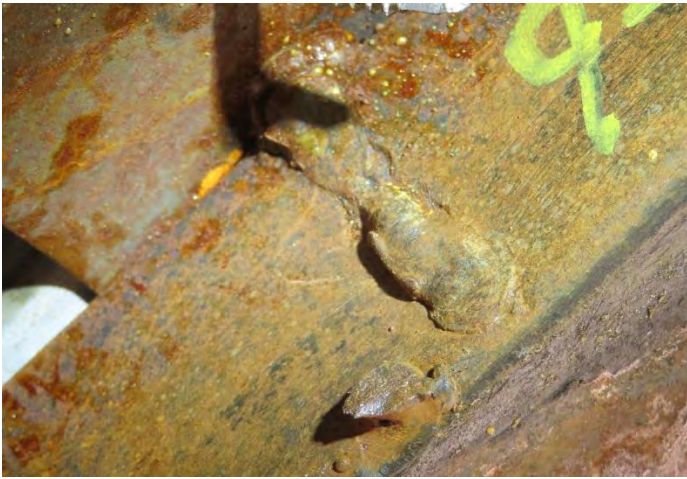
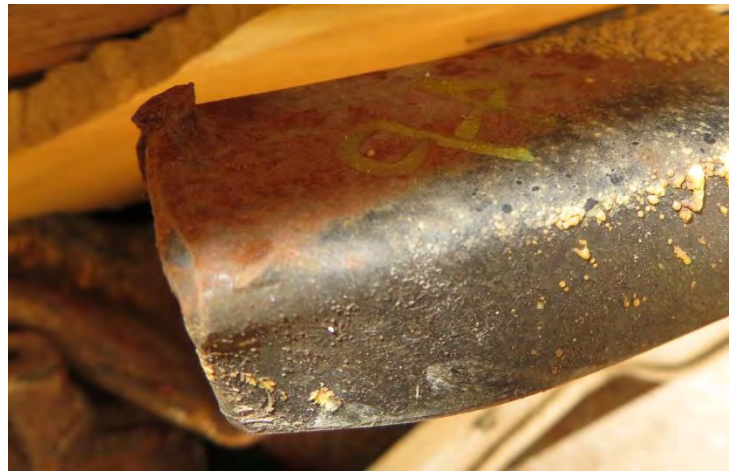
9-A: Incomplete fusion (bottom weld) - Ref Table 1: Common Types of Discontinuities₄, poor weld placement

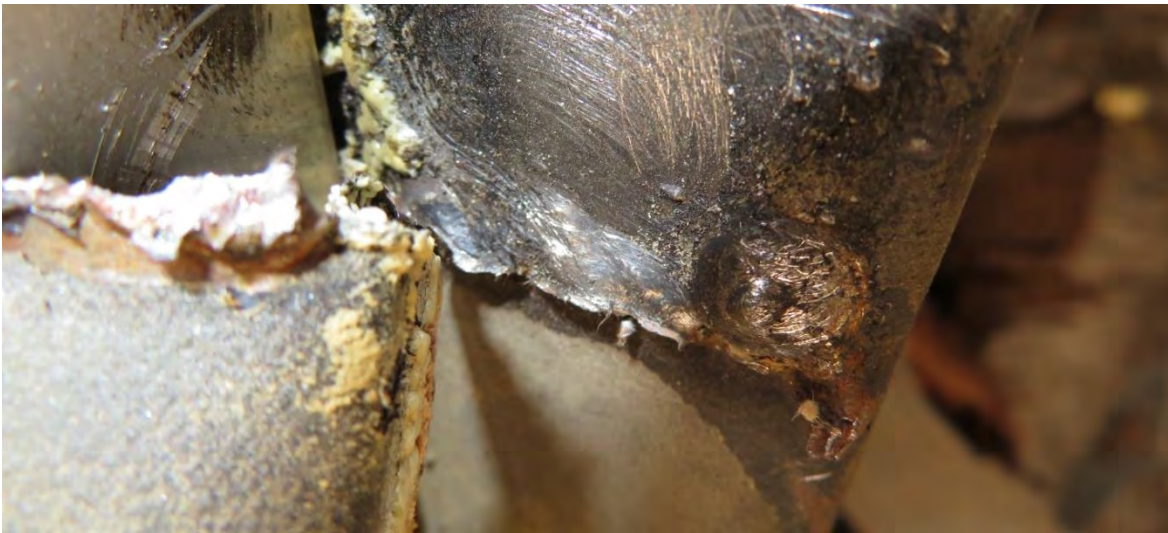
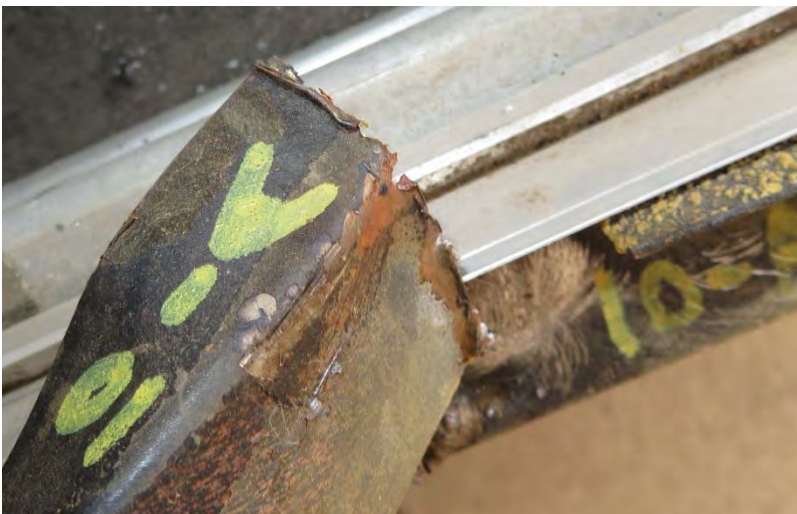
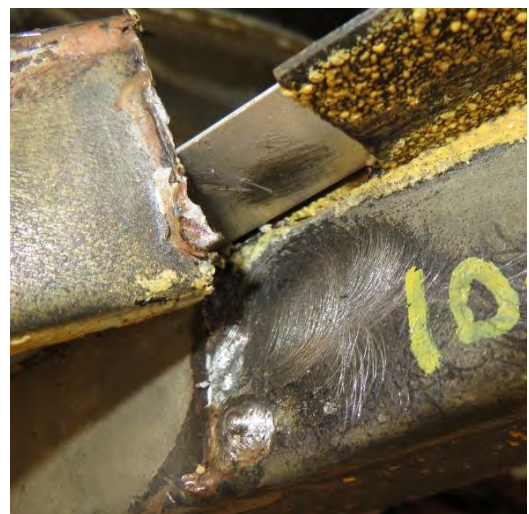
10-A: Cumulative 33/64" Incomplete fusion - Ref Table 1: Common Types of Discontinuities₄, 5.1.10 Overlap₂, 5.1.2 Craters₁.

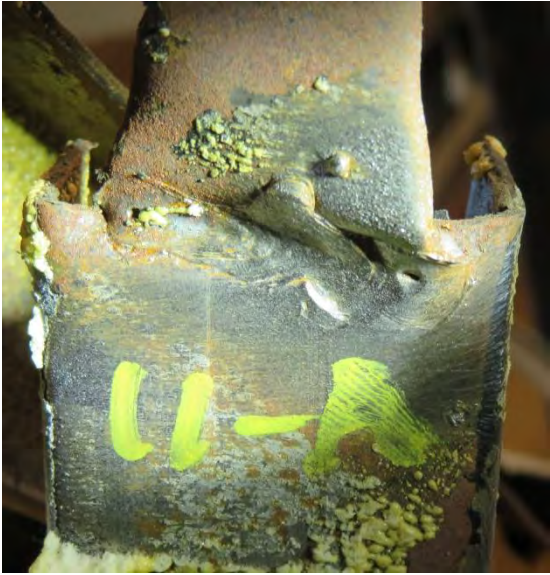
11-A: Incomplete fusion - Ref Table 1: Common Types of Discontinuities₄, 5.1.2 Craters₁.

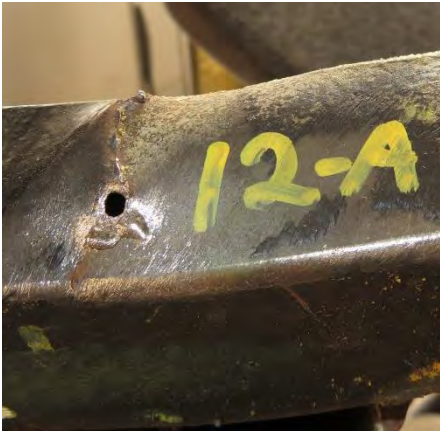
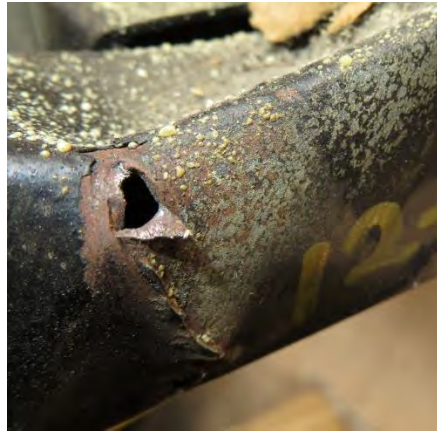
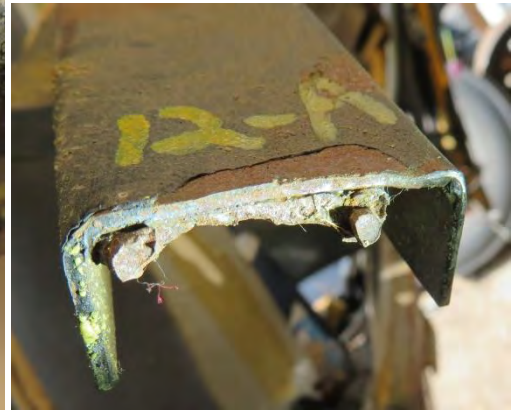
12-A: Incomplete fusion of the root - Ref Table 1: Common Types of Discontinuities₄, ¼" no weld deposit.

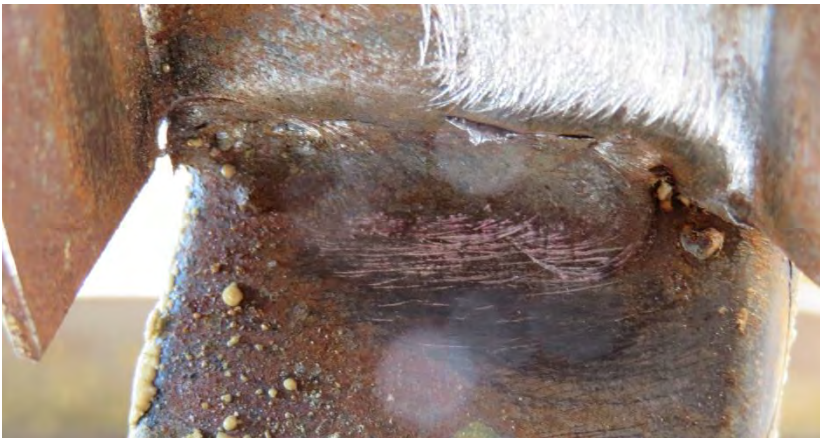
13-A: ¼" Incomplete fusion - Ref Table 1: Common Types of Discontinuities₄, 5.1.2 Craters₁, 5.1.10 Overlap₂.

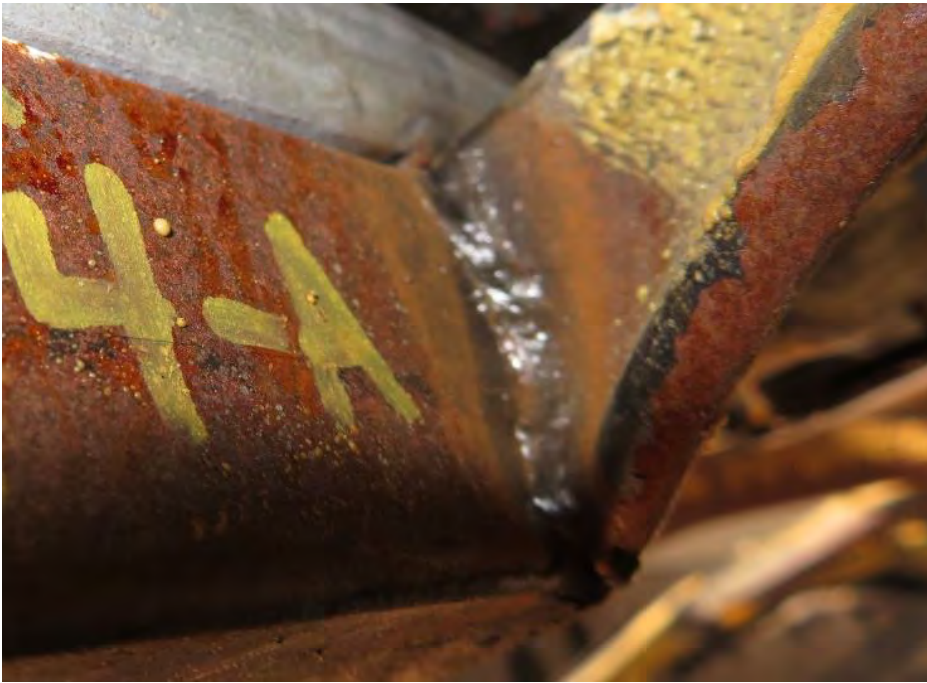
14-A: 5.1.2 Craters₁

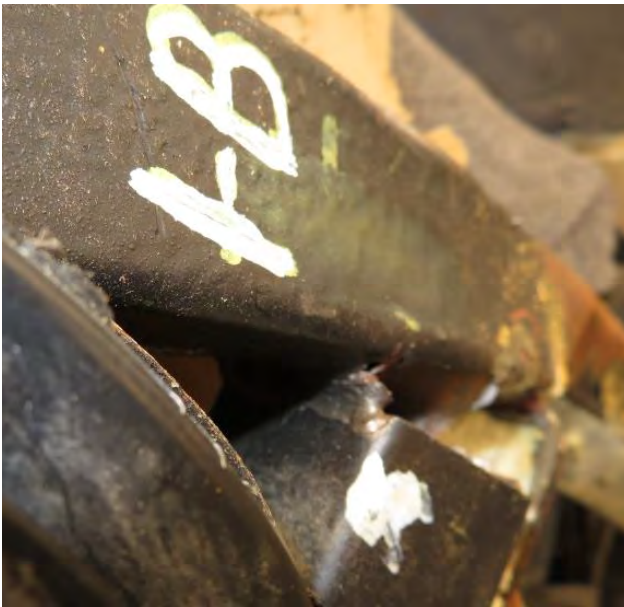
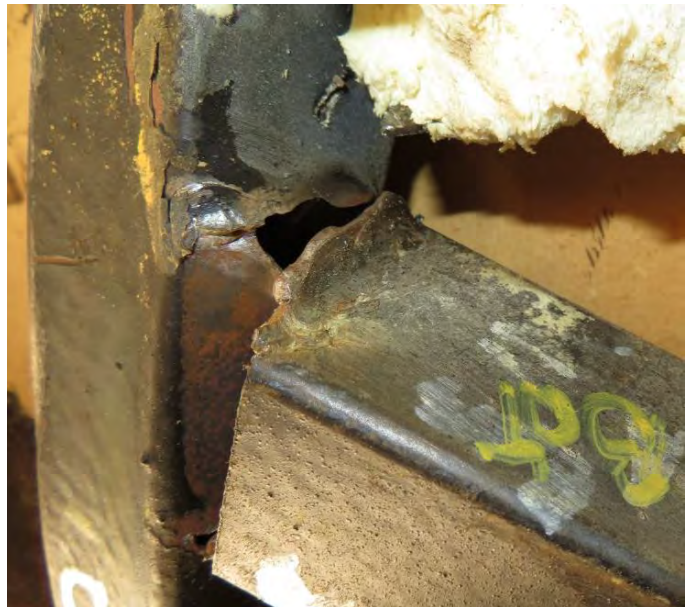
1-B: Top weld = inaccessible, bottom weld: $\frac{1}{4}$ " Incomplete fusion - Ref Table 1: Common Types of Discontinuities₄,

5.1.2 Craters₁

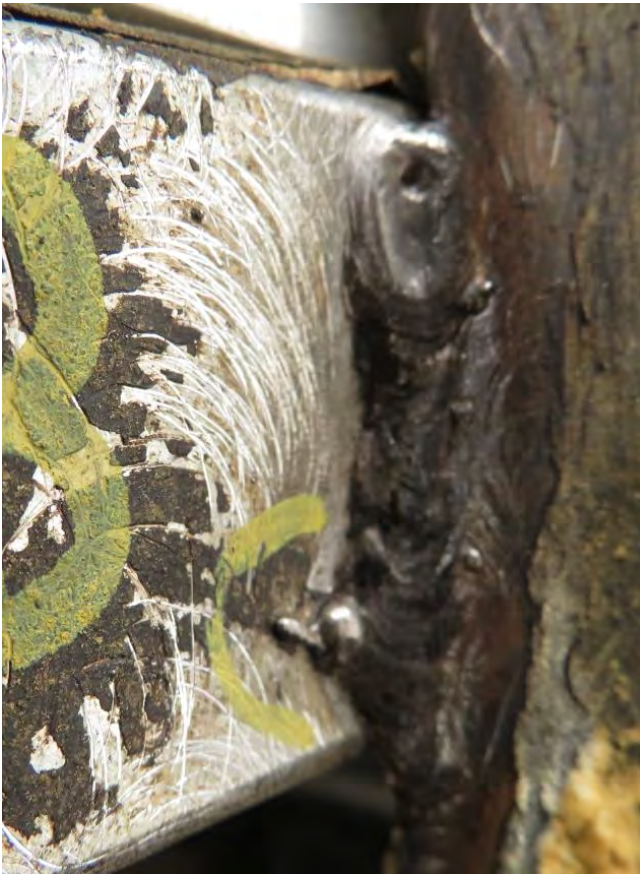
2-B: ¼" Incomplete fusion - Ref Table 1: Common Types of Discontinuities₄, 5.1.10 Overlap₂, 5.1.2 Craters₁, no weld deposited ¼".

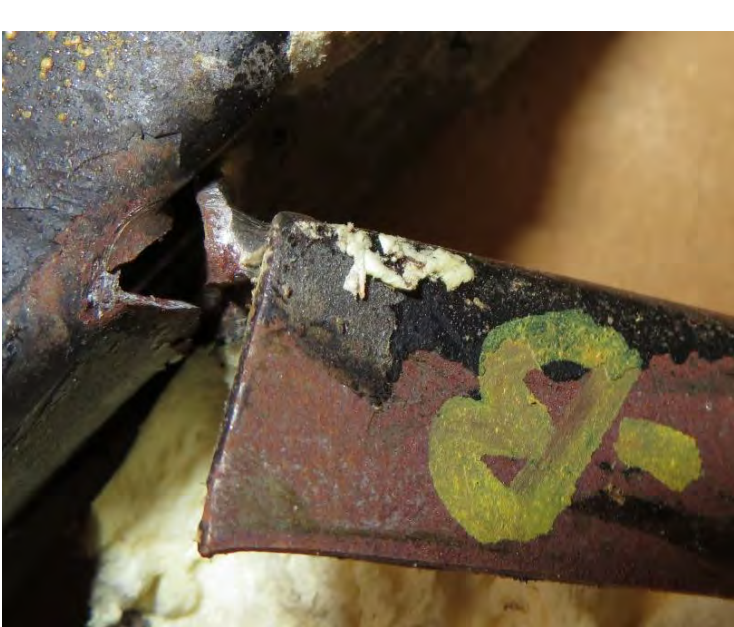
3-B: 5.1.2 Craters₁,

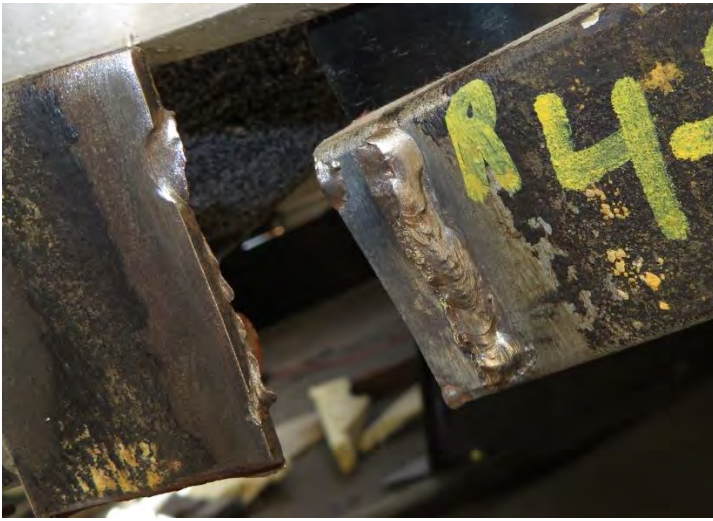
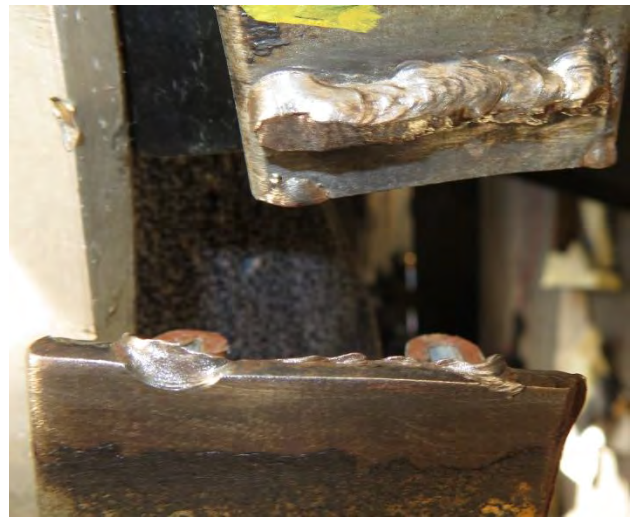
4-B: 5.1.13: 5.1.2 Craters₁, Incomplete fusion - Ref Table 1: Common Types of Discontinuities₄,

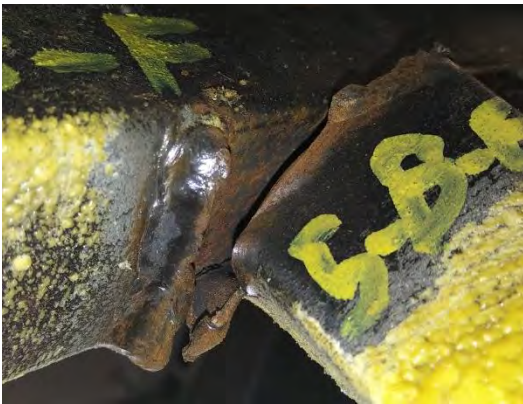
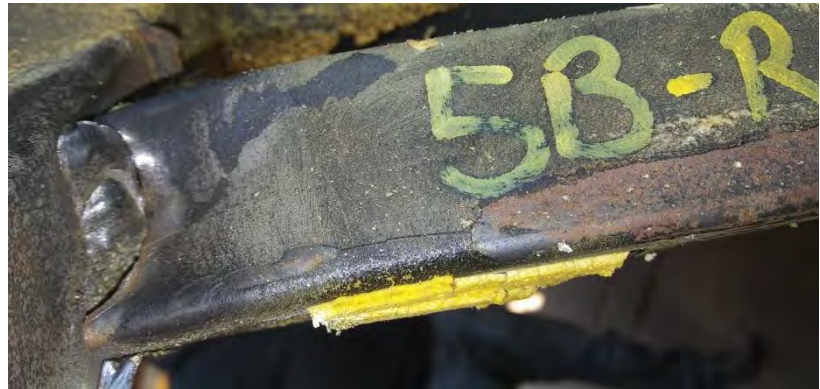
5-B: Rear weld 1/8" no weld, 5.1.10 Overlap₂. Front weld : 5.1.2 Craters₁,

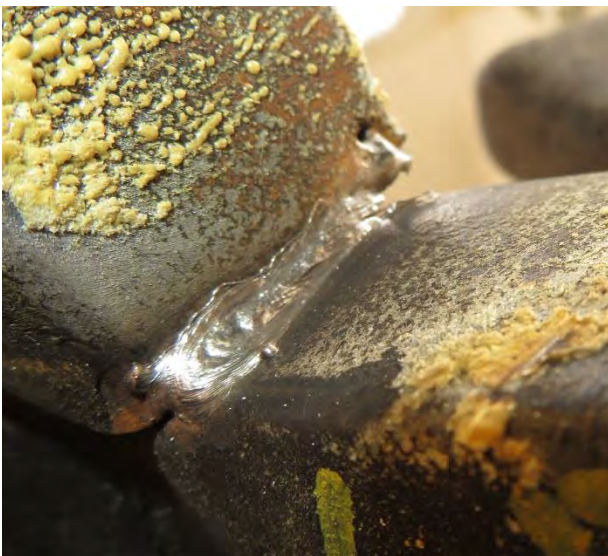
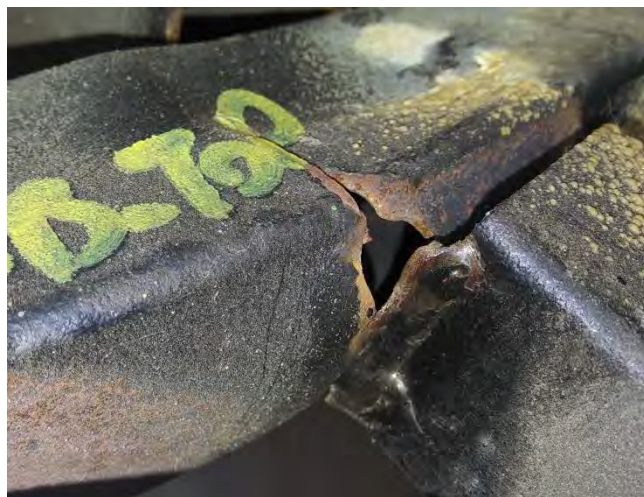
6-B: Bottom weld 1/2" Incomplete fusion - Ref Table 1: Common Types of Discontinuities₄, 5.1.2 Craters₁, Top weld 3/32" no weld deposit.

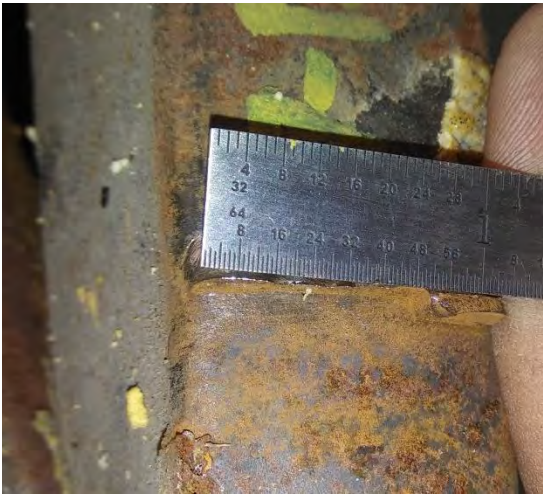
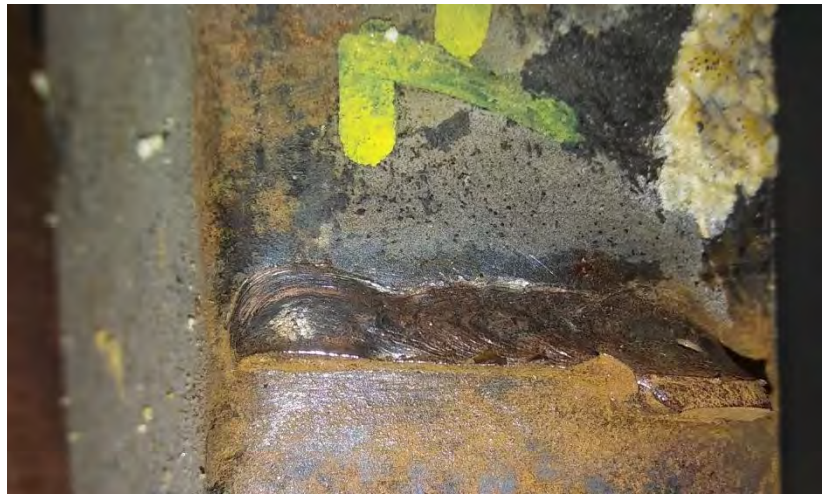
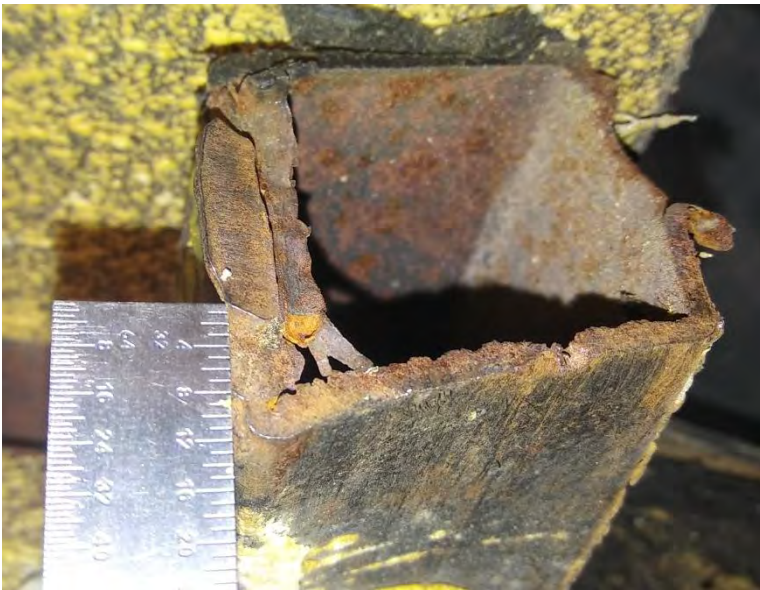
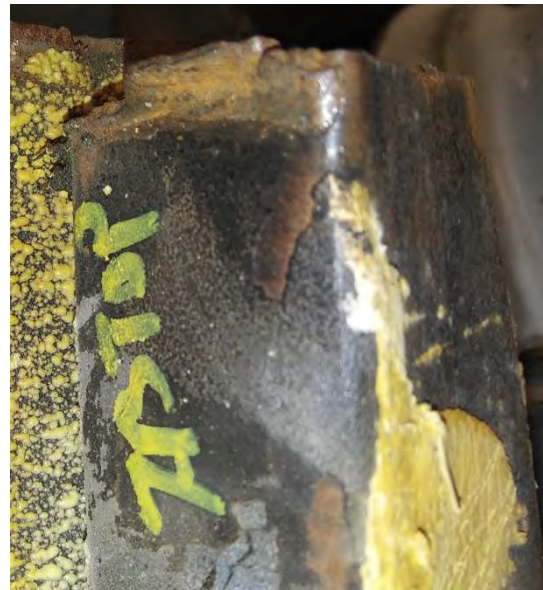
7-B: Top Weld ¼" Incomplete fusion - Ref Table 1: Common Types of Discontinuities₄, Bottom weld 48/64 Incomplete fusion - Ref Table 1: Common Types of Discontinuities₄.

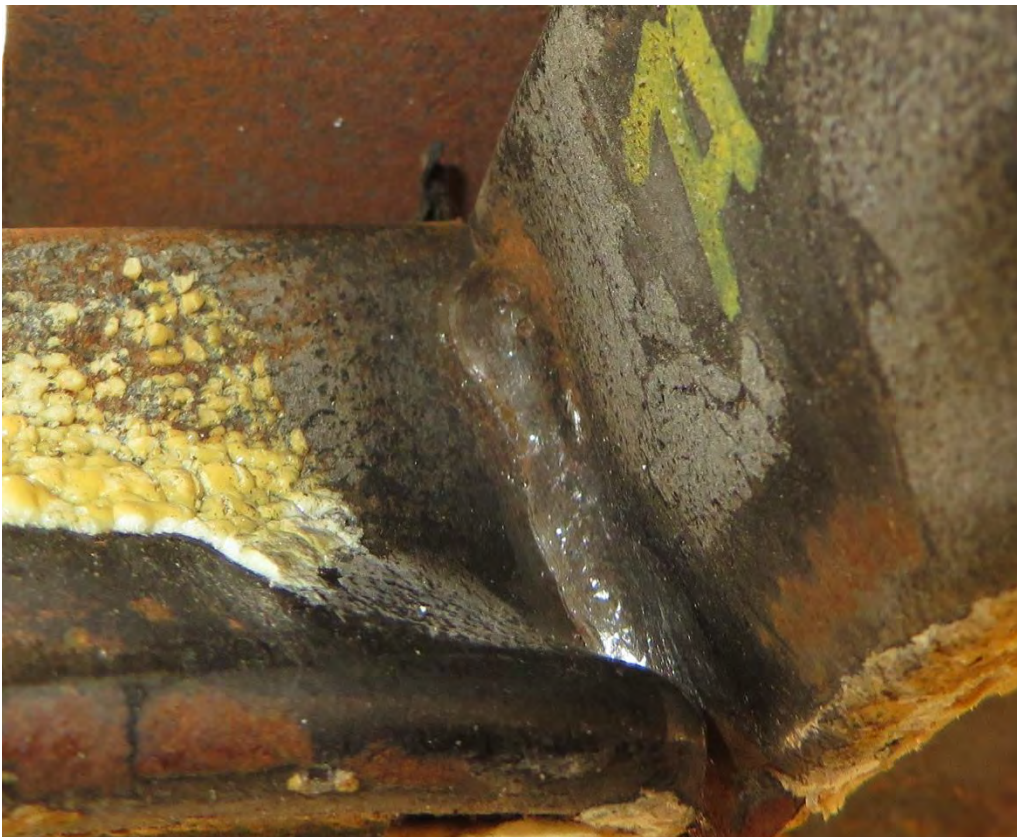
8-B: non weld deposit of 3/32", 5.1.2 Craters₁.

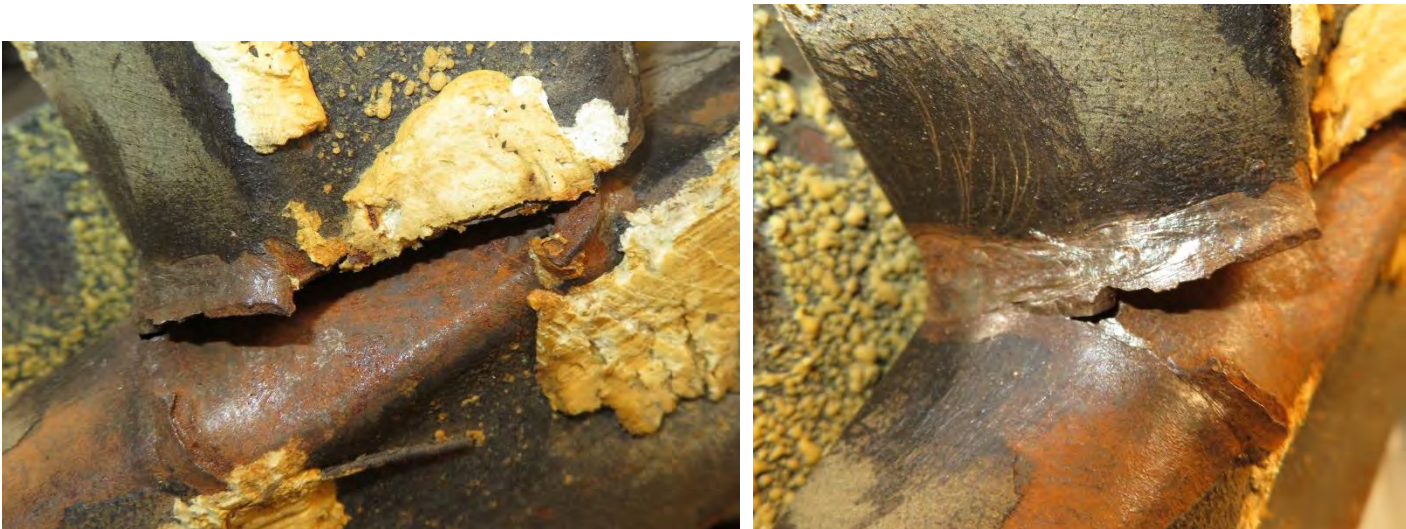
1-C: 16/32" suspicion of non-fusion, 5.1.2 Craters₁.

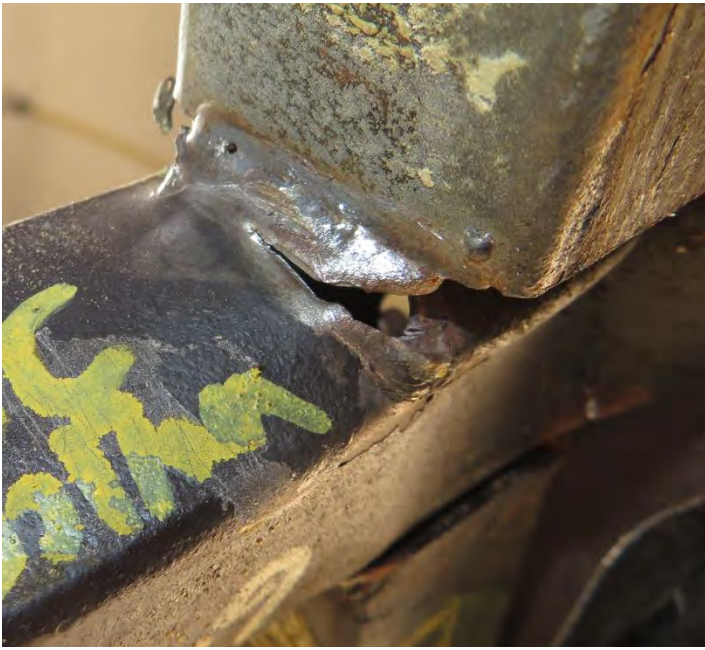
2-C: Bottom weld - 5.1.2 Craters, end of weld not fused 3/32".

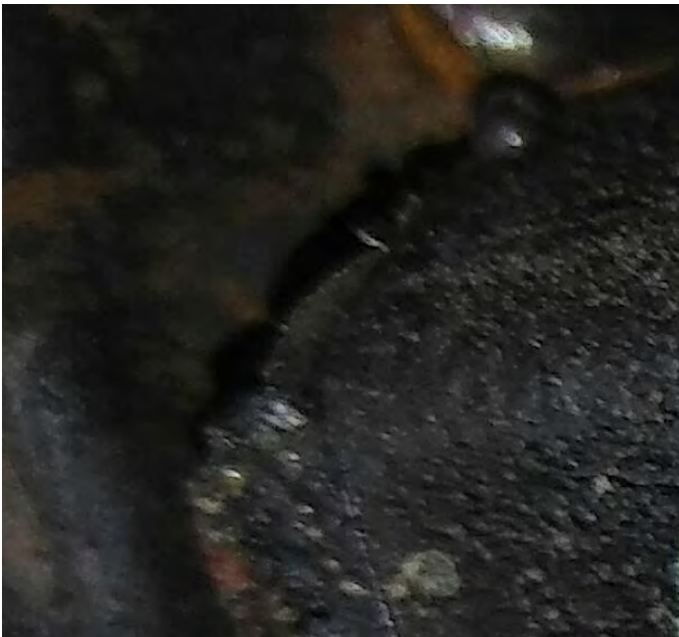
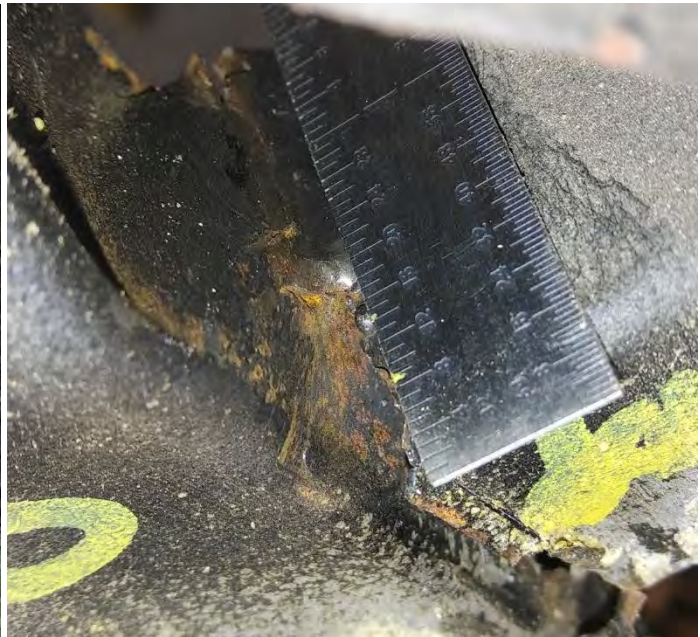
2-C Top weld – 1/2" no weld deposit

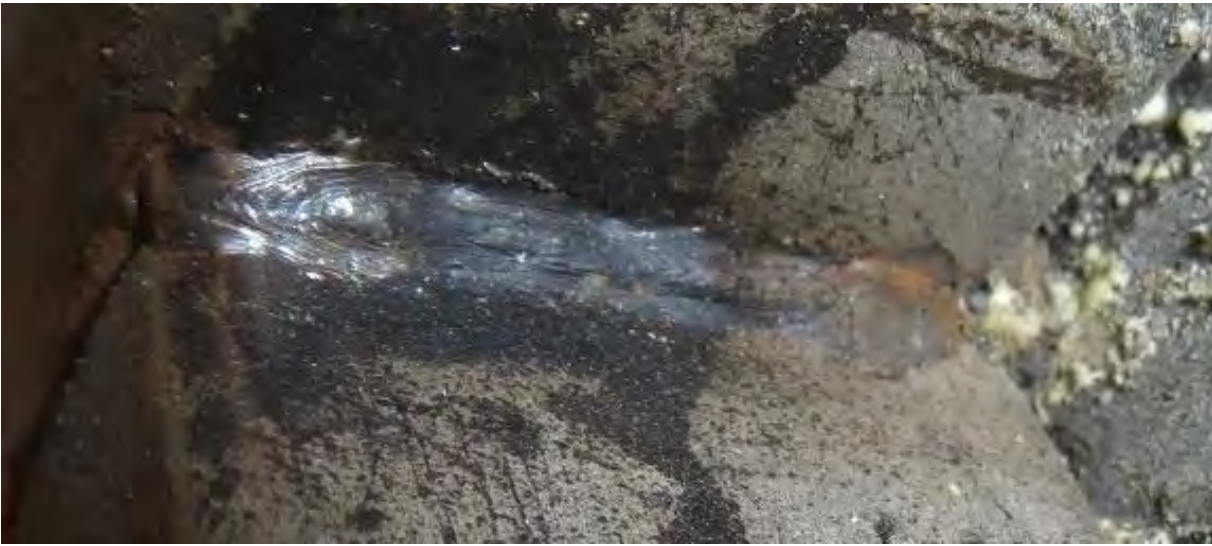
3-C: 5.1.2 Craters₁.

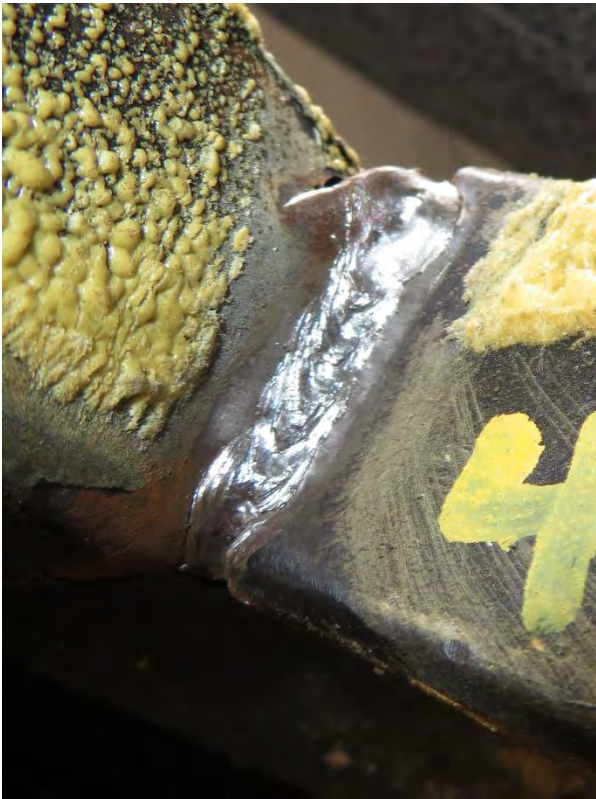
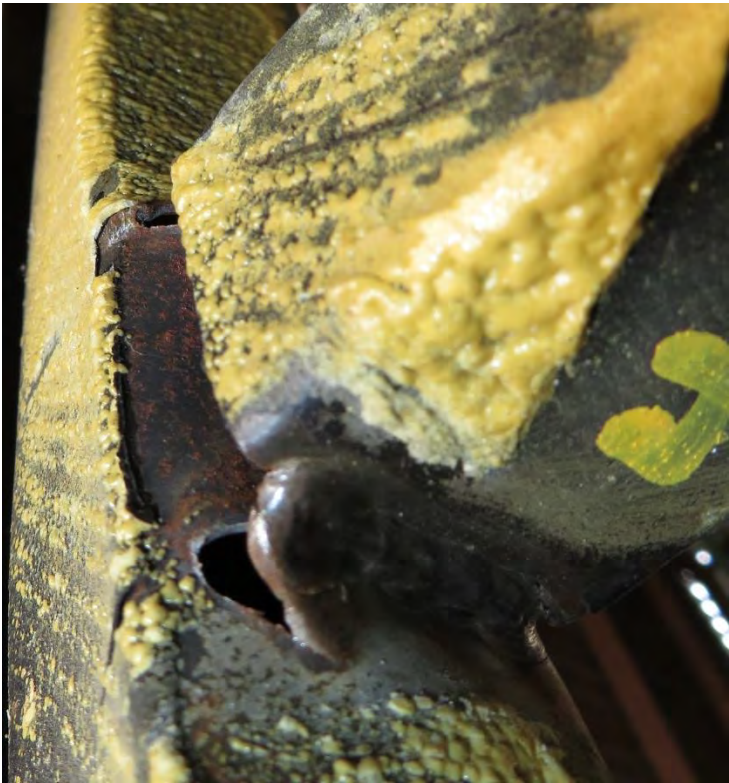
4-C: Rear weld: 2/32" no weld deposit, 5.1.2 Craters₁, 5.1.10 Overlap₂.

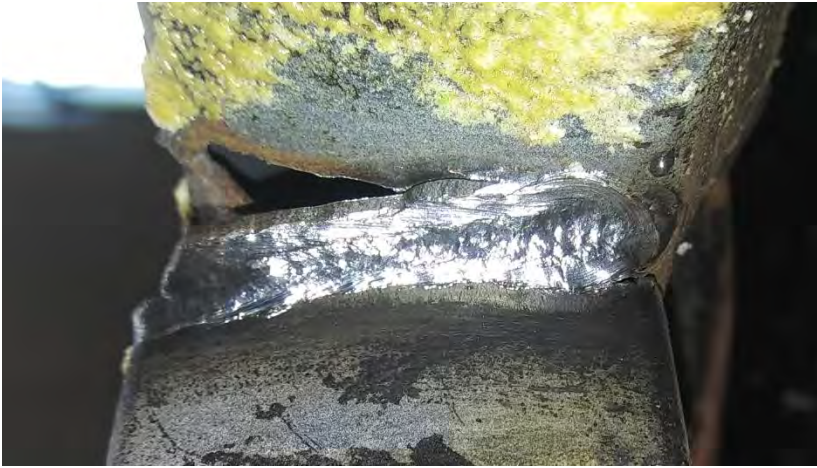
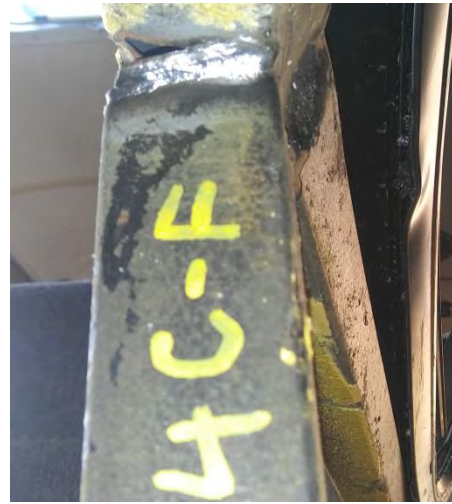
4-C: Front weld: base metal sheared in Heat Affected Zone (HAZ), fillet weld toe. (not a rejectable discontinuity)

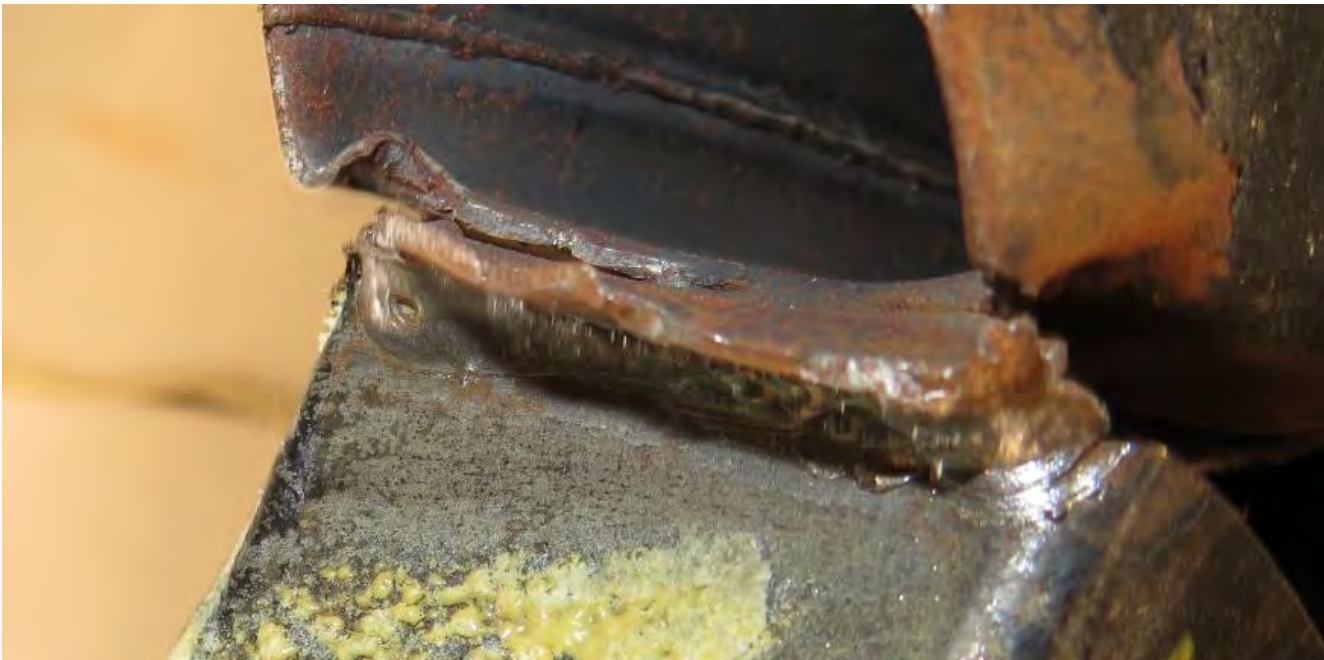
5-C: 5.1.2 Craters, 4.5.4.1 Surface Porosity

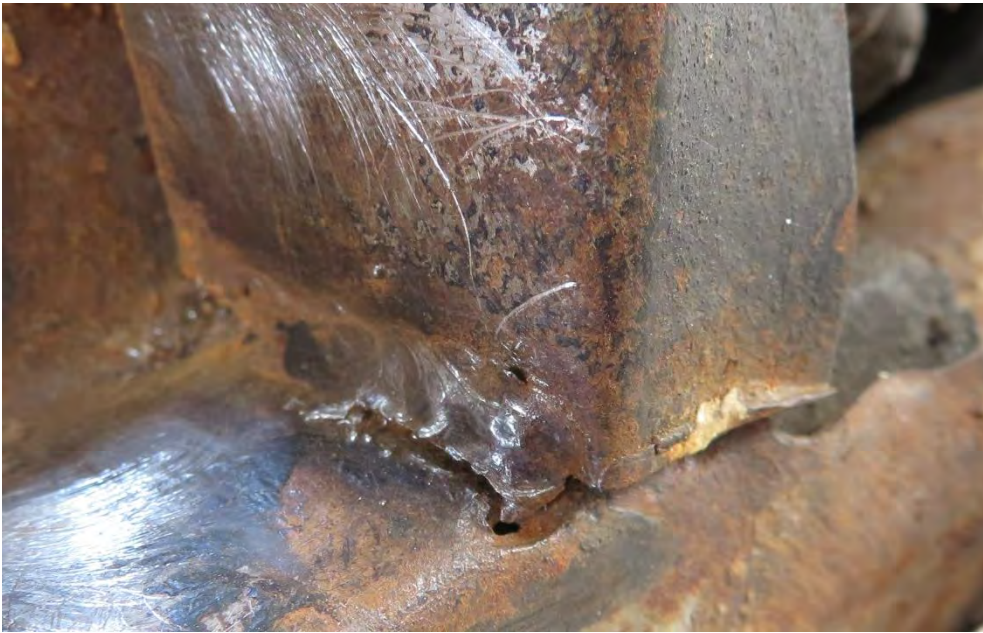
6-C: ¼" non weld deposit.

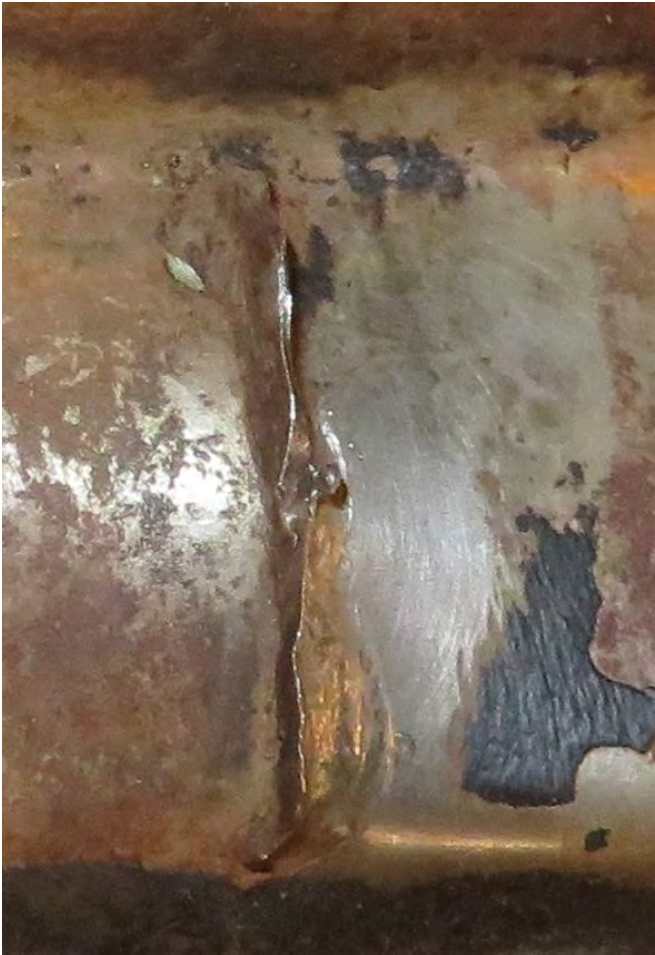
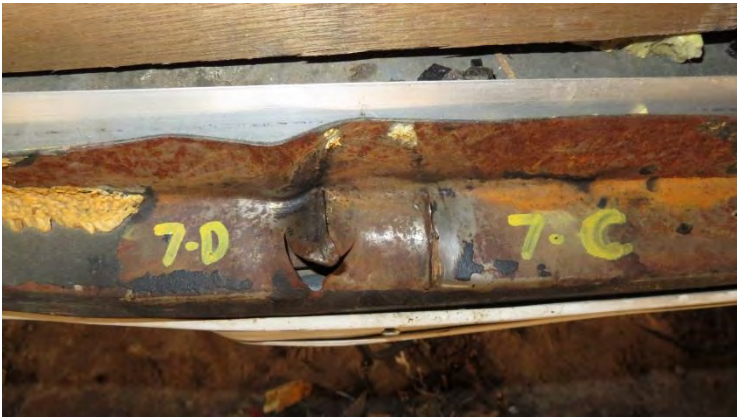
7-C: Tubing ripped away from weld toes
