INSPECTION OF CHAMPION DEFENDER BUS :

DRIVER SIDEWALL, FRAME (PART # 0414250)

PASSENGER SIDEWALL, FRAME (PART #0414249)

Re: Champion Defender bus accident, Davis, Oklahoma

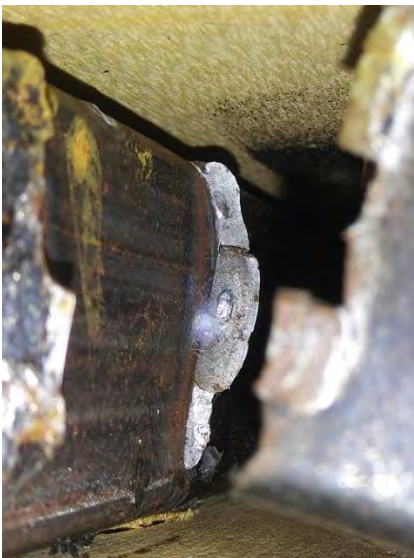
1-D Bottom Weld: Limited visual access, suspected incomplete fusion, Incomplete fusion - Ref Table 1: Common Types of Discontinuities₄,

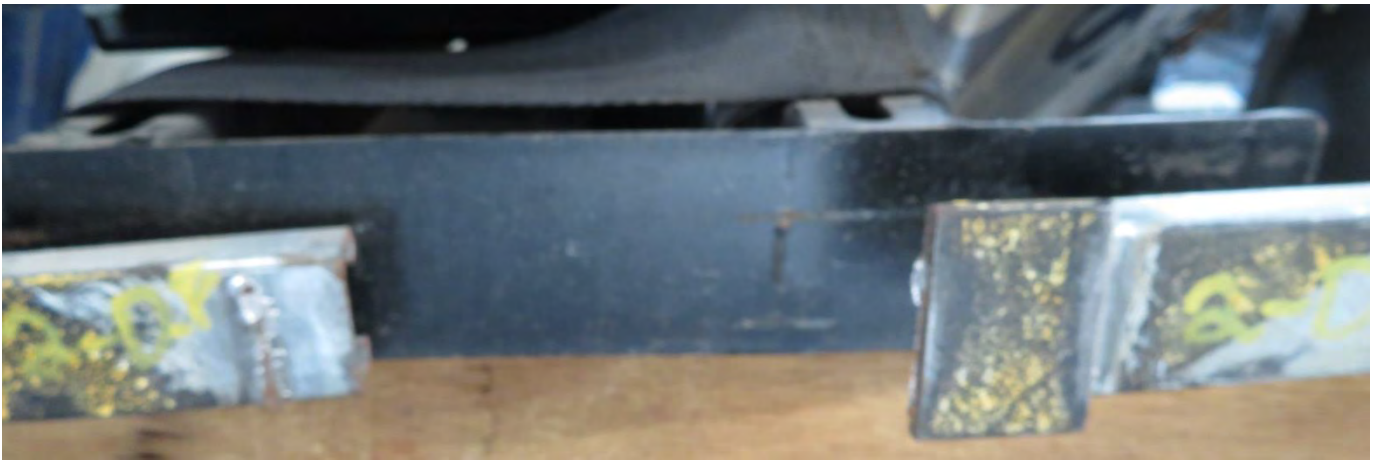
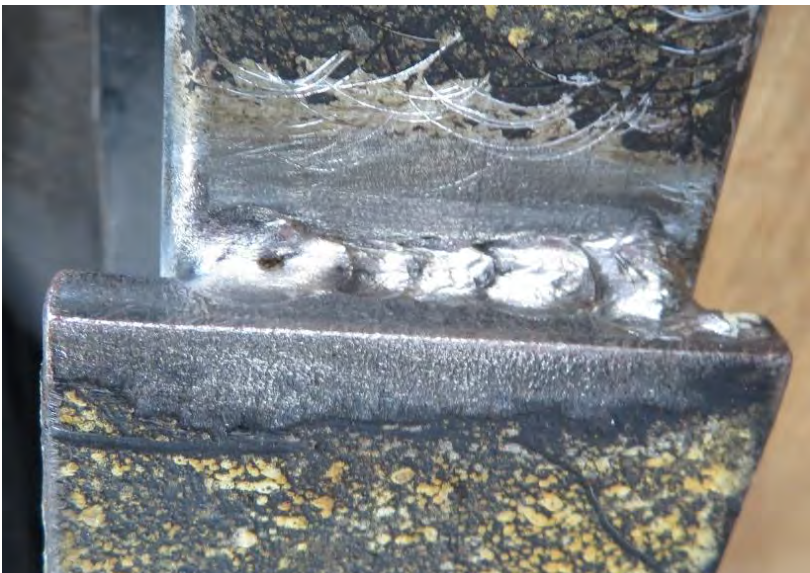
2-D Rear weld: 5.1.2 Craters₁, 5.1.10 Overlap₂.

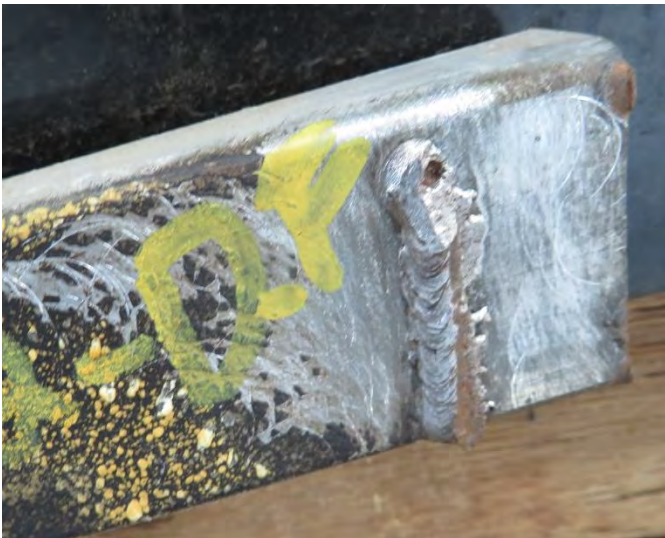
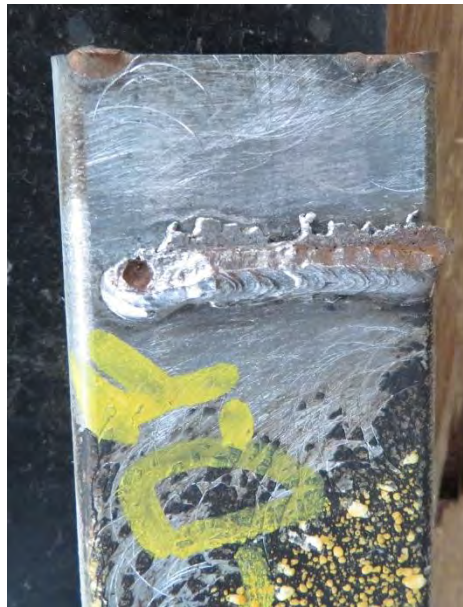
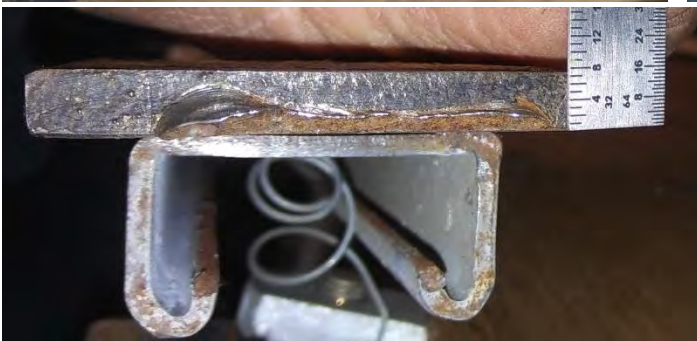
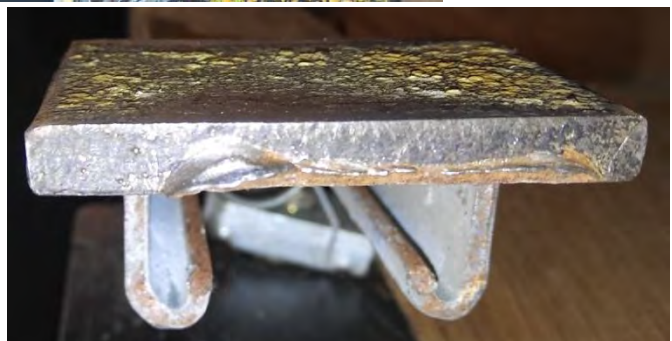
2-D Front weld: Poor placement of weld deposit creating dissimilar legs on 15/64" thick splice plate. 5.3.1 Fillet Welds₇ - Fillet weld leg fusion attached to splice plate exhibits only 2/32" (1/16") of fusion.

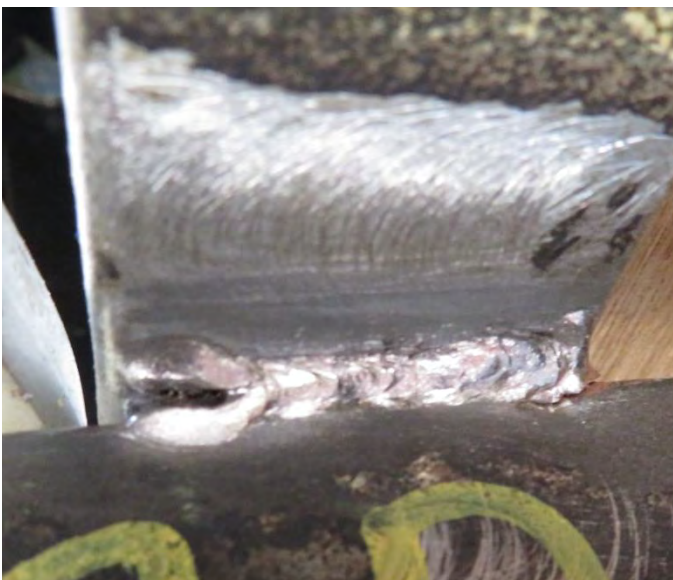
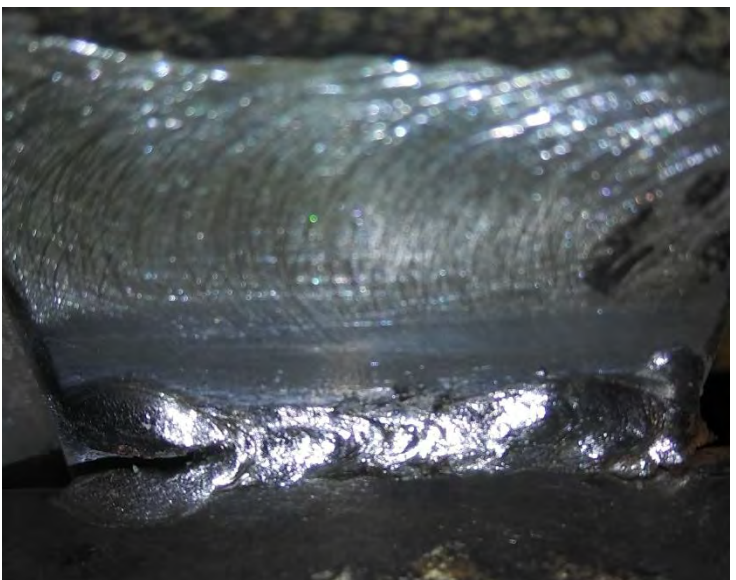
3-D: Root Incomplete fusion - Ref Table 1: Common Types of Discontinuities₄, 5.1.9 Notching₈.

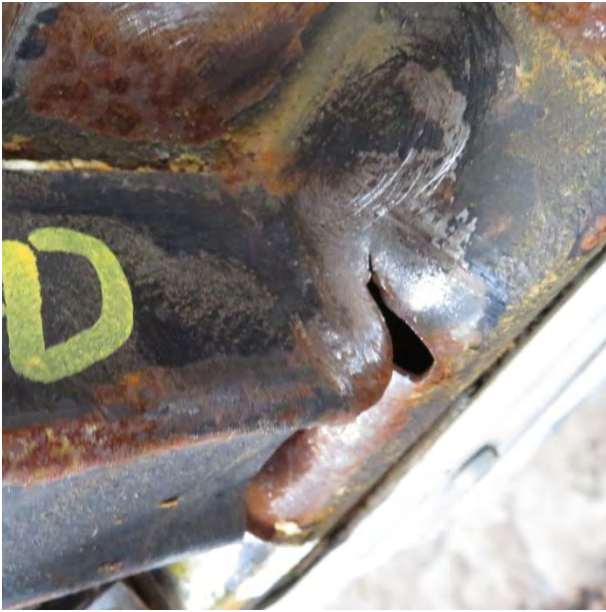
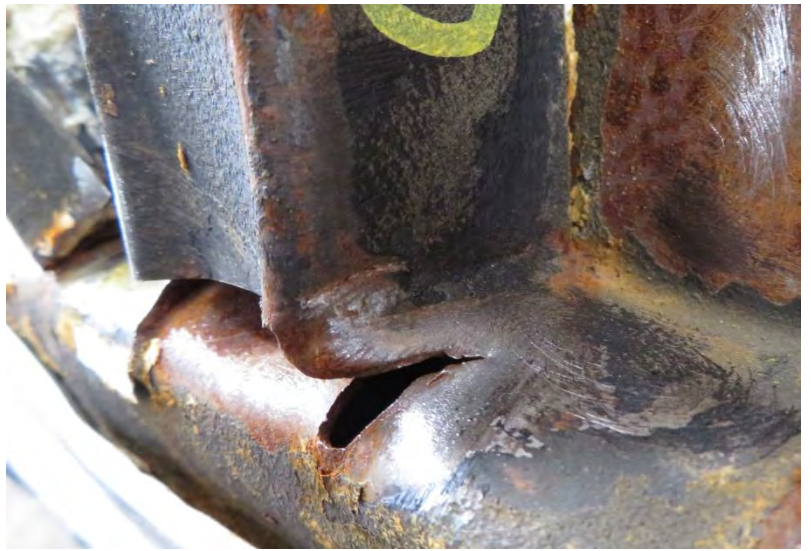
4-D: Tear in Heat Affected Zone (HAZ) (not a rejectable discontinuity)

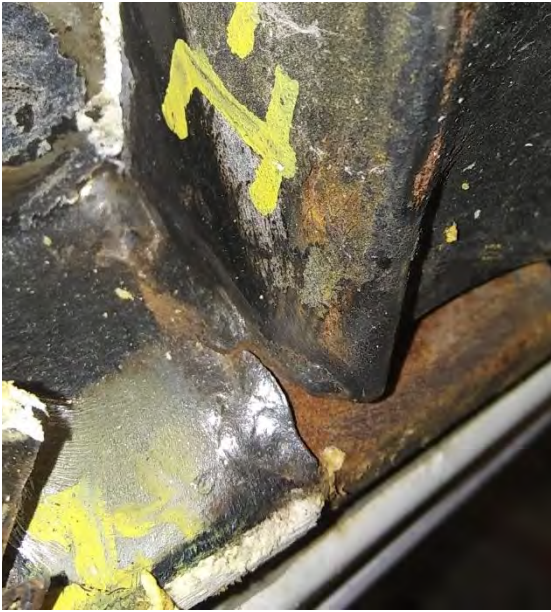
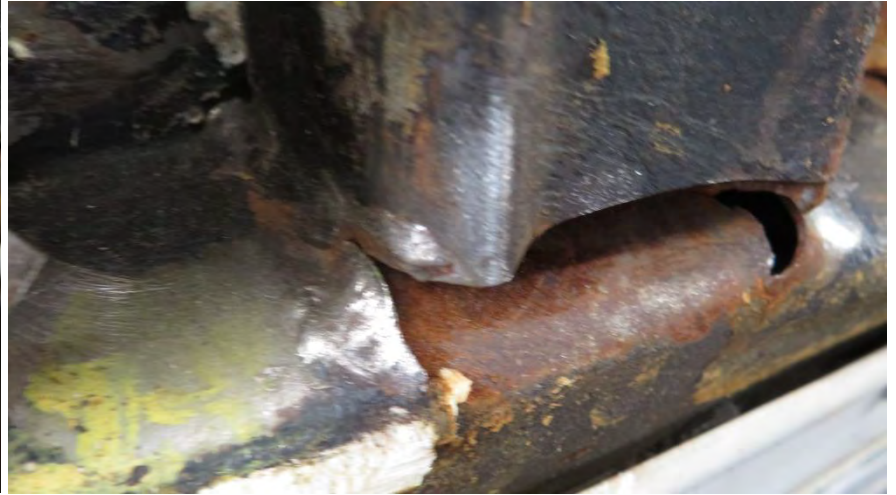
1-E: 5.1.10 Overlap₂, ½" Incomplete fusion - Ref Table 1: Common Types of Discontinuities₄.

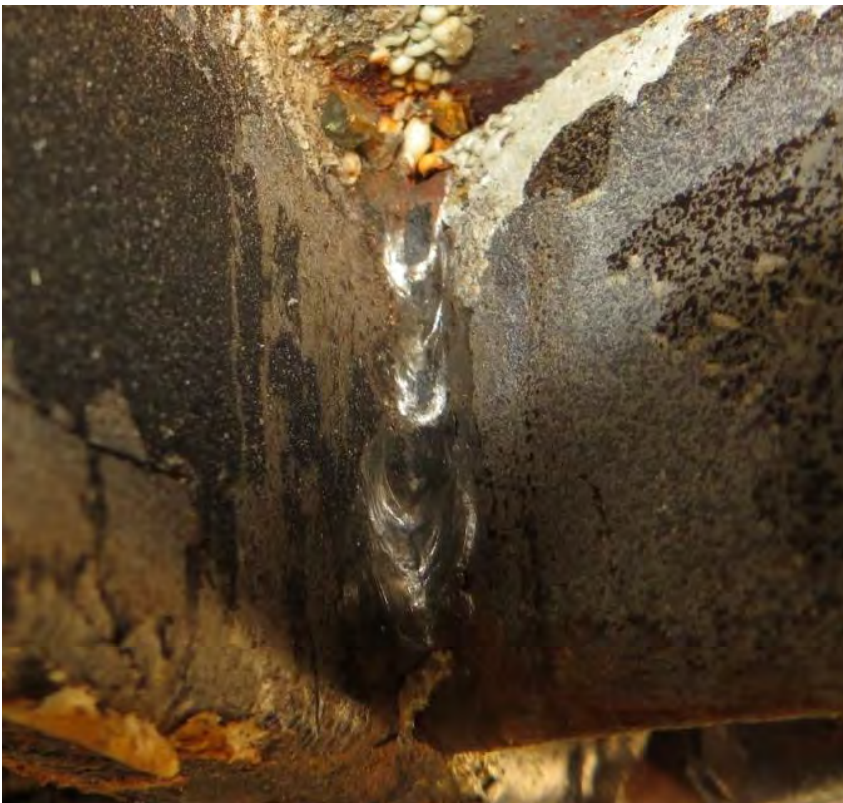
2-E: 5.1.10 Overlap₂. 5.1.2 Craters₁

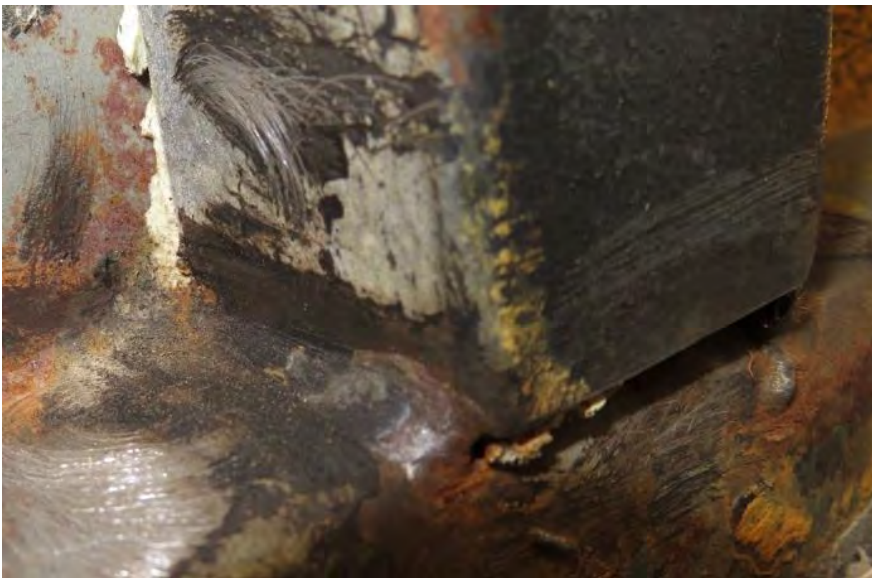
1-F: Surface exhibits no discontinuities.

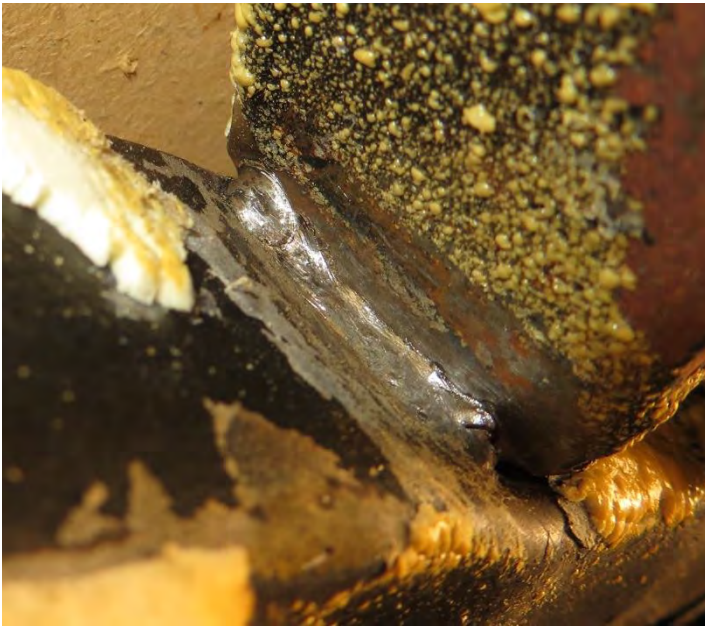
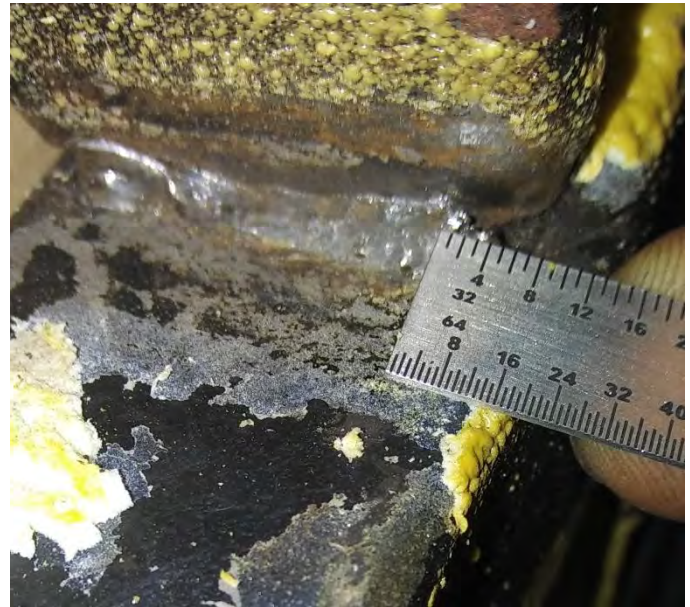
2-F: 5/32" Incomplete fusion - Ref Table 1: Common Types of Discontinuities₄, 5.1.2 Craters₁,

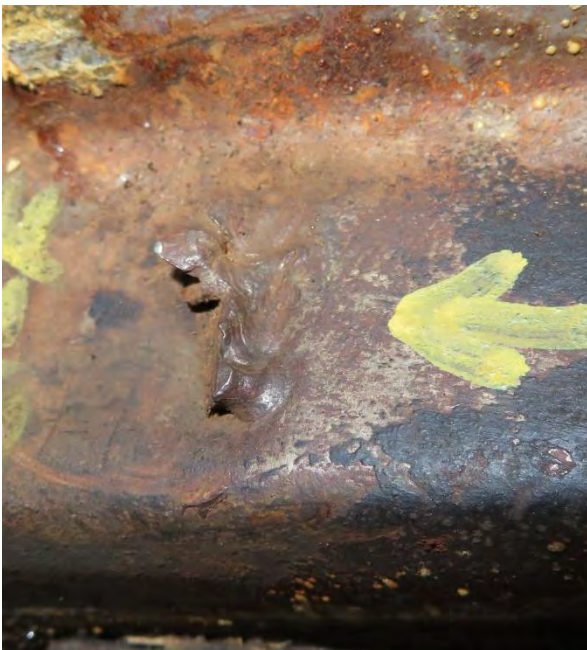
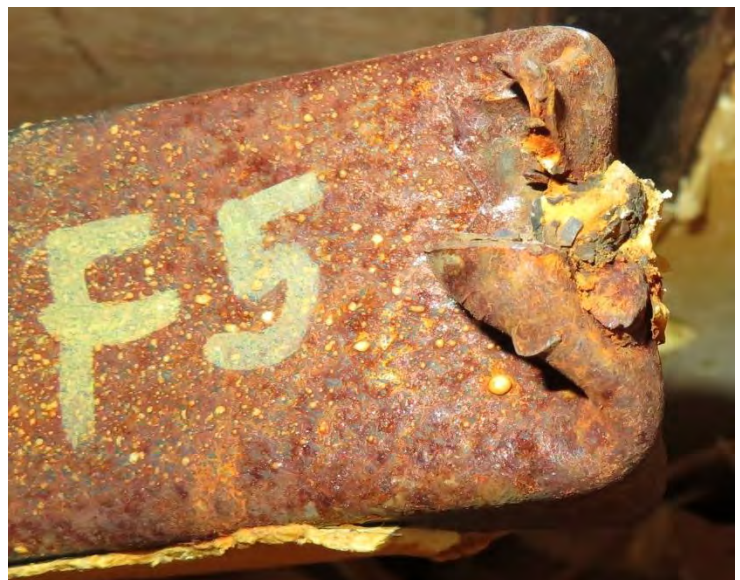
5-F: Further lab examination required

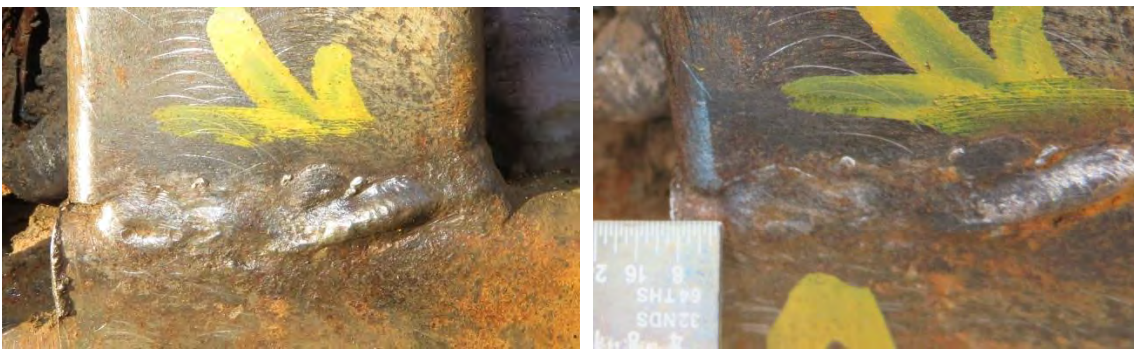
G-1A: 8/64" Incomplete Fusion - Ref Table 1: Common Types of Discontinuities₄, 5.1.10 Overlap₂.

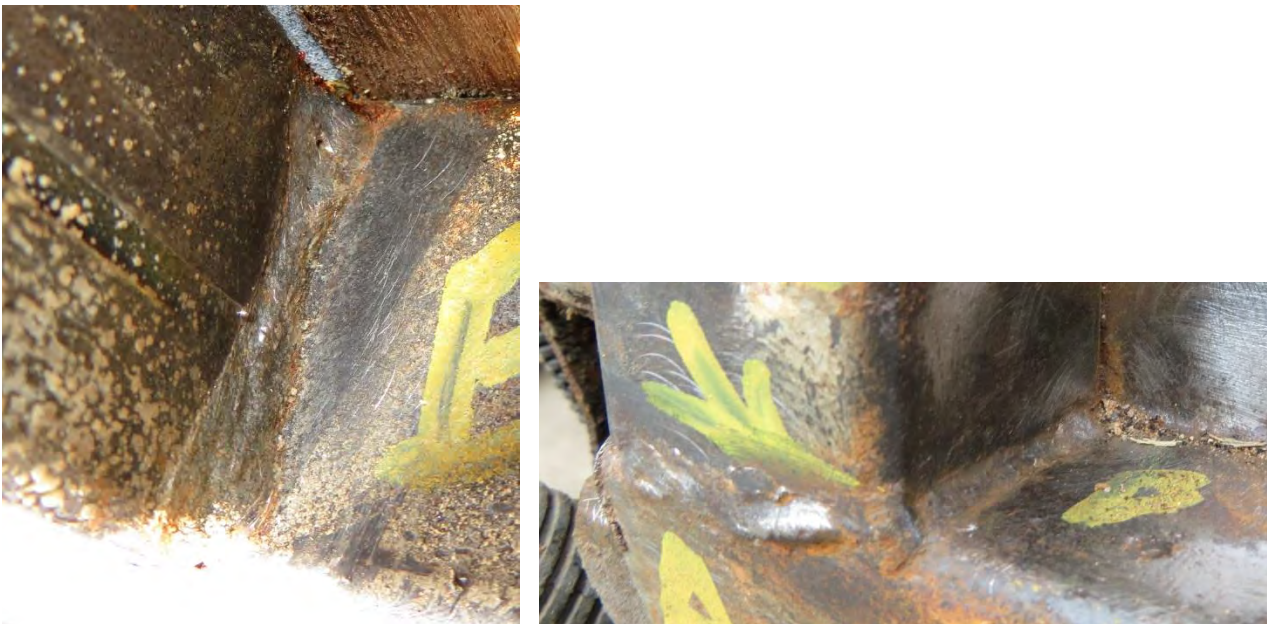
G1-B: 5.1.1 Undercut₁₀ $T = 0.065"$. $0.2T = 0.013"$ (= permissible depth of undercut in this weld). Actual depth of undercut in this weld is 0.031 ($1/32"$). Length of undercut is $24/64"$, this is also outside the permissible length of cumulative $1/8$ of specified weld.

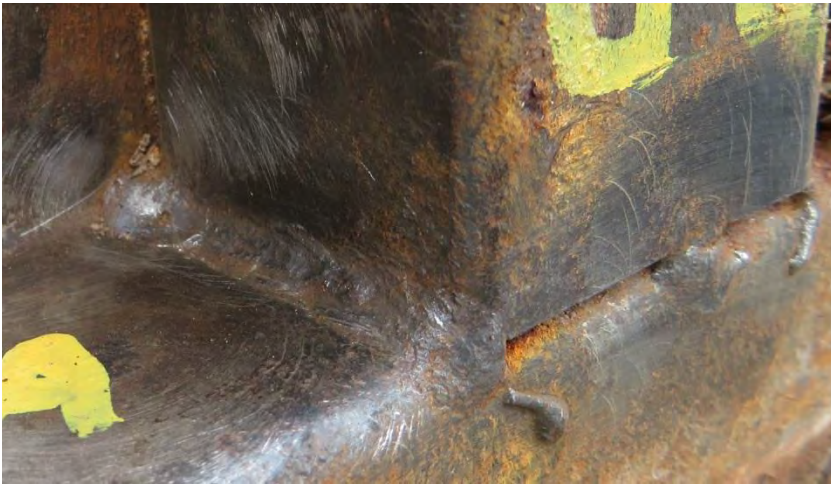
G-2A: 5.1.2 Craters₁

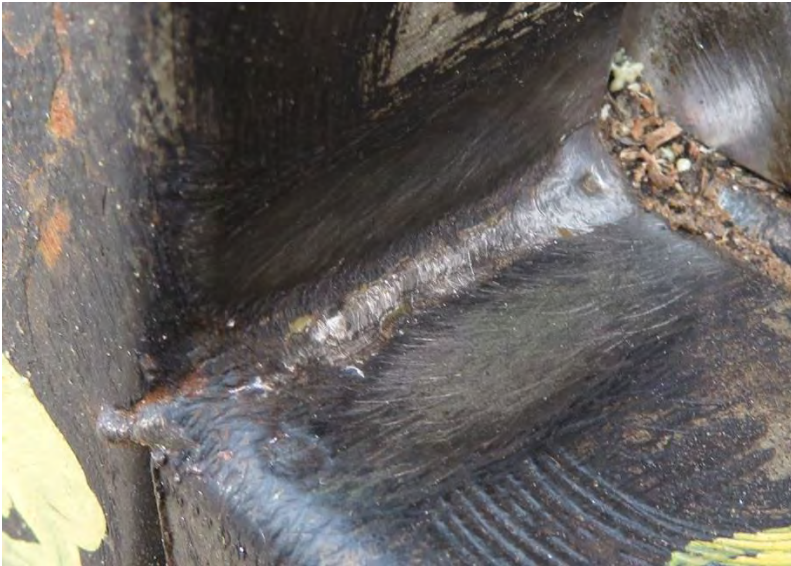
G-3A: 5.1.2 Craters₁

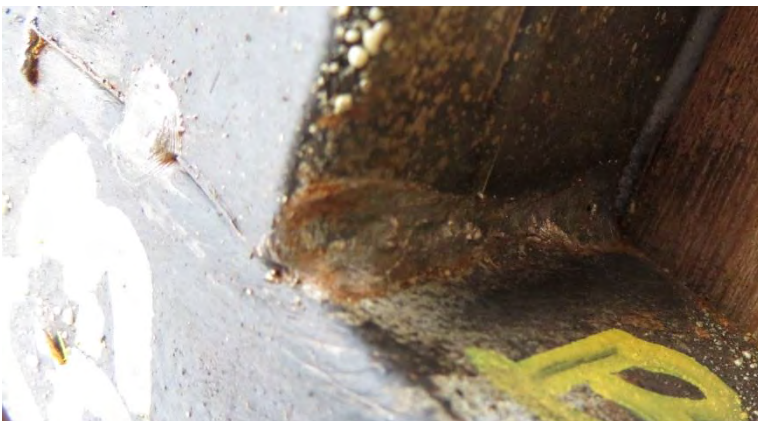
G-3B: 5.1.10 Overlap₂, 5.1.2 Craters₁

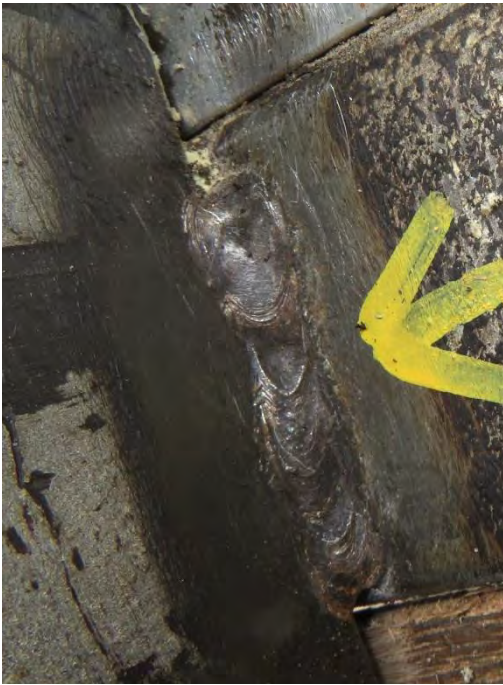
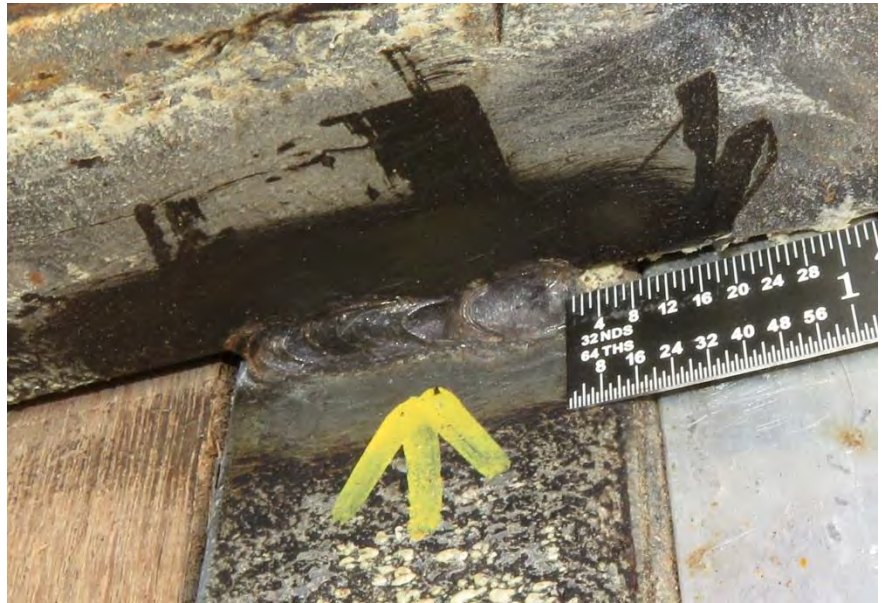
G-6: 7/32" Incomplete Fusion - Ref Table 1: Common Types of Discontinuities₄, 2 x 5.1.2 Craters₁.

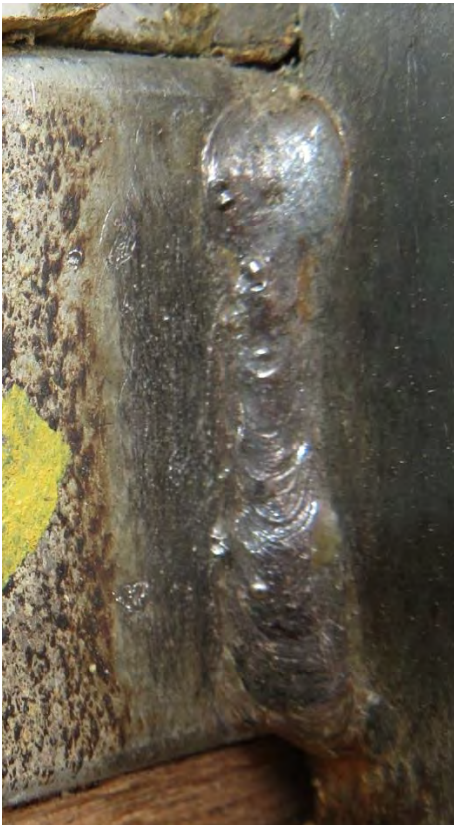
G-7: 5.1.2 Craters₁, Zinc plated C-channel spliced with unknown plate.

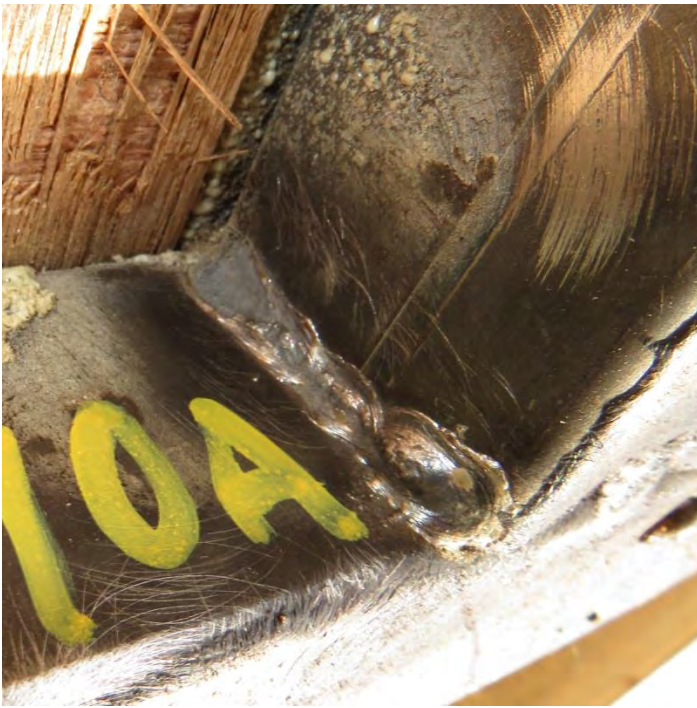
G-10A: 5.1.10 Overlap₂, 5.1.2 Craters₁.

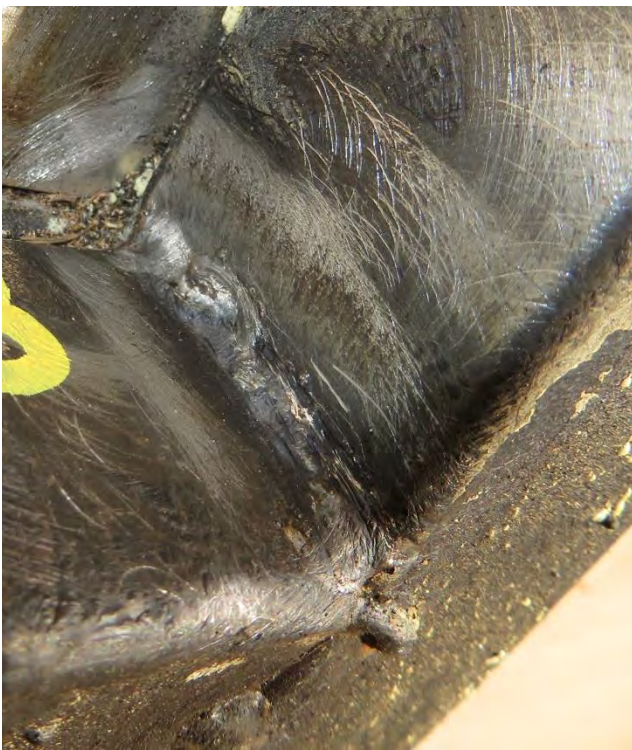
G-10B: Excessive arc strike (5.1.10 Overlap₂), 5.1.2 Craters₁.

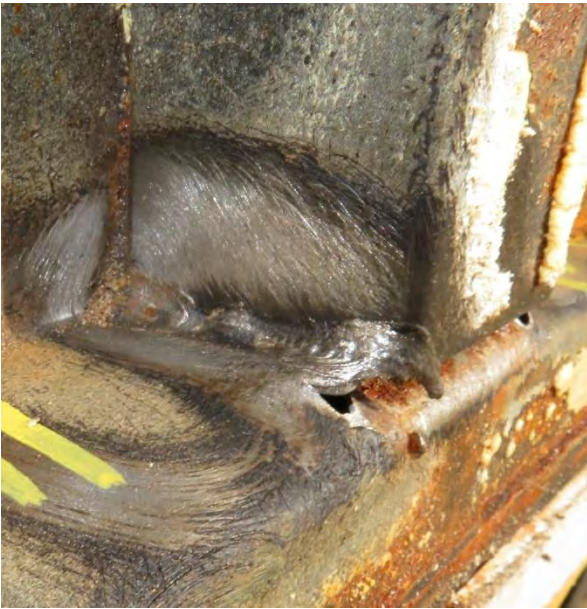
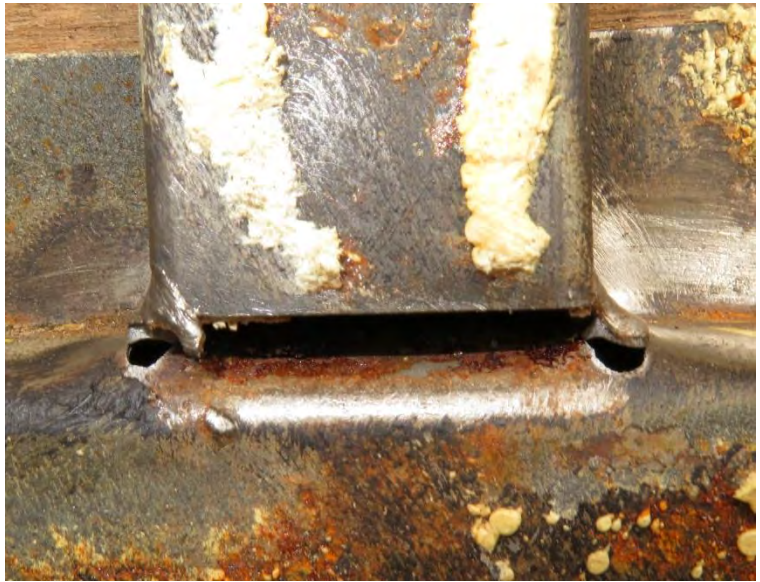
G-11: 5.1.2 Craters₁, HAZ (Heat Affected Zone) / toe of weld tearing 6/32"

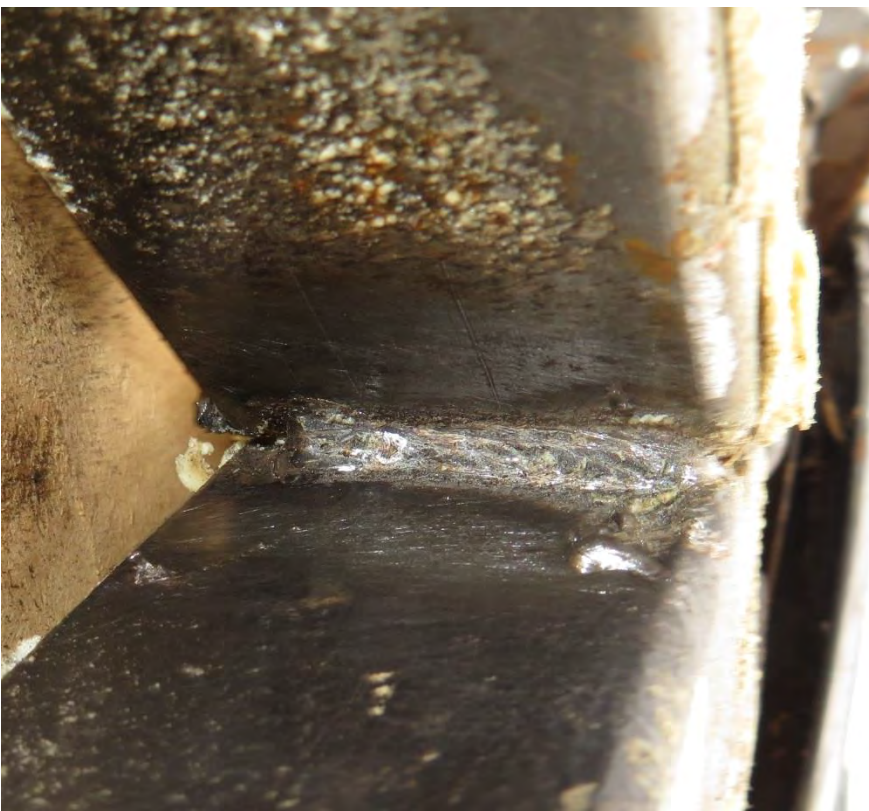
G-12: ¼" Incomplete Fusion - Ref Table 1: Common Types of Discontinuities₄, 5.1.10 Overlap₂.

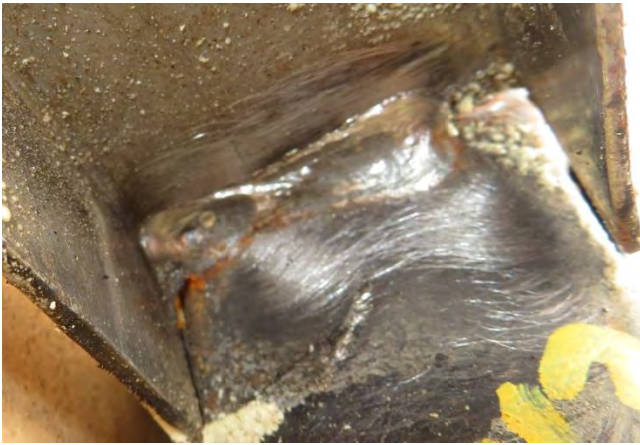
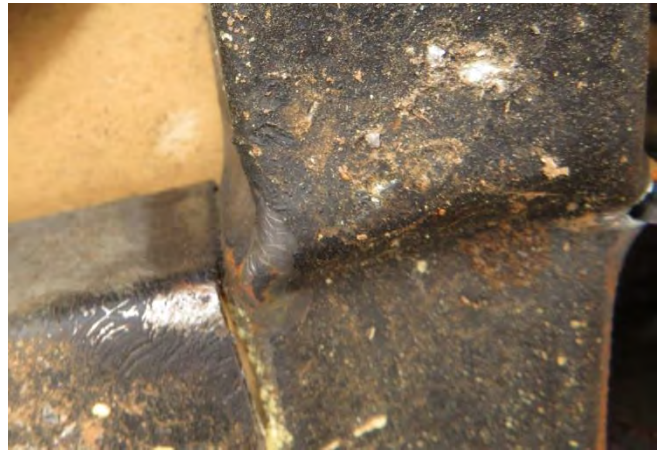
G-13: ¼" Incomplete Fusion - Ref Table 1: Common Types of Discontinuities₄, 5.1.10 Overlap₂, 5.1.2 Craters₁.

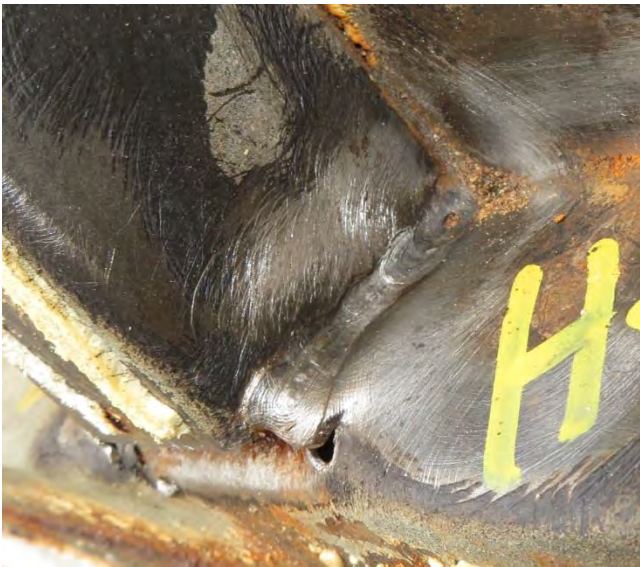
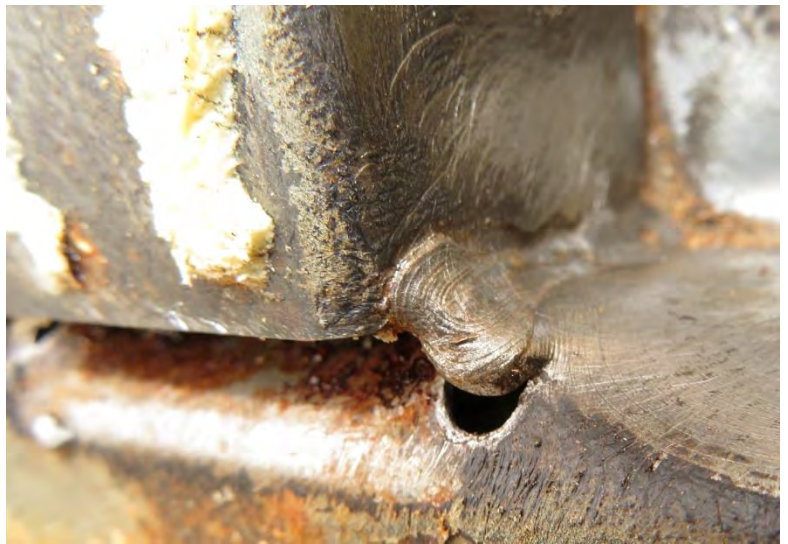
H-1: 5.1.2 Craters₁, HAZ (Heat Affected Zone)/ toe of weld tearing 1/8"

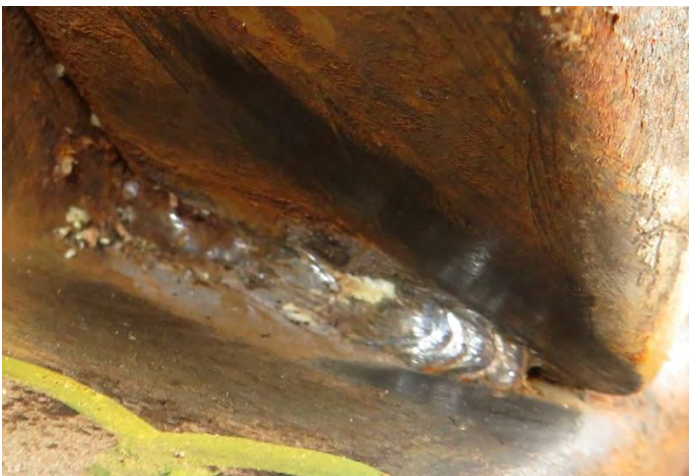
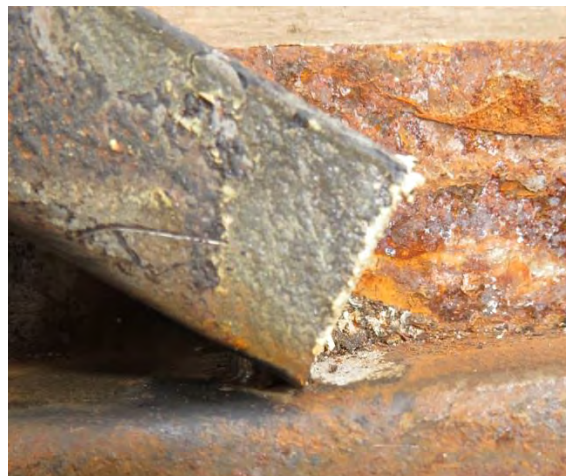
H-2: 1/8" Incomplete Fusion - Ref Table 1: Common Types of Discontinuities₄.

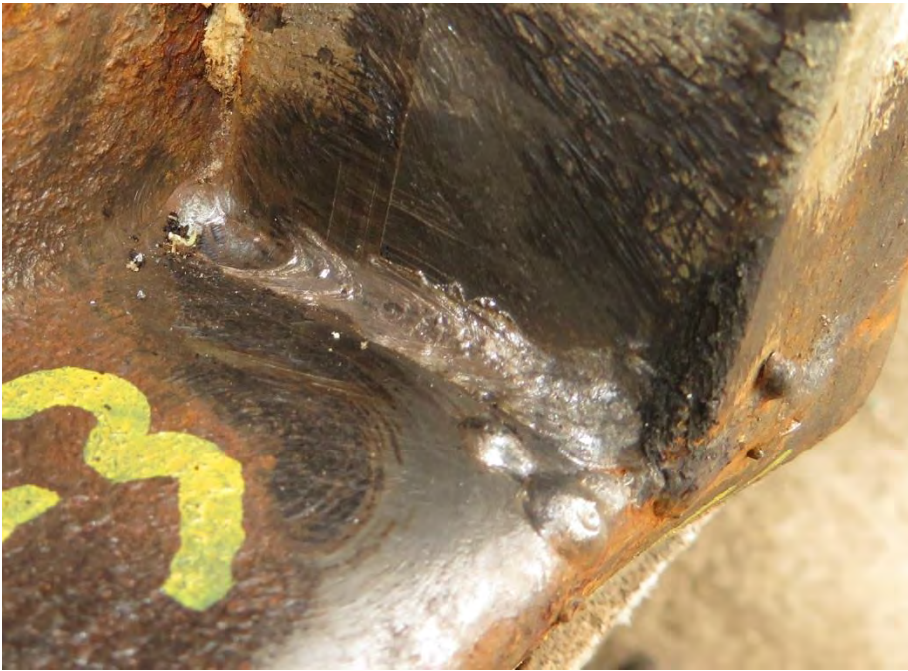
H-3: Excessive arc strike (5.1.10 Overlap₂), 5.1.2 Craters₁.

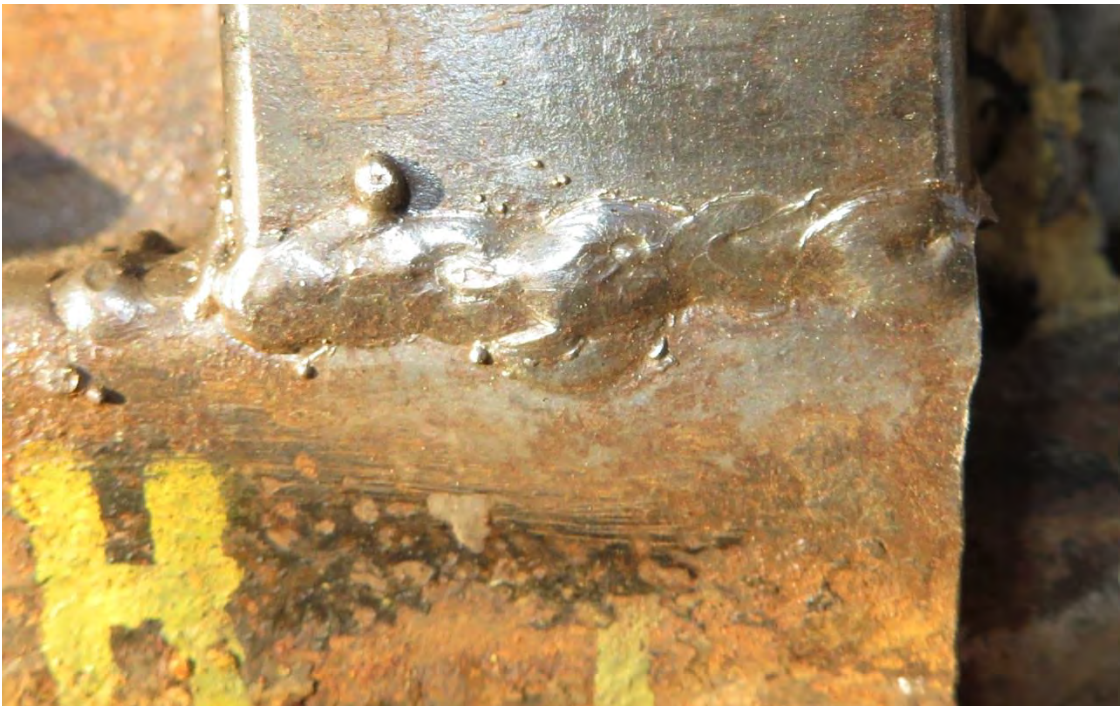
H-4: Excessive arc strike (5.1.10 Overlap₂), 5.1.2 Craters₁.

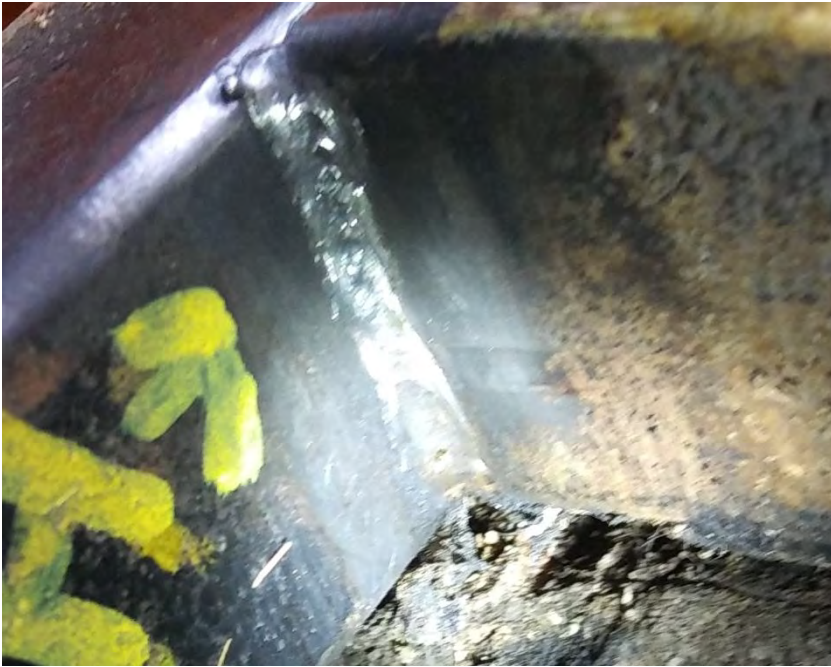
H-5: 5.1.2 Craters₁.

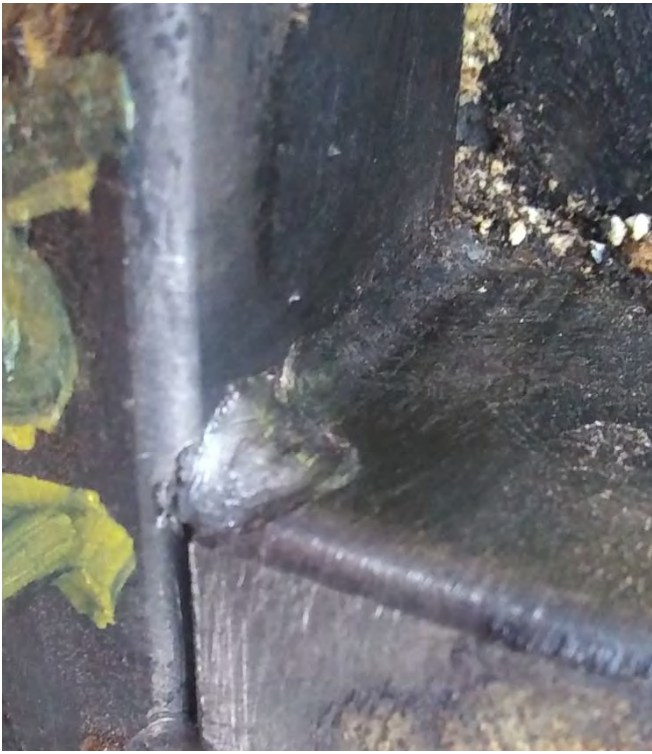
H-6: 5.1.2 Craters₁.

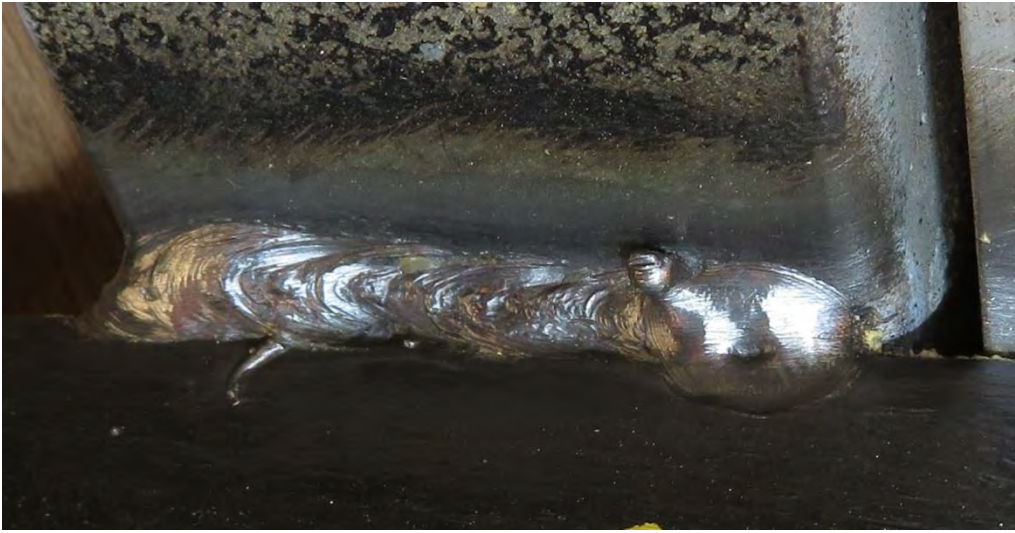
H-7: 5.1.2 Craters₁, 5.1.10 Overlap₂.

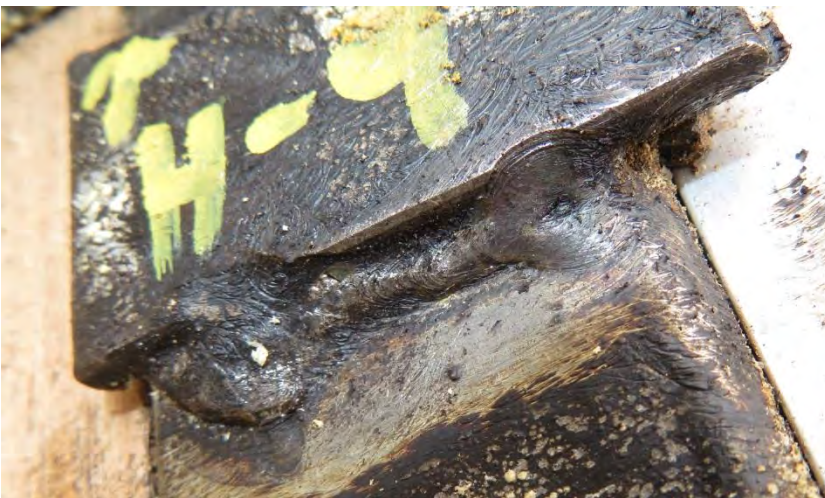
H-8: 5.1.2 Craters₁, 5.1.10 Overlap₂, 5.1.7 Meltback₁₁.

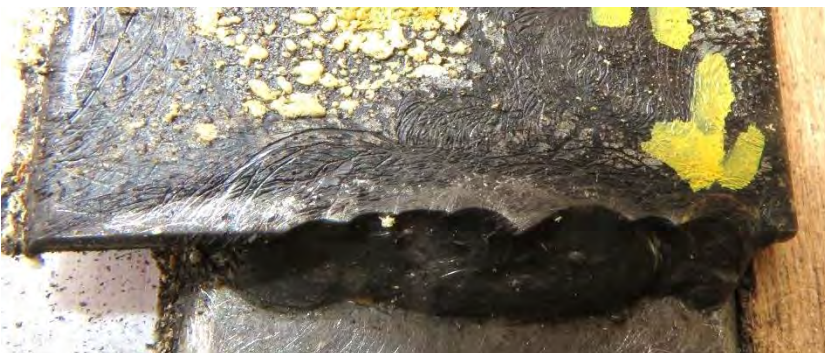
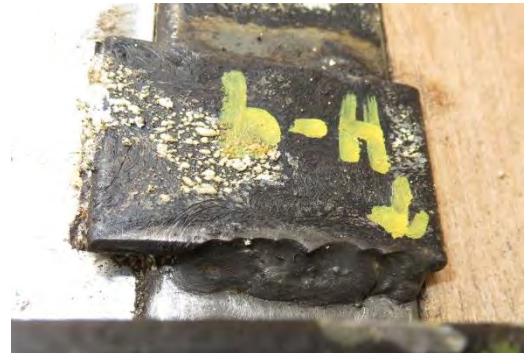
H-9: 5.1.2 Craters₁, 5.1.7 Meltback₁₁, 1/8" Incomplete Fusion - Ref Table 1: Common Types of Discontinuities₄.

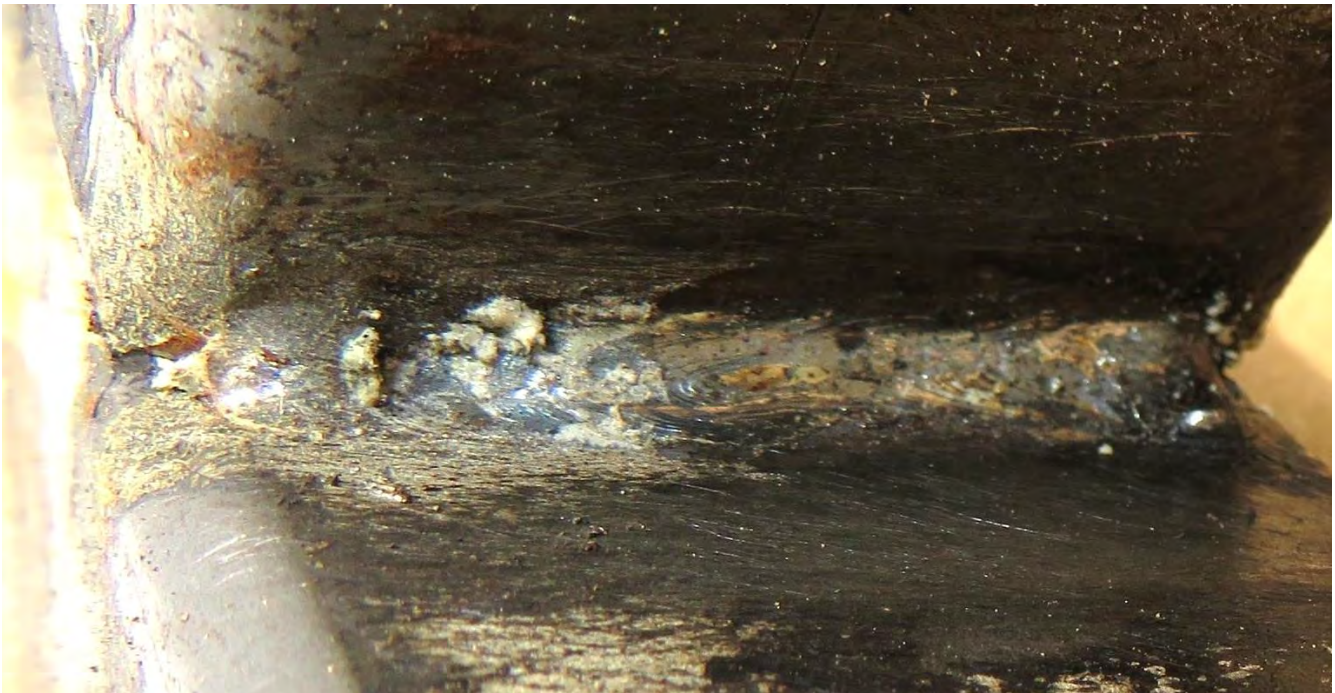
H-11: 5.1.2 Craters₁

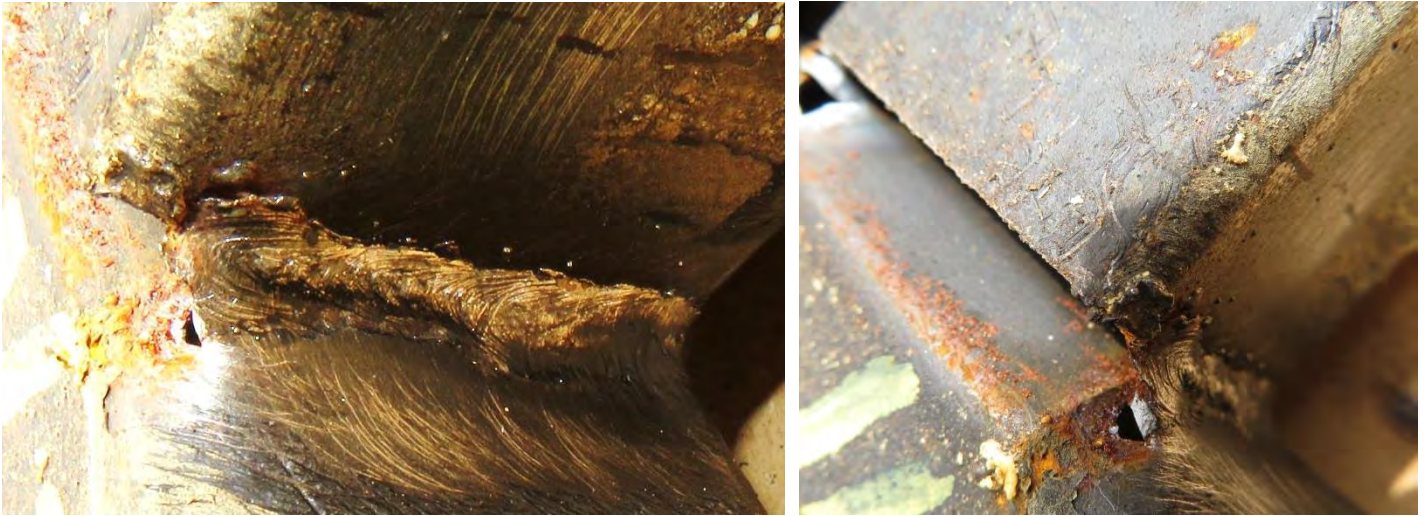
H-12A: 5.1.10 Overlap₂, 5.1.2 Craters₁, HAZ (Heat Affected Zone) / toe of weld tearing 1/16"

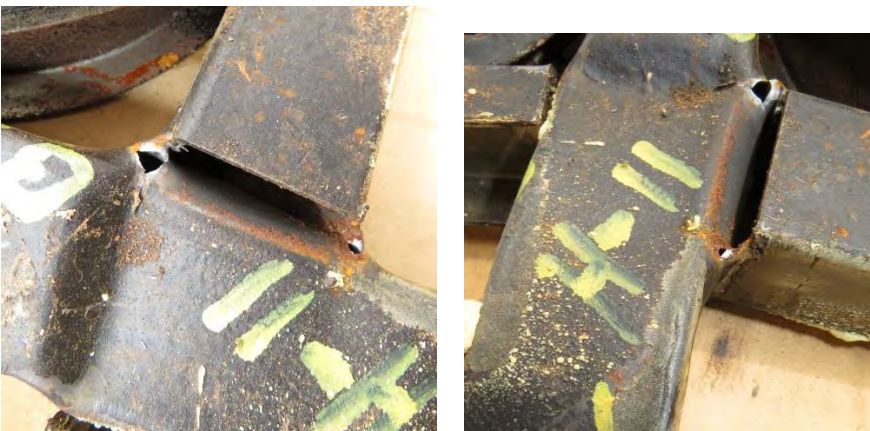
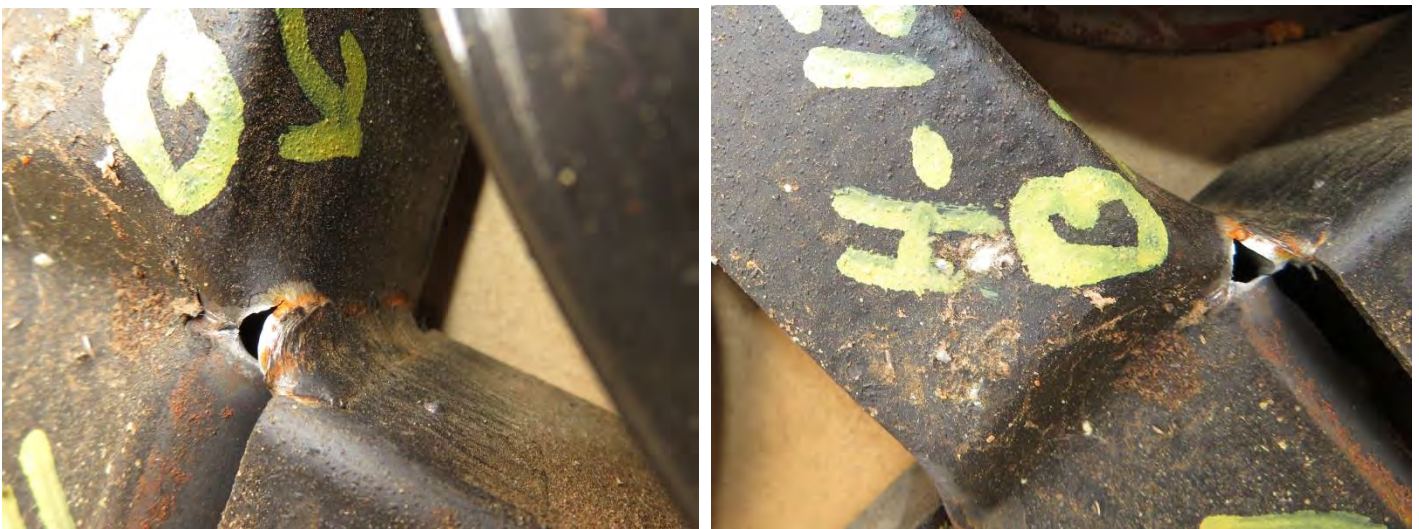
H-12B: Limited accessibility for cleaning & visual inspection, HAZ (Heat Affected Zone) / toe of weld tearing 1/16"
