INSPECTION OF CHAMPION DEFENDER BUS :

DRIVER SIDEWALL, FRAME (PART # 0414250)

PASSENGER SIDEWALL, FRAME (PART #0414249)

Re: Champion Defender bus accident, Davis, Oklahoma

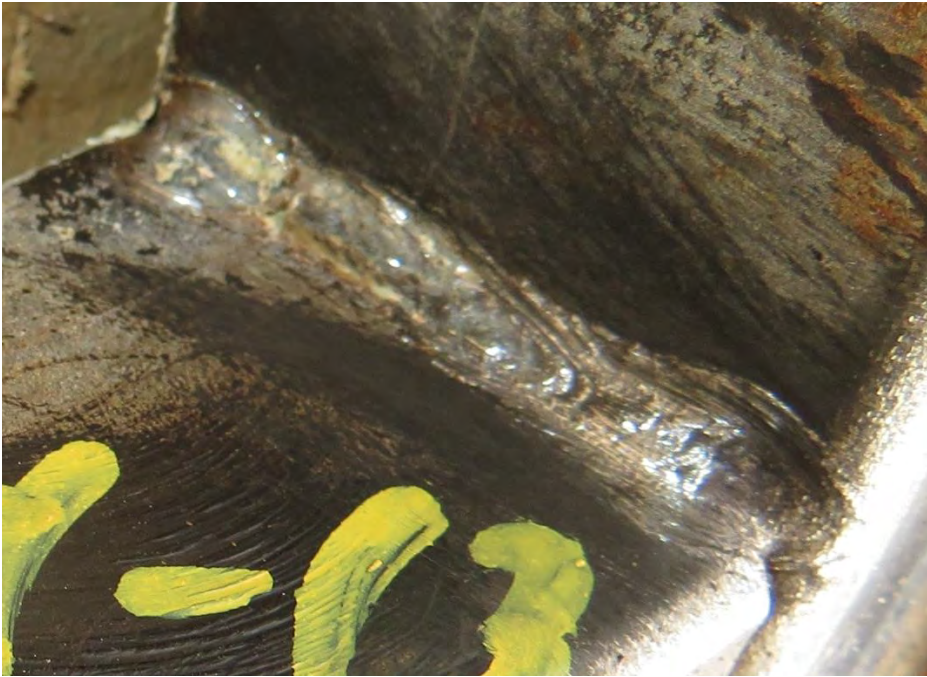
H-13A: 5.1.2 Craters₁.

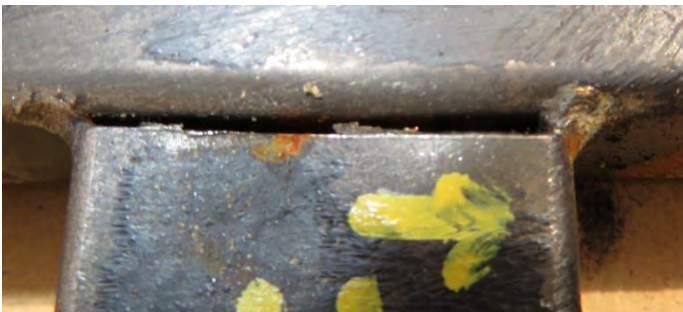
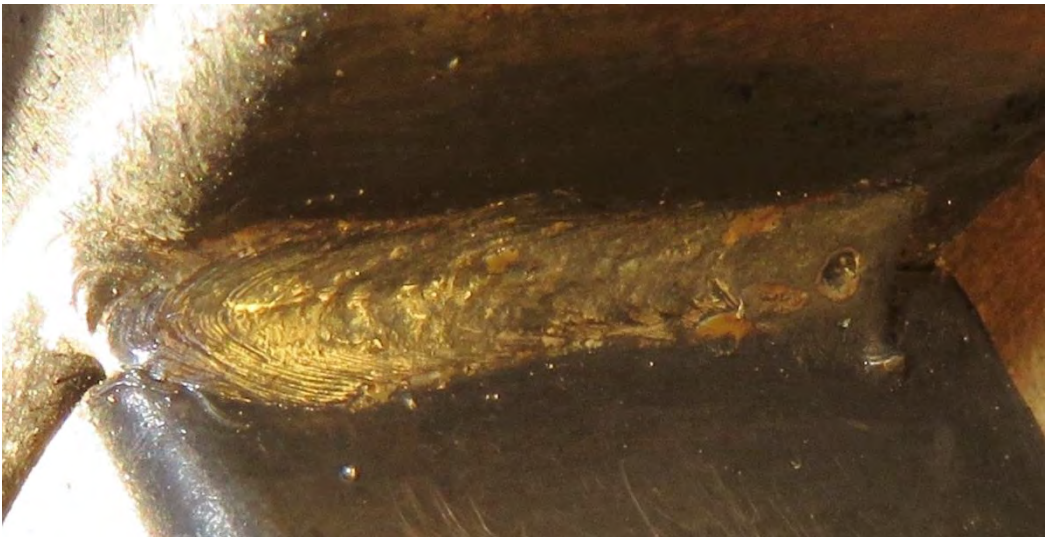
H-13B: 1/4" Incomplete Fusion - Ref Table 1: Common Types of Discontinuities₄, : 5.1.2 Craters₁.

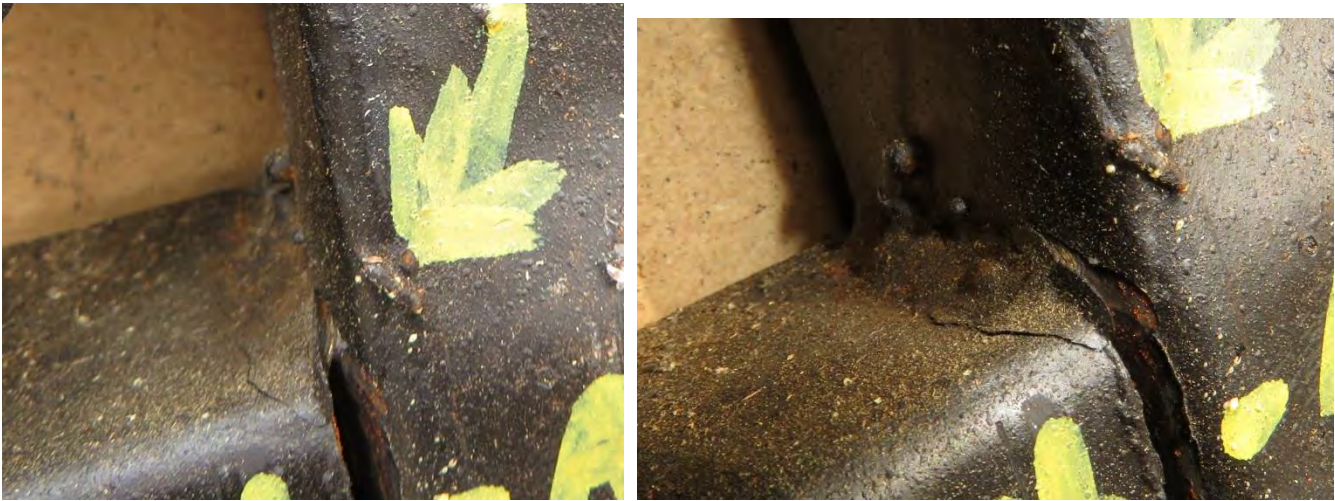
H-14B: Inaccessible for cleaning and visual inspection

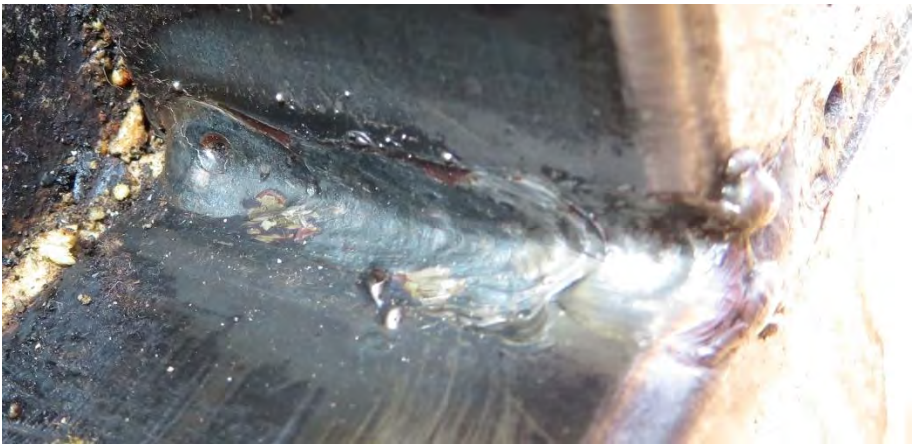
H-15: 5.1.2 Craters₁, Excessive arc strike (5.1.10 Overlap₂).

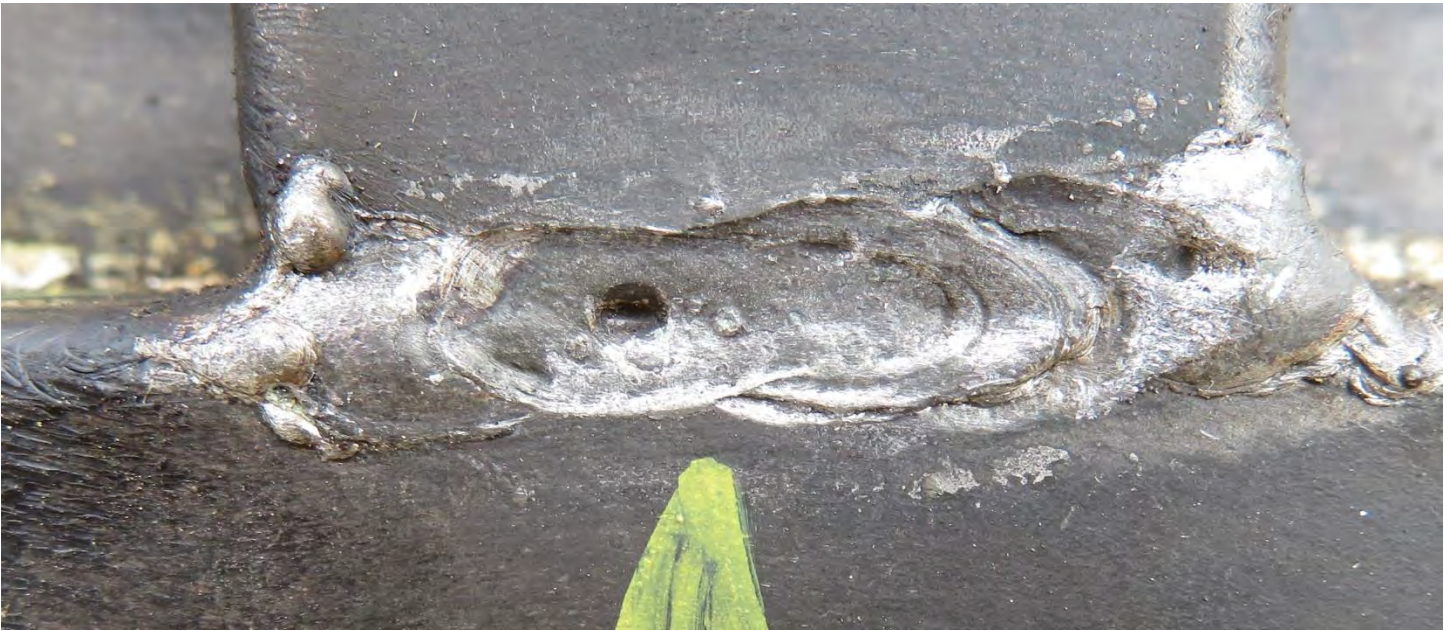
H-16: Undersized weld (5.3.2.2 Welds in Butt & Groove Joints₁₂), 5.1.2 Craters₁,

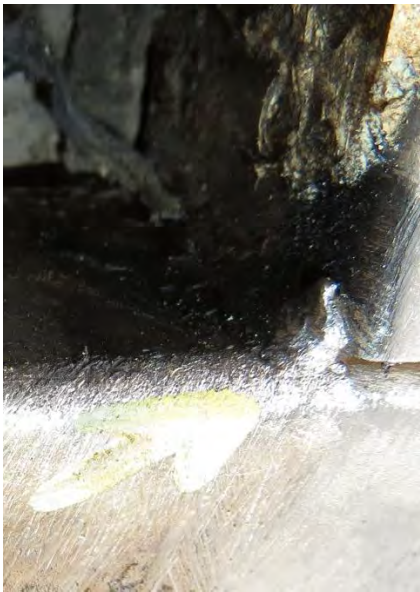
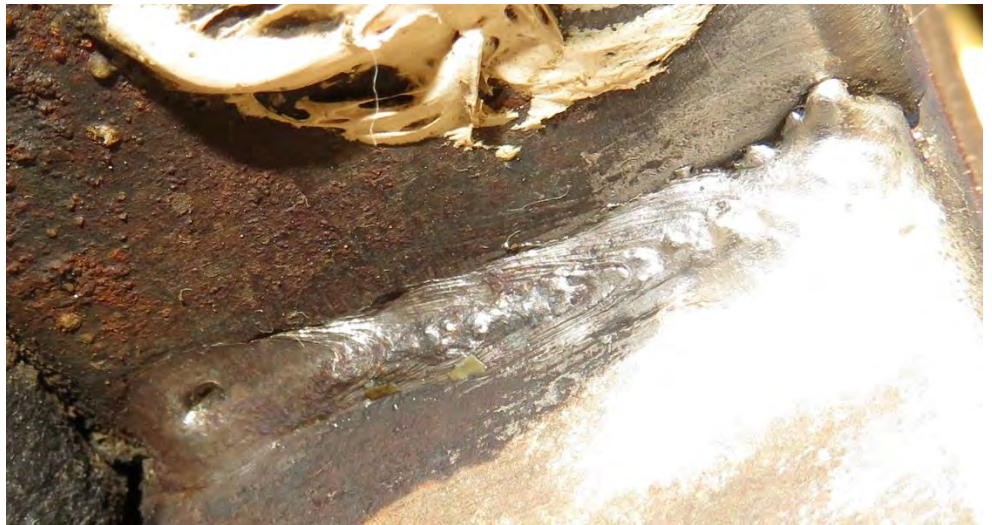
I-3B: 5.1.2 Craters₁, 5.1.10 Overlap₂.

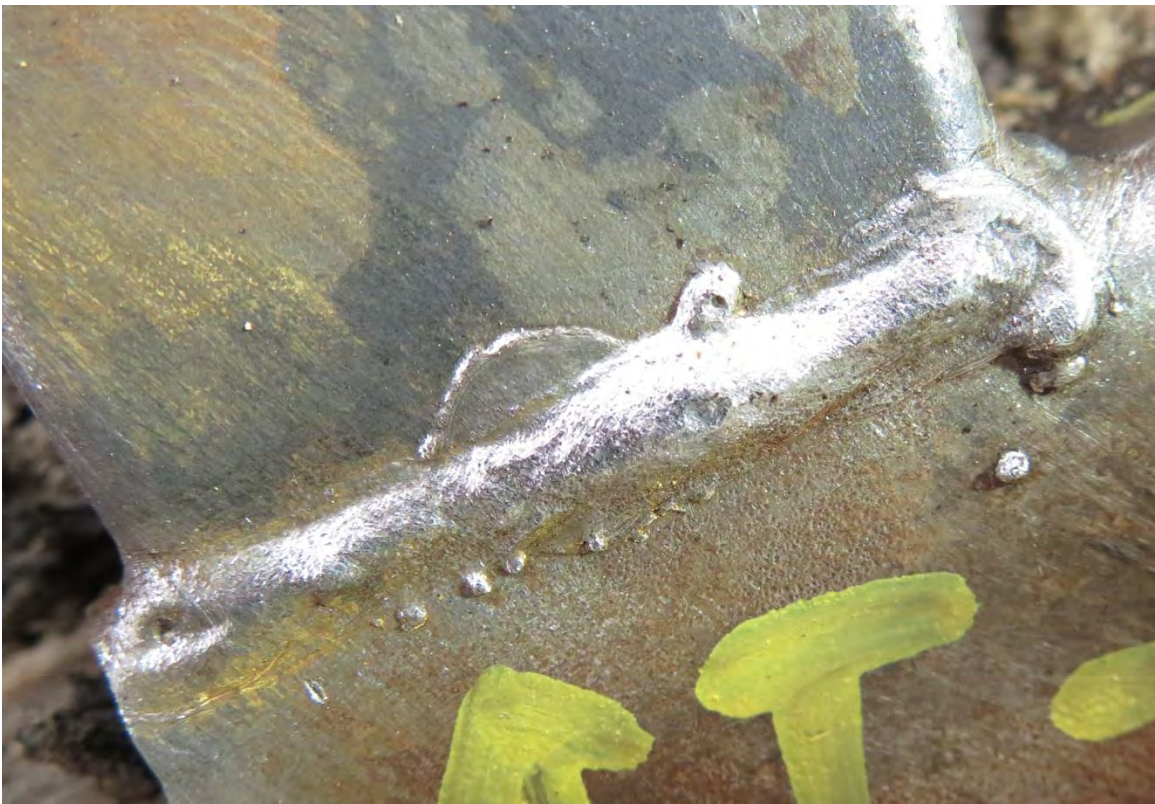
I-4A: 5.1.2 Craters₁, 5.1.10 Overlap₂.

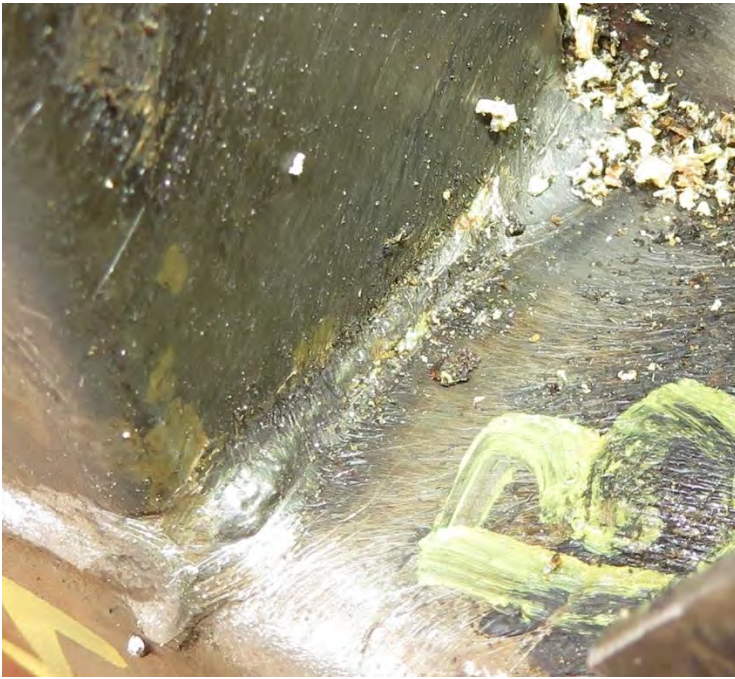
I-4B: 5.1.2 Craters₁.

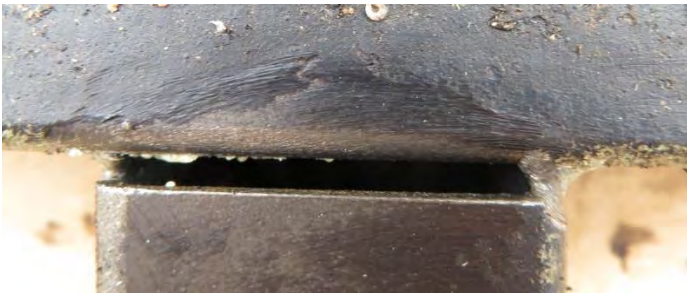
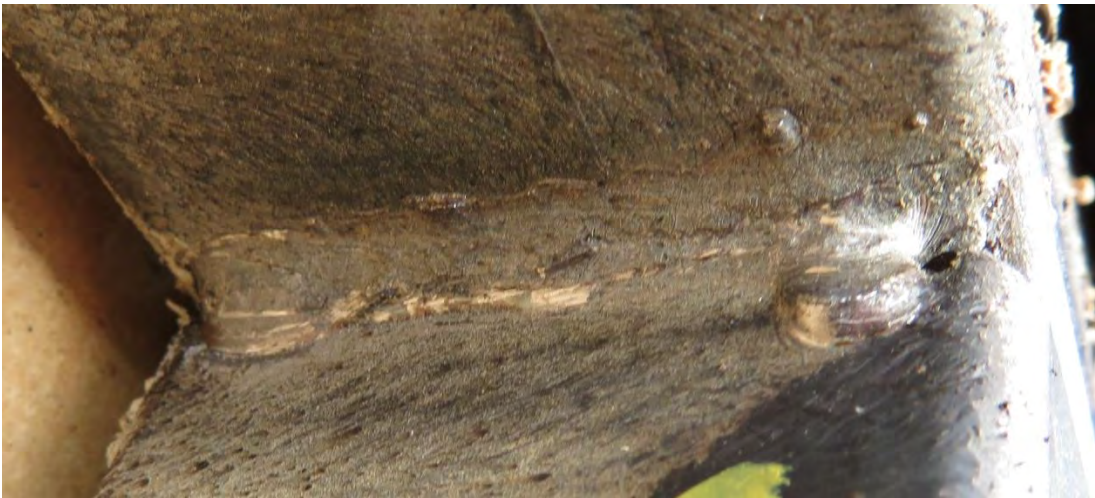
I-5A: 1/8" Incomplete Fusion - Ref Table 1: Common Types of Discontinuities₄, 5.1.10 Overlap₂.

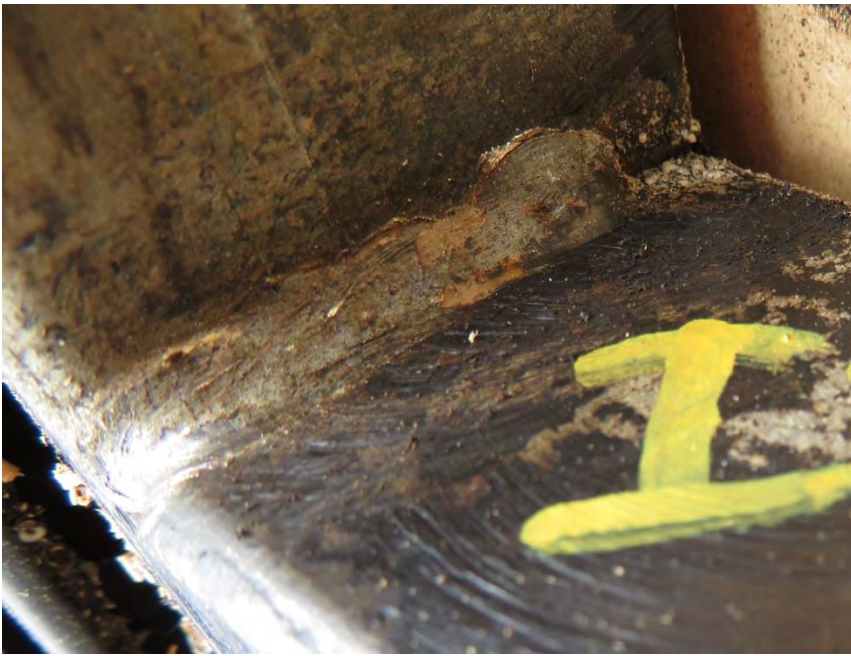
I-5B: ¼" Incomplete Fusion - Ref Table 1: Common Types of Discontinuities₄, 5.1.2 Craters₁.

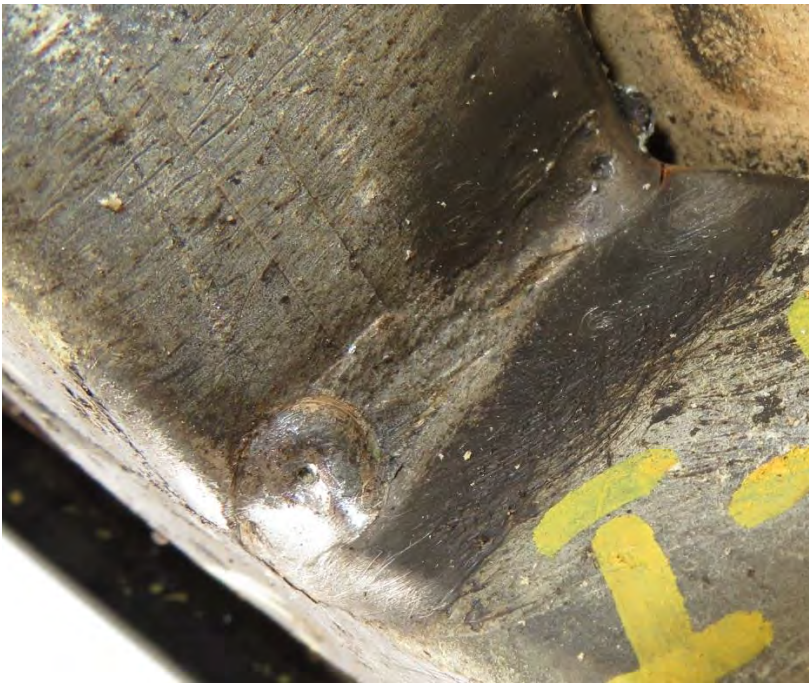
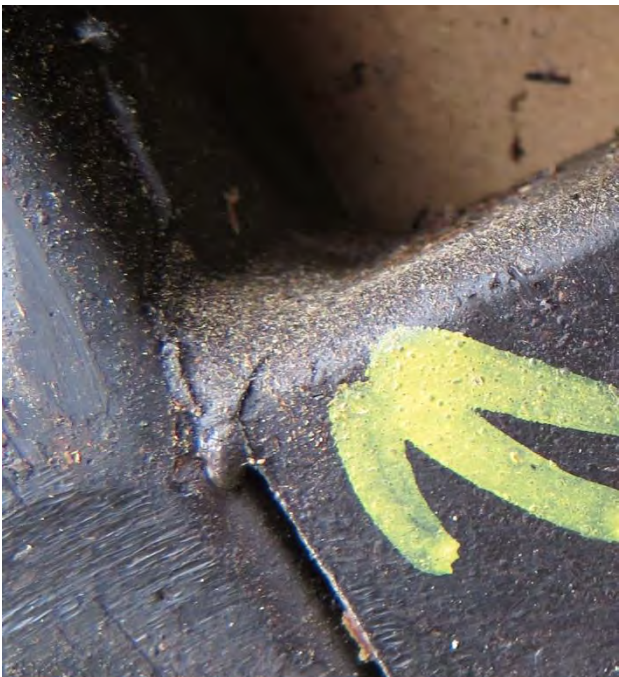
I-6A : 5.1.2 Craters₁. I-6B: Inaccessible for cleaning & visual inspection

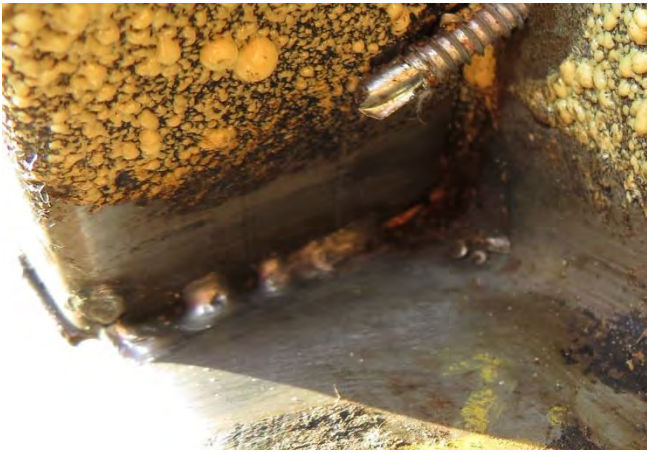
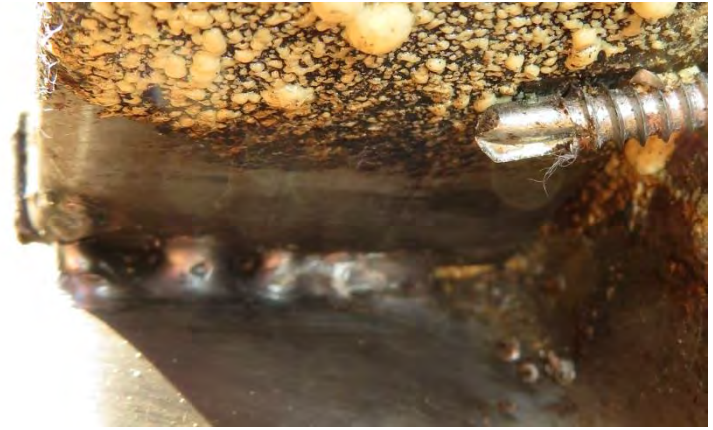
I-7: ½" Incomplete Fusion - Ref Table 1: Common Types of Discontinuities₄,

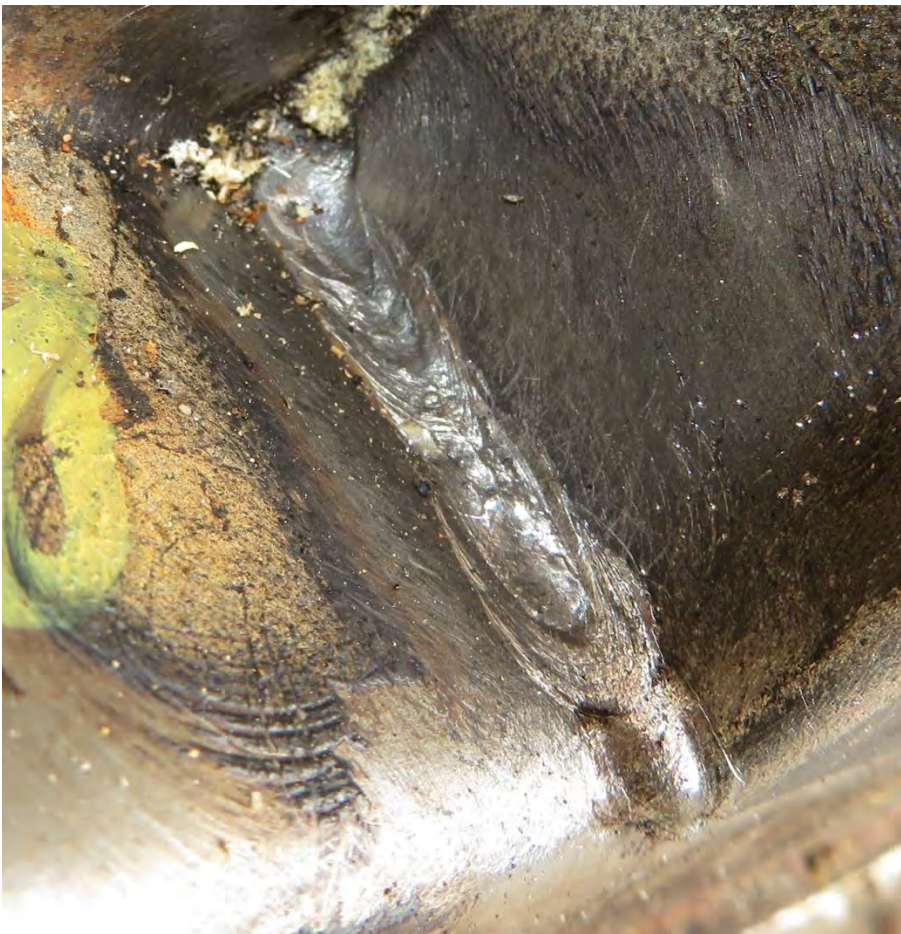
I-8: 5.1.2 Craters₁.

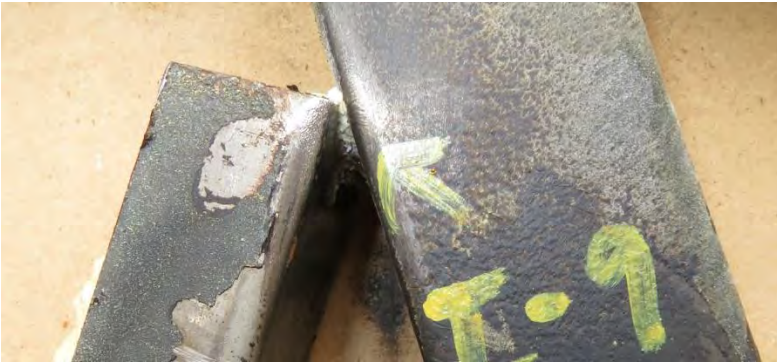
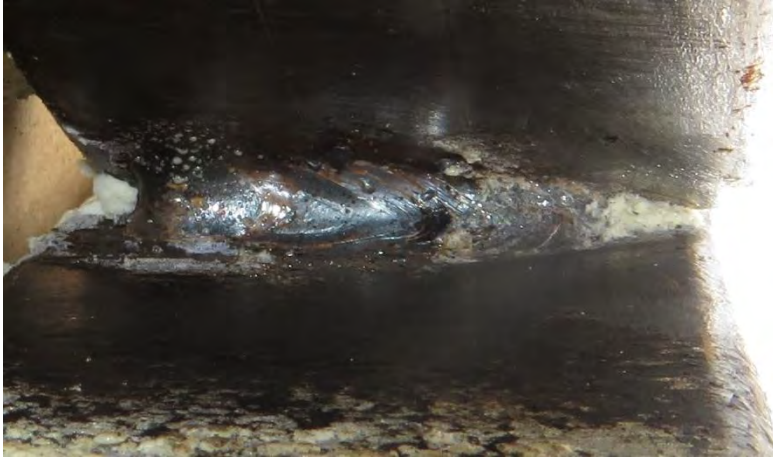
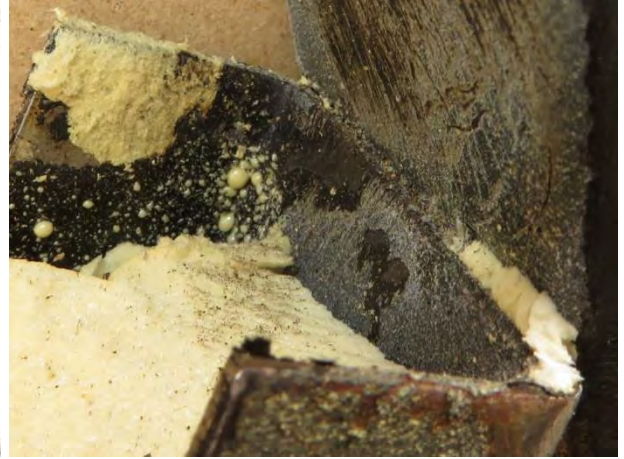
I-9: 1/4" Incomplete Fusion - Ref Table 1: Common Types of Discontinuities₄, 5.1.2 Craters₁.

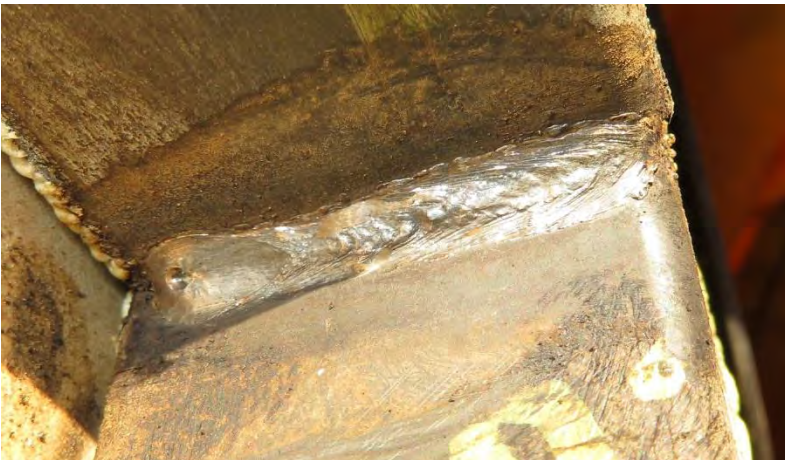
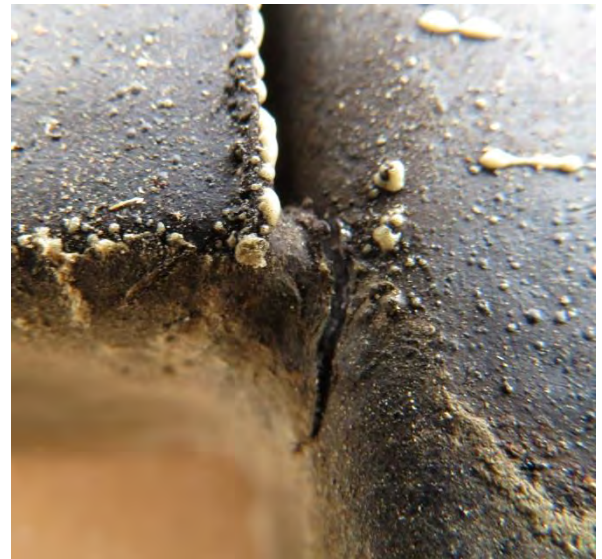
I-10A: 5.1.2 Craters₁, 5.1.10 Overlap₂.

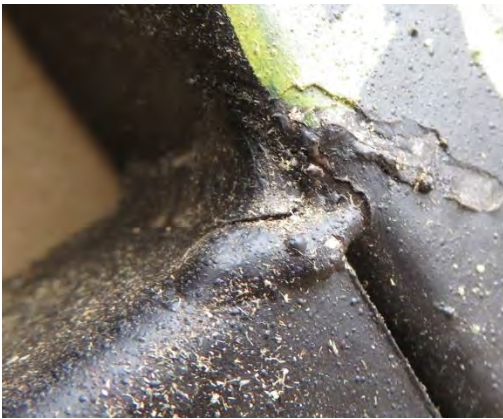
I-10B: Inaccessible for full inspection due to cleaning, 5.1.10 Overlap₂.

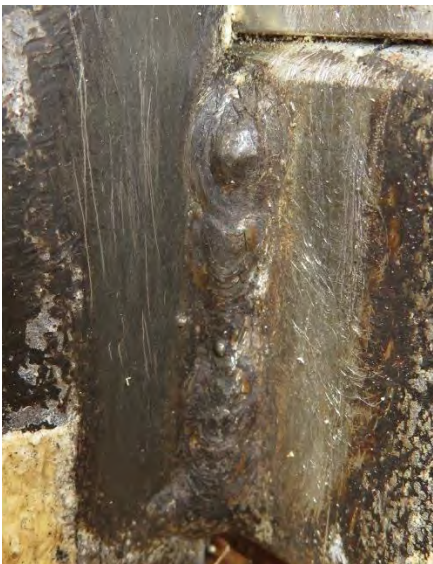
I-11: 1/8" Incomplete Fusion - Ref Table 1: Common Types of Discontinuities₄,

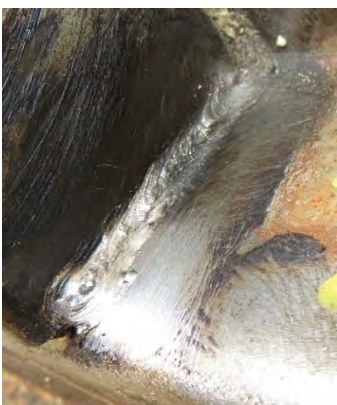
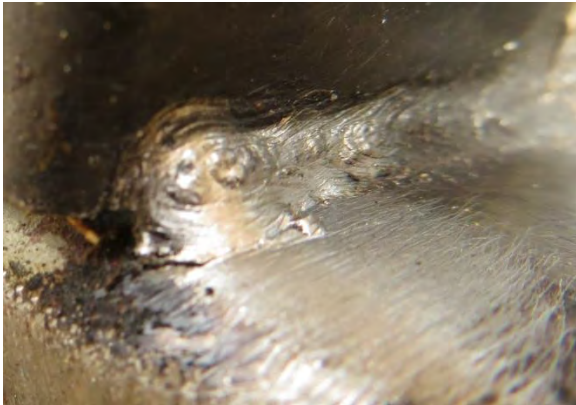
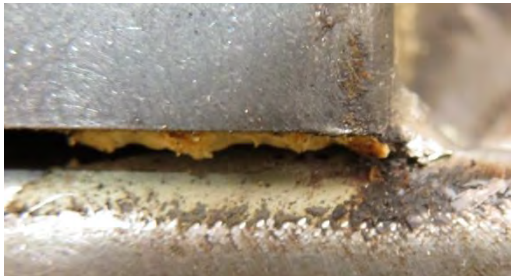
J-1: 5.1.10 Overlap₂, 5.1.2 Craters₁.

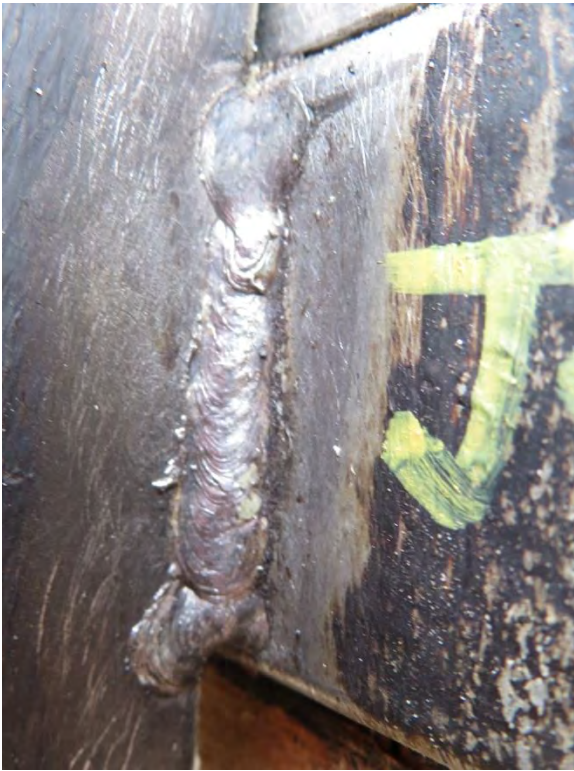
J-2: 5.1.10 Overlap₂, 5.1.2 Craters₁.

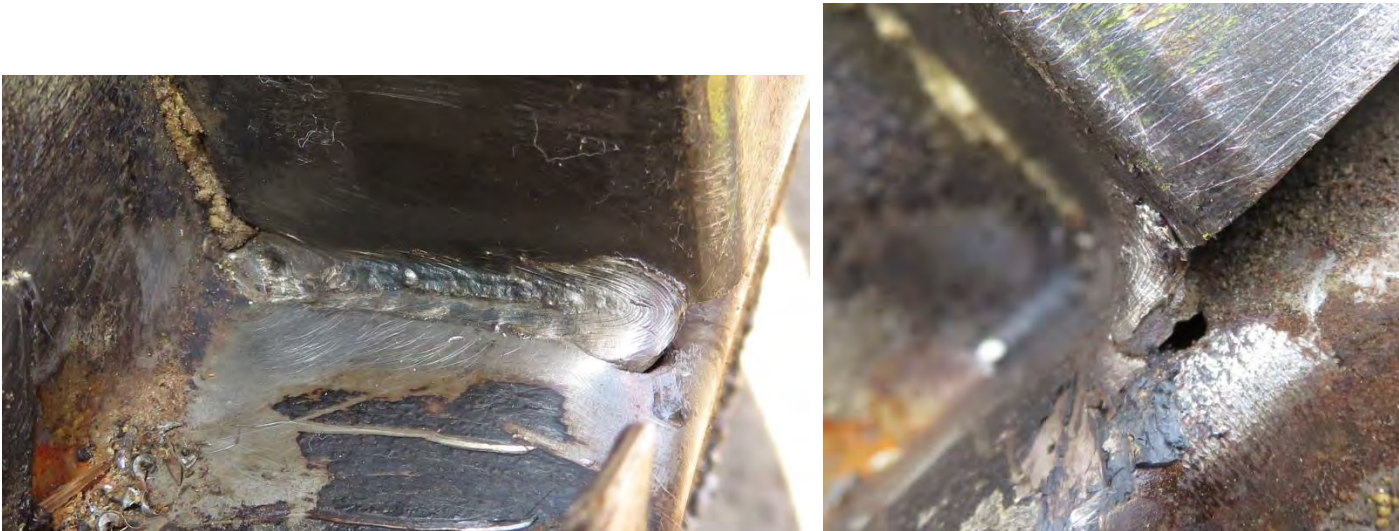
J-5: 5.1.2 Craters₁, HAZ (Heat Affected Zone) / toe of weld tearing 1/16"

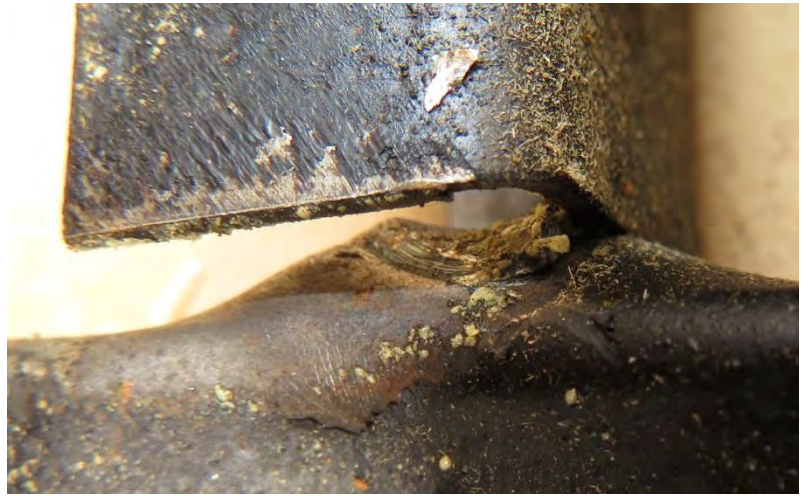
J-6: 5/32" Incomplete Fusion - Ref Table 1: Common Types of Discontinuities₄, 5.1.2 Craters₁.

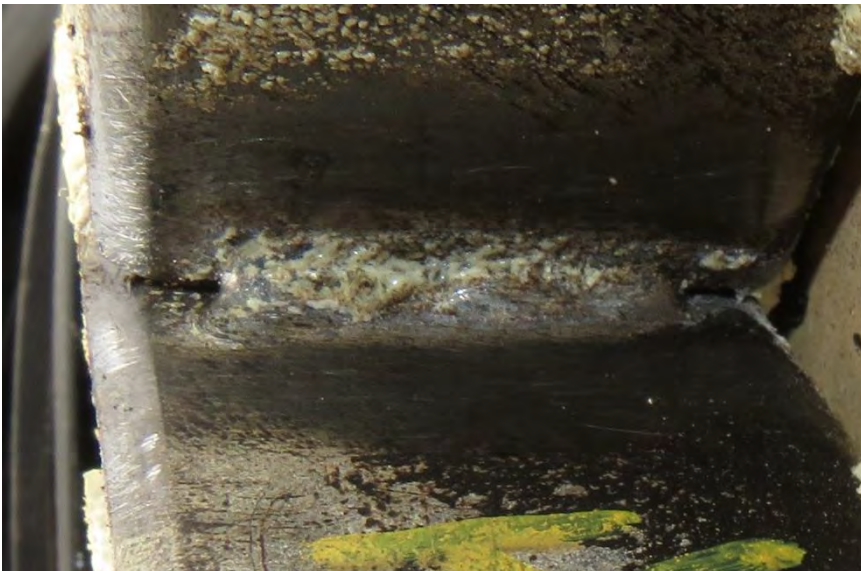
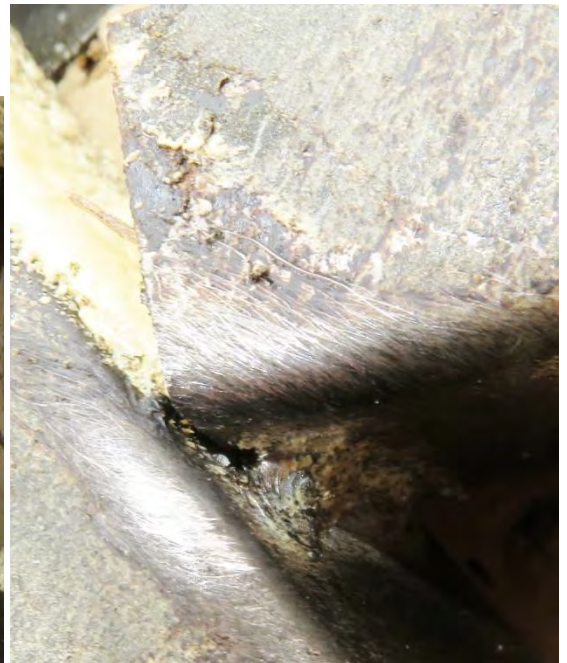
J-7: 3/8" Incomplete Fusion - Ref Table 1: Common Types of Discontinuities₄, (cumulative for both sides).

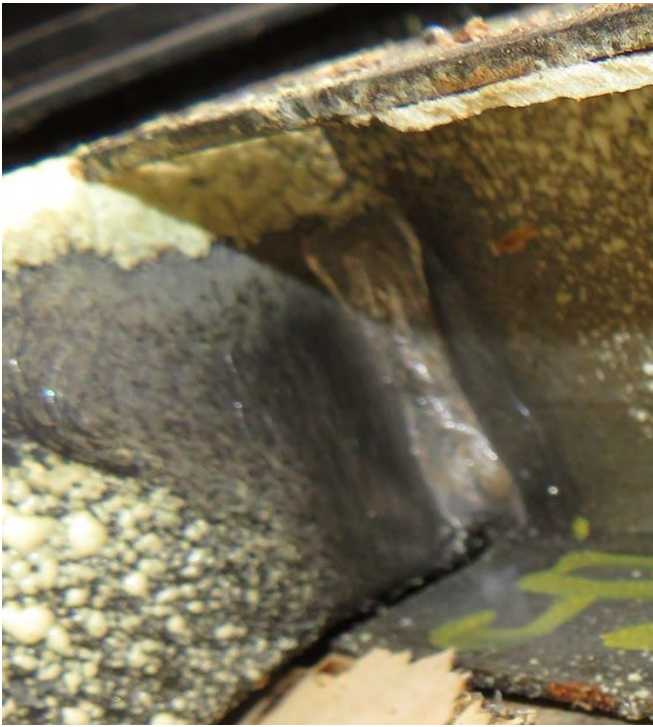
J-8: 1/4" Incomplete Fusion - Ref Table 1: Common Types of Discontinuities₄, 5.1.2 Craters₁.

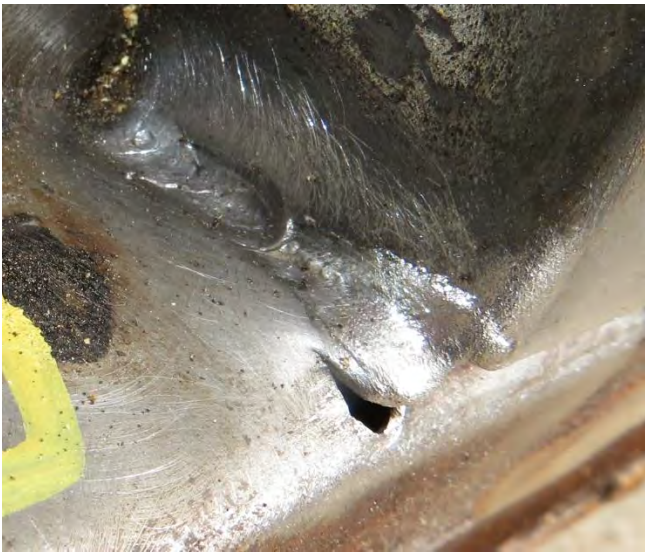
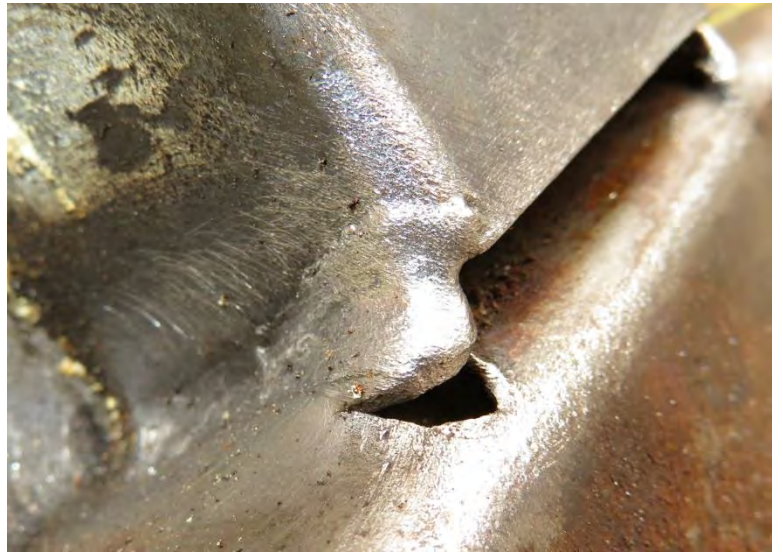
K-3: HAZ (Heat Affected Zone) / toe of weld tearing 1/4", 5.1.2 Craters₁.

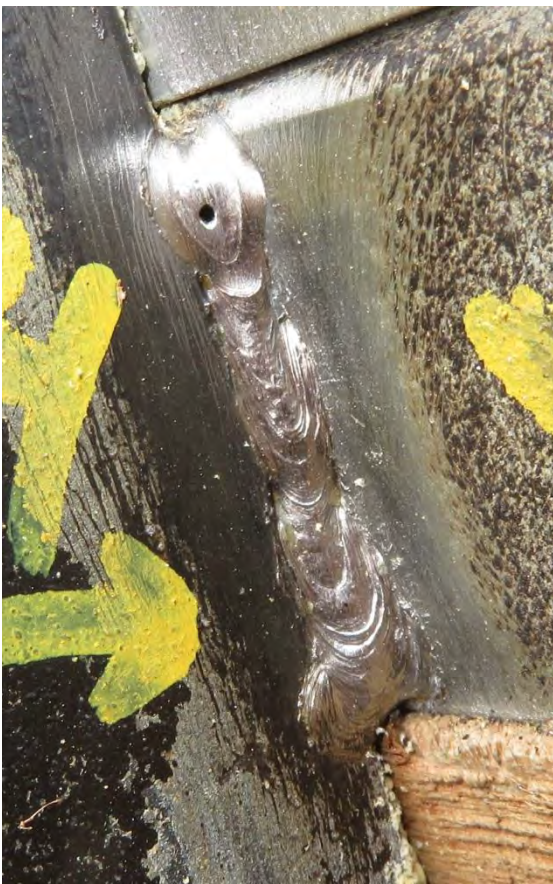
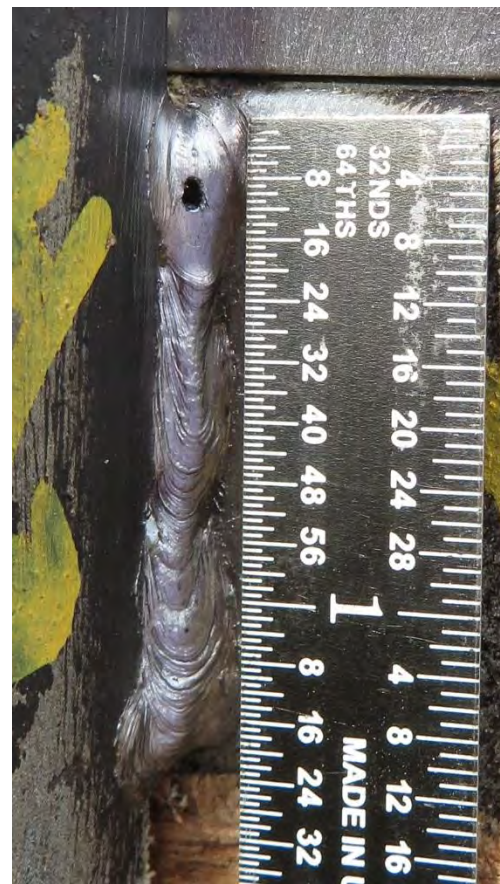
K-4: 5.1.2 Craters₁, 5.1.10 Overlap₂.

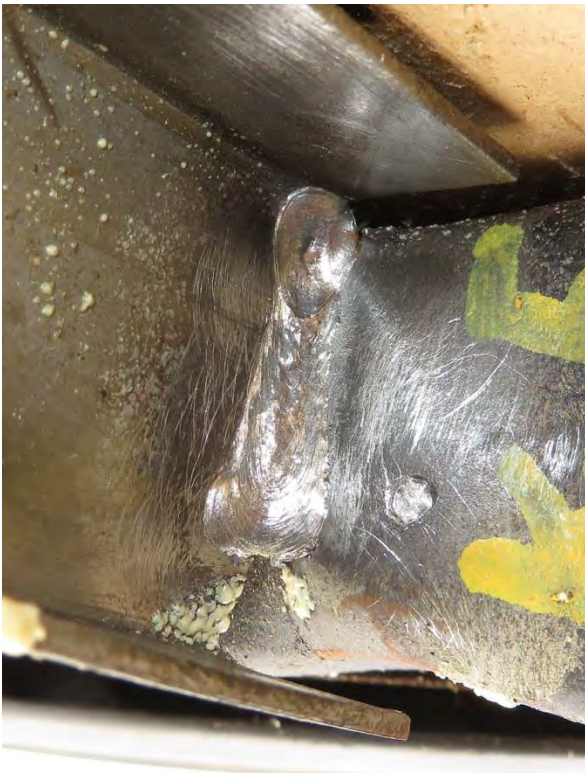
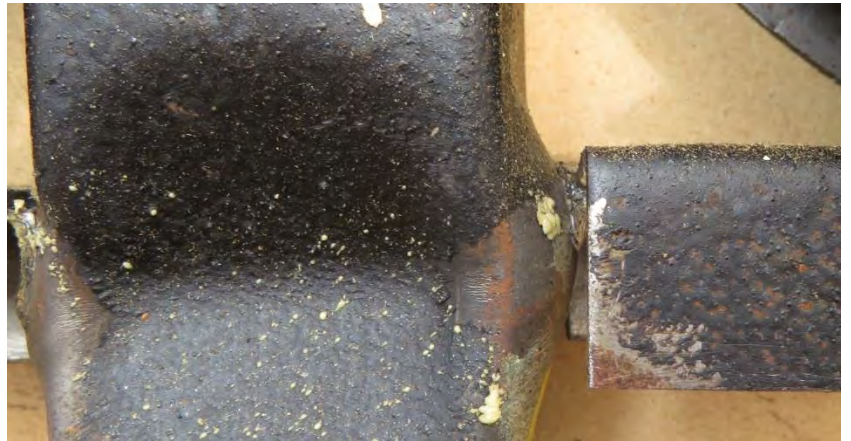
K-5: 3/8" Incomplete Fusion - Ref Table 1: Common Types of Discontinuities₄, 5.1.2 Craters₁.

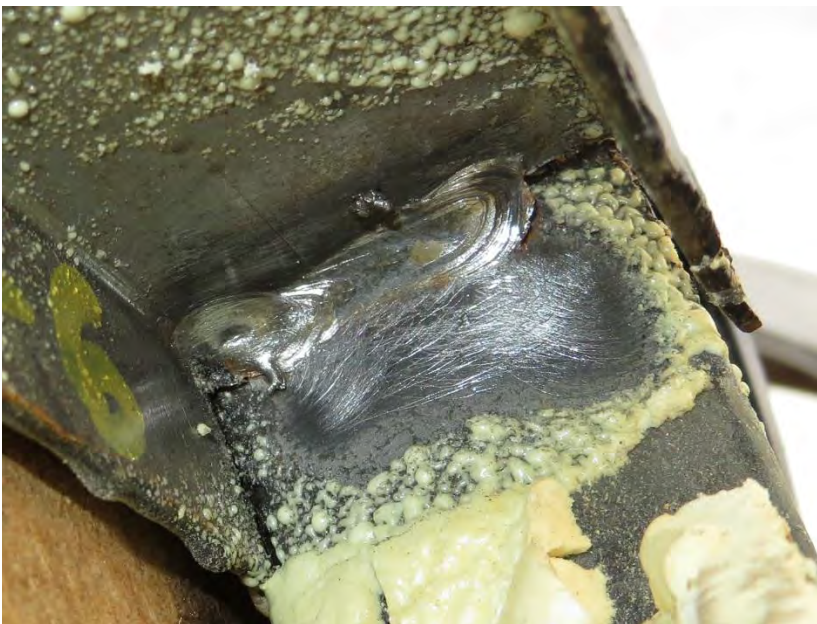
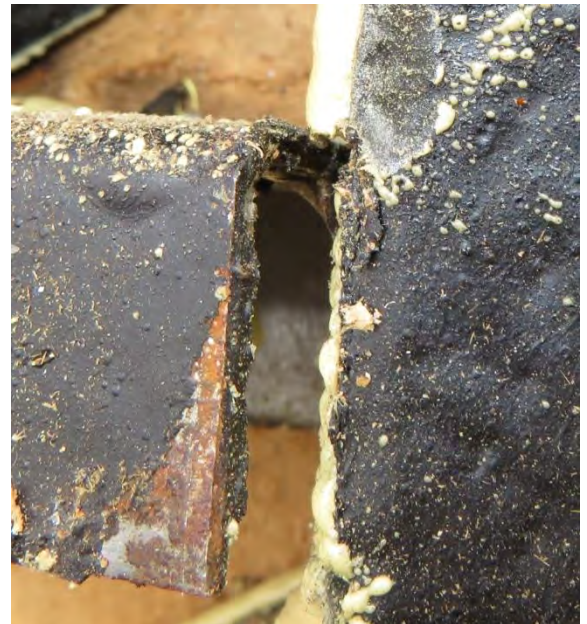
K-6: 3/8" Incomplete Fusion - Ref Table 1: Common Types of Discontinuities₄, 5.1.2 Craters₁.

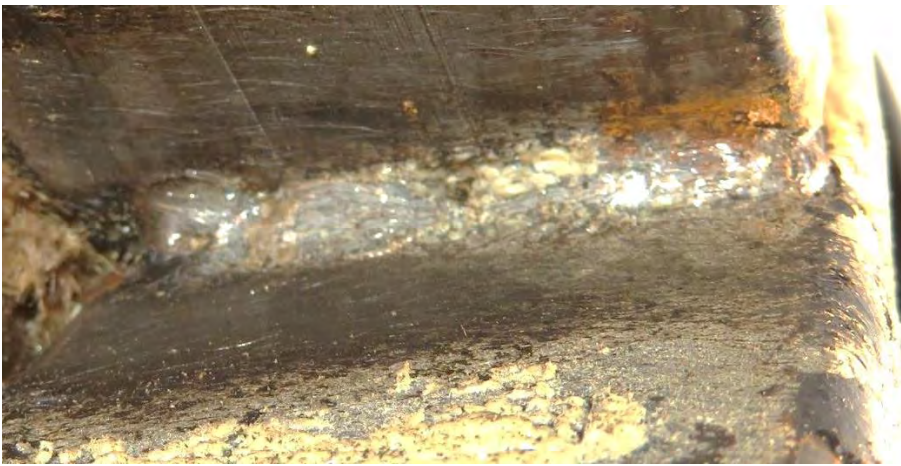
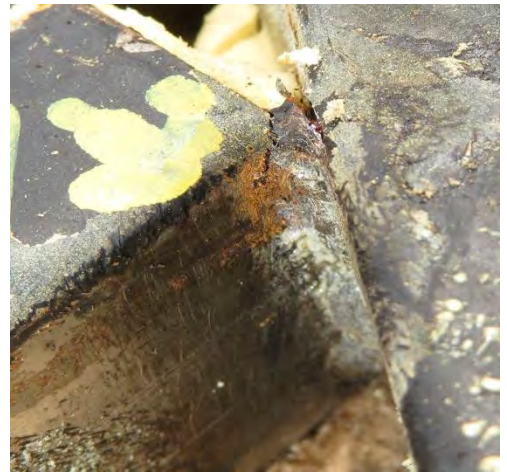
K-7: 5.1.2 Craters₁.

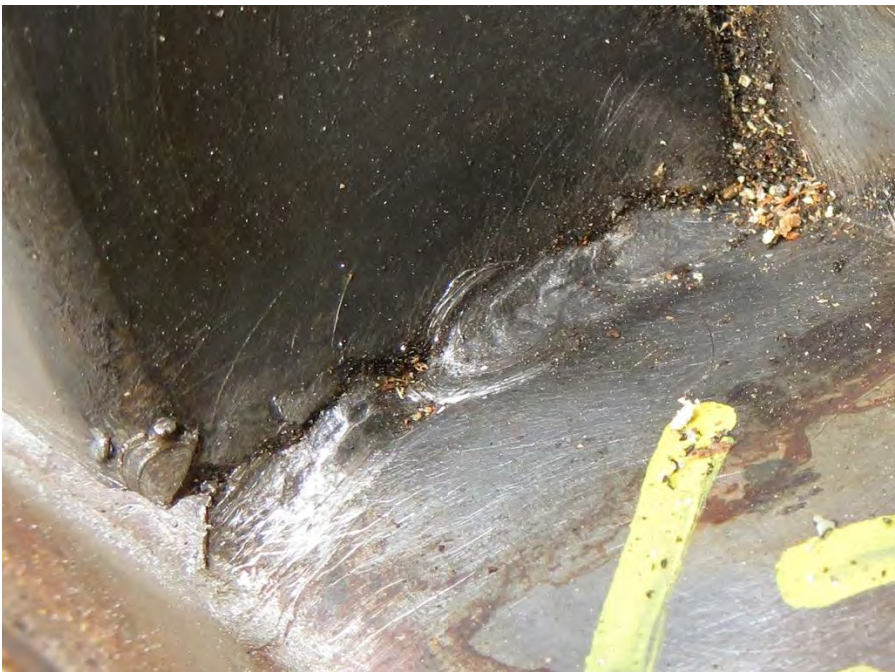
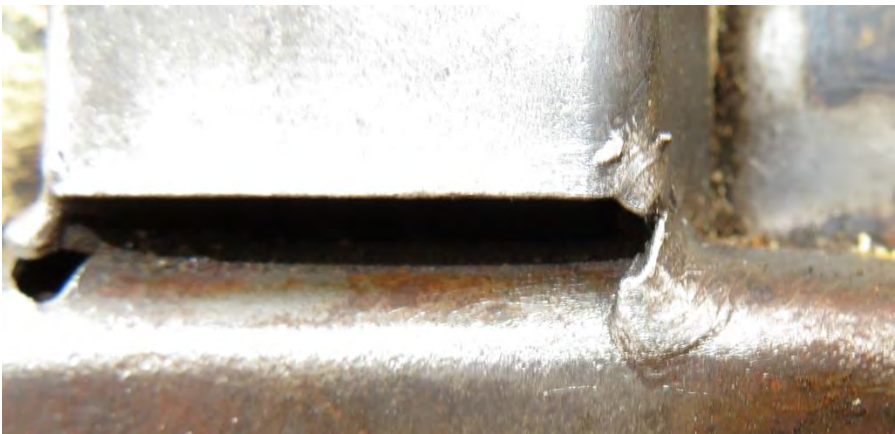
L-1: 1/2" Incomplete Fusion - Ref Table 1: Common Types of Discontinuities₄.

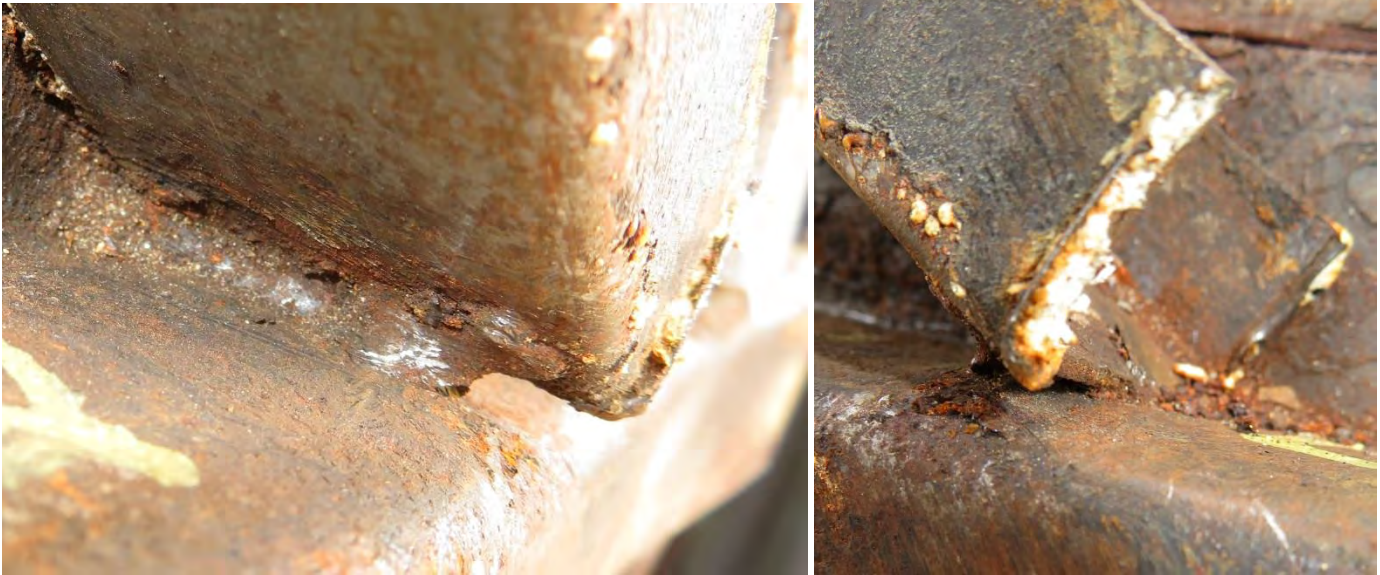
L-2: 1/4" Incomplete Fusion - Ref Table 1: Common Types of Discontinuities₄.

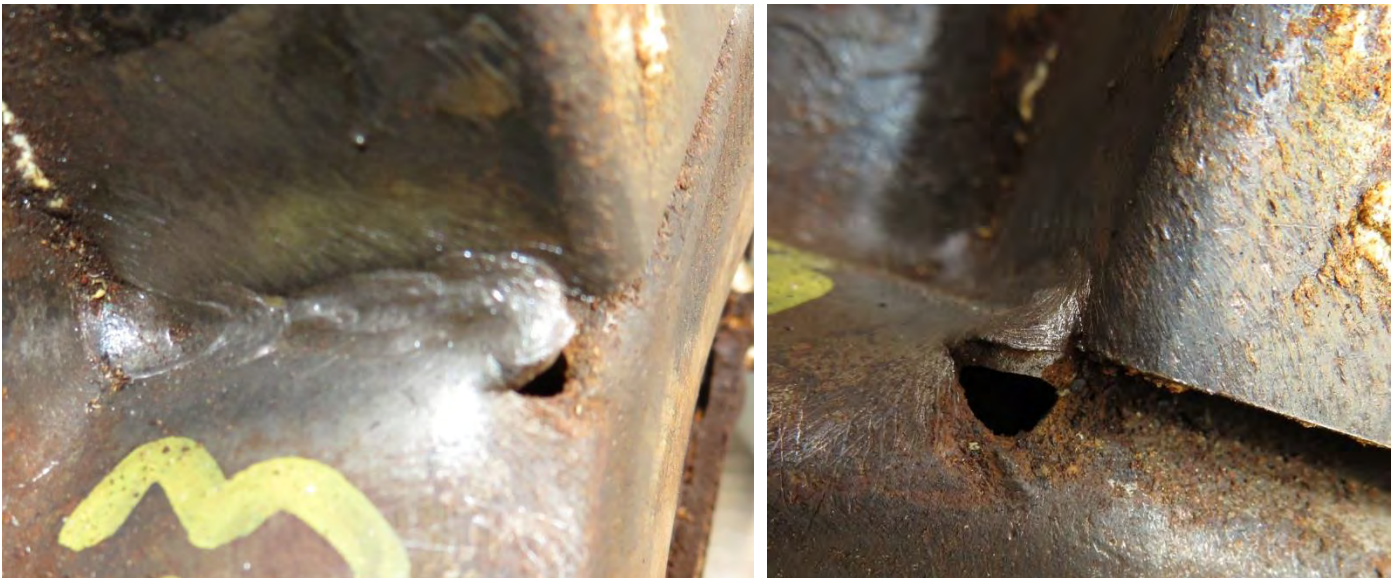
L-3: HAZ (Heat Affected Zone) / toe of weld tearing 1/4", 5.1.2 Craters₁.

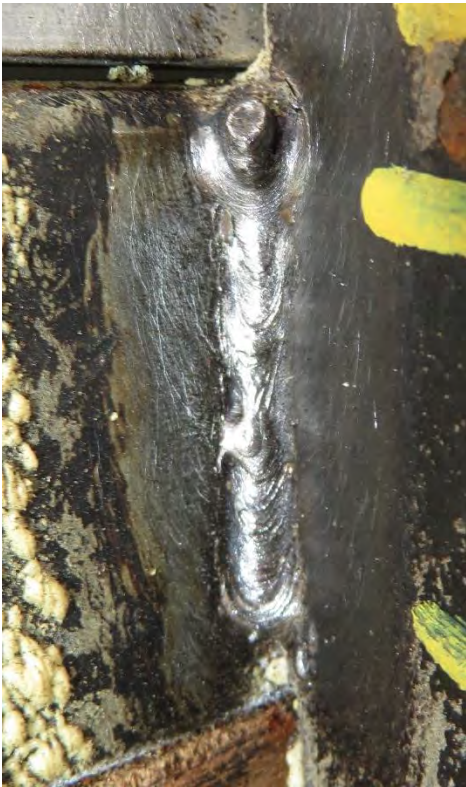
L-4: 3/16" Incomplete Fusion - Ref Table 1: Common Types of Discontinuities₄, 5.1.2 Craters₁.

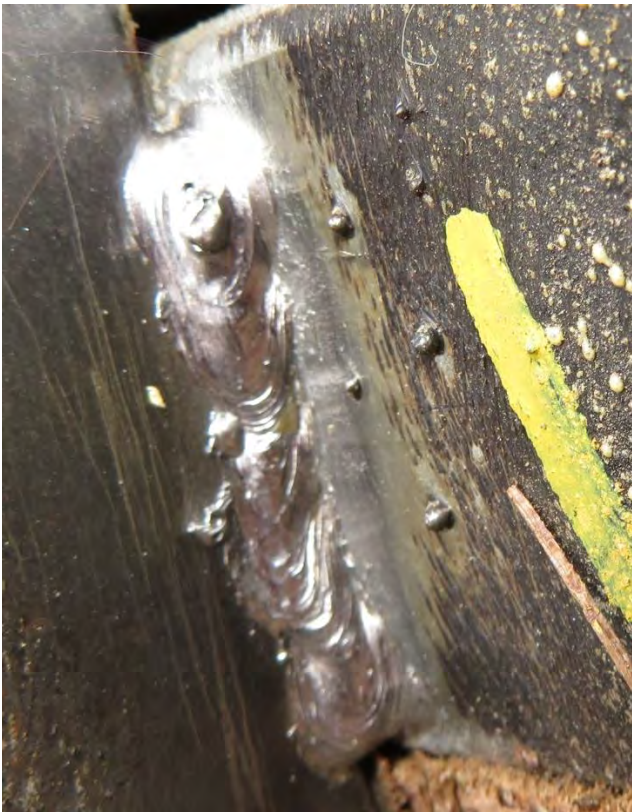
L-5: 1/8" Incomplete Fusion - Ref Table 1: Common Types of Discontinuities₄, 5.1.2 Craters₁.
