INSPECTION OF CHAMPION DEFENDER BUS :

DRIVER SIDEWALL, FRAME (PART # 0414250)

PASSENGER SIDEWALL, FRAME (PART #0414249)

Re: Champion Defender bus accident, Davis, Oklahoma

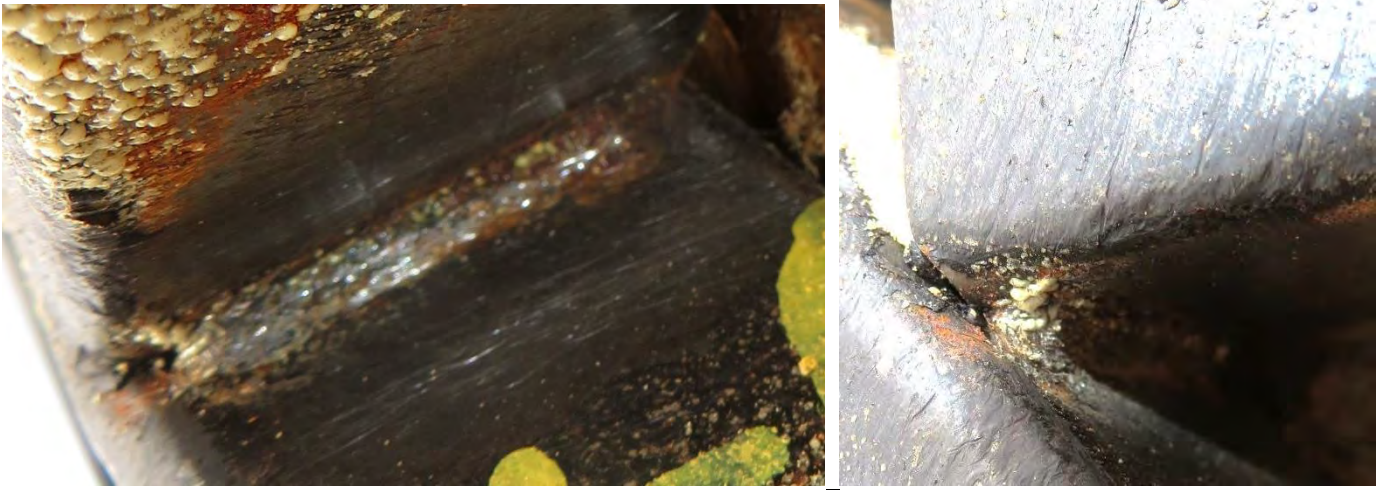
L-6: 5/32" Incomplete Fusion - Ref Table 1: Common Types of Discontinuities₄,

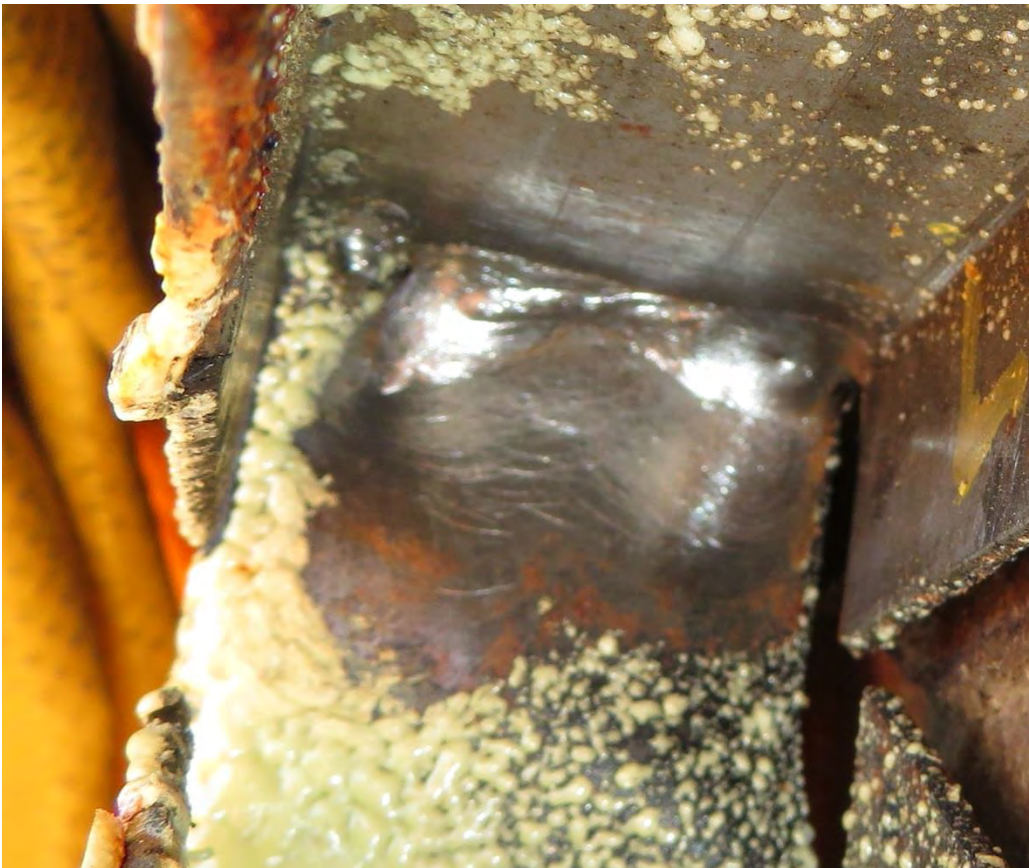
L-7: 3/8" Incomplete Fusion - Ref Table 1: Common Types of Discontinuities₄, 5.1.2 Craters₁, 5.1.10 Overlap₂.

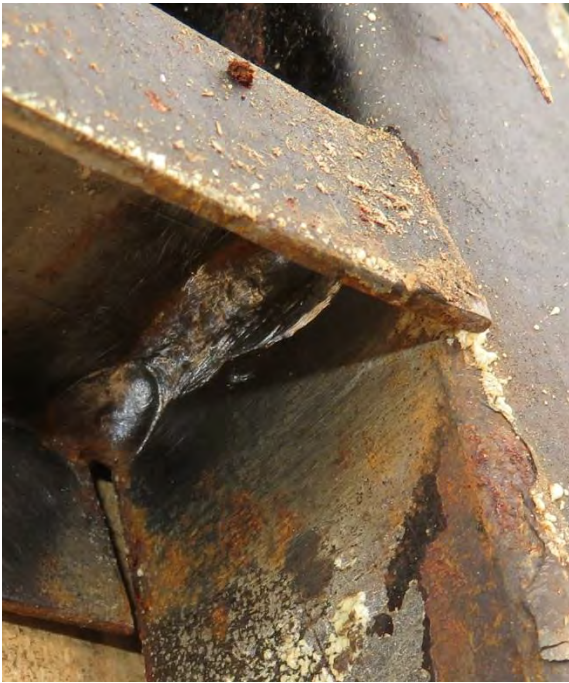
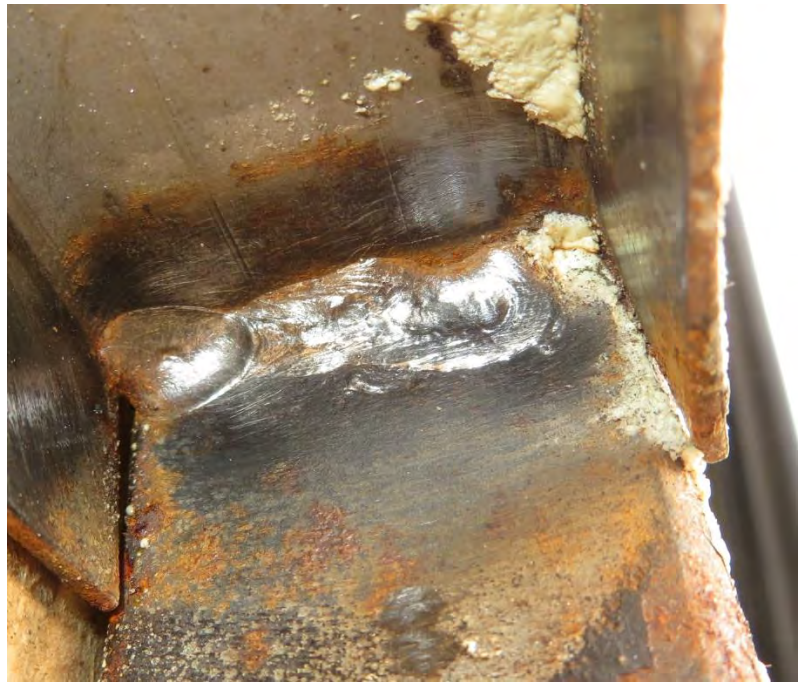
L-8: 1/8" Incomplete Fusion - Ref Table 1: Common Types of Discontinuities₄, 5.1.2 Craters₁, 5.1.10 Overlap₂.

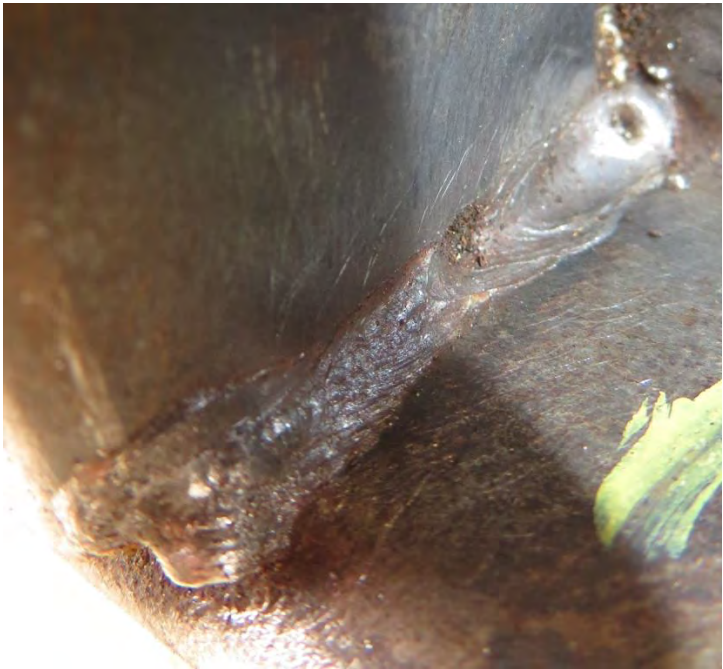
M-1: 5/64" Incomplete Fusion - Ref Table 1: Common Types of Discontinuities₄, 5.1.2 Craters₁, 5.1.10 Overlap₂.

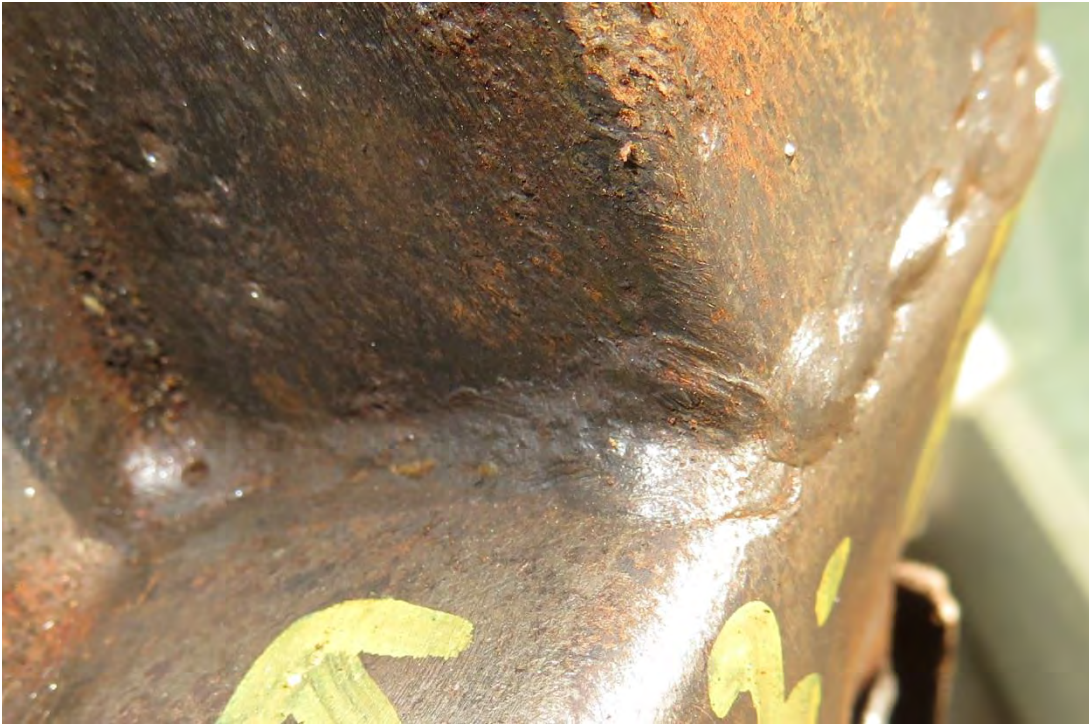
M-2A: 5.1.2 Craters₁, 5.1.10 Overlap₂.

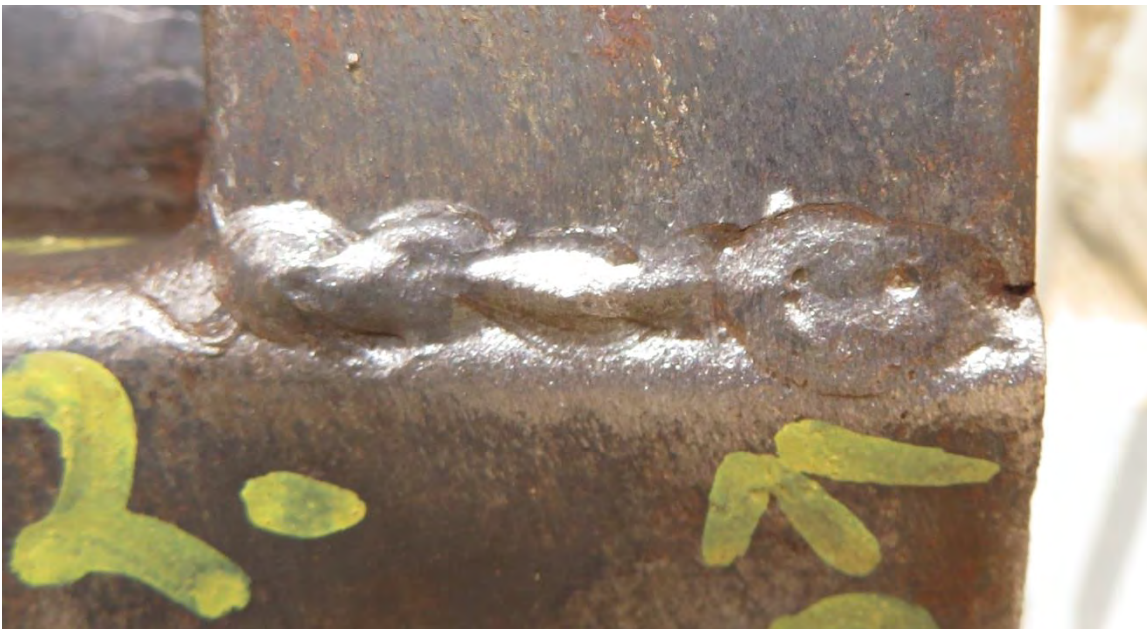
M-2B: 1/16" Incomplete Fusion - Ref Table 1: Common Types of Discontinuities₄, 5.1.2 Craters₁, 5.1.10 Overlap₂.

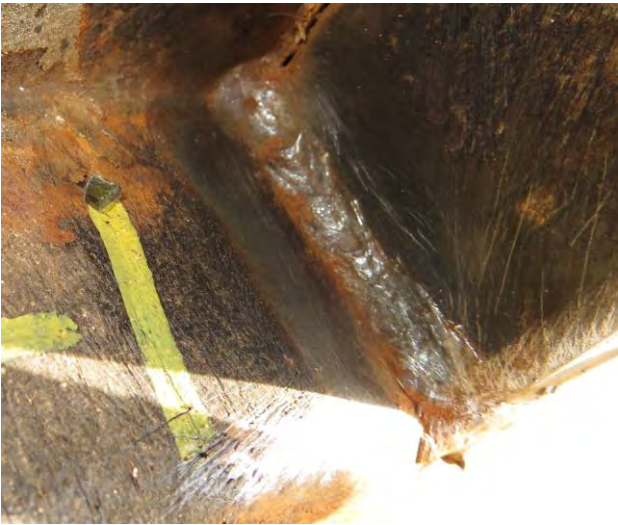
X-1: 5.1.2 Craters₁,

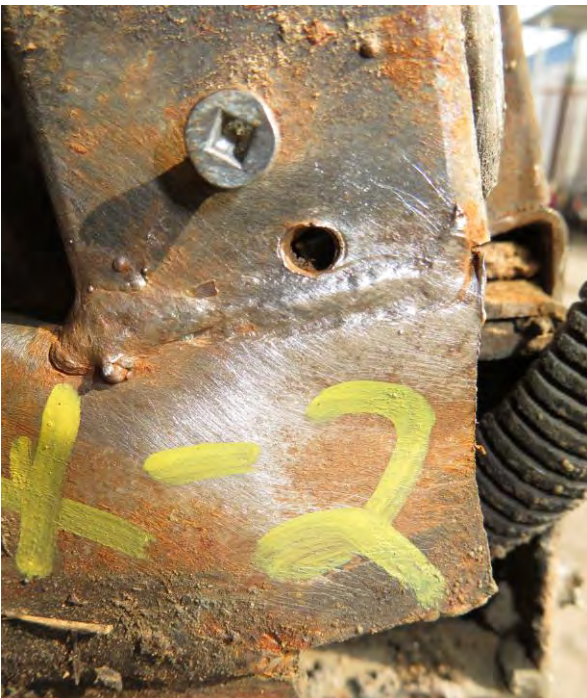
X-2: 5.1.2 Craters₁, 5.1.10 Overlap₂.

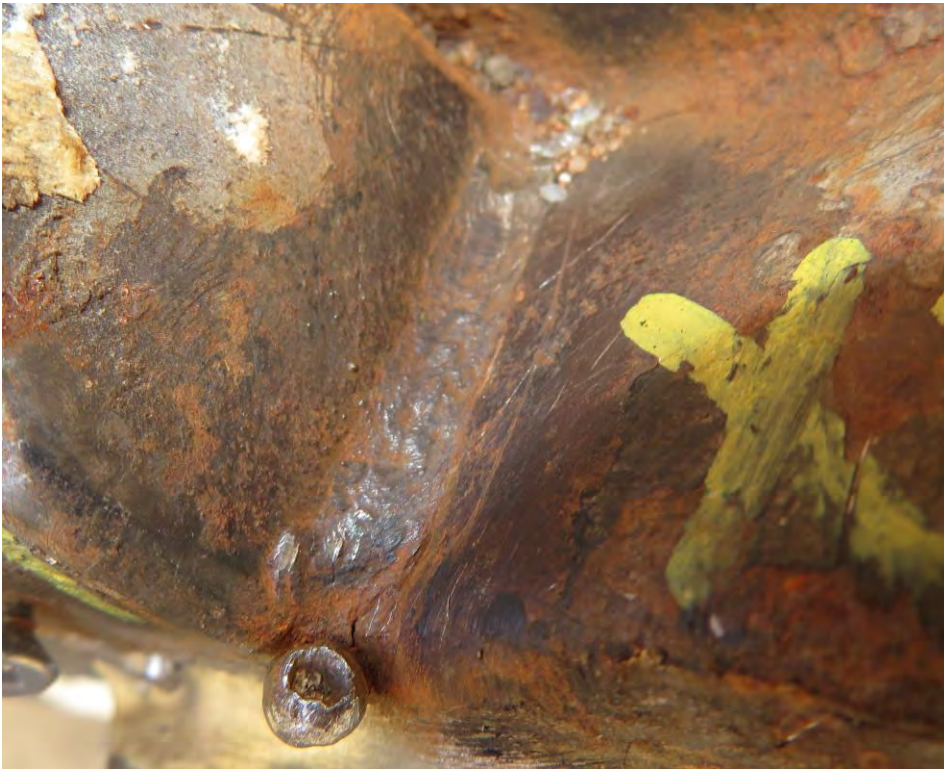
X-3: Oxidised overlay, 5.1.2 Craters₁.

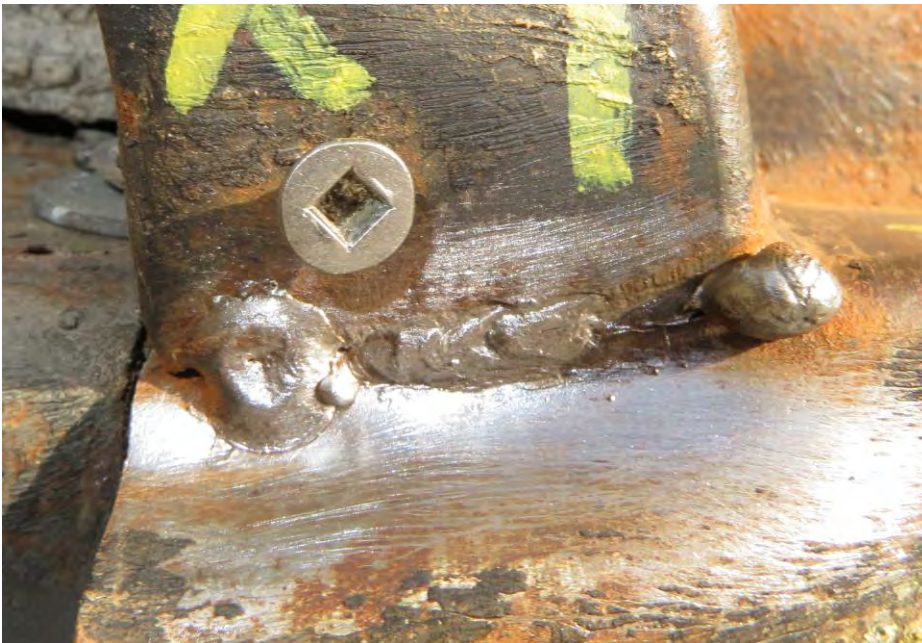
X-4: Oxidised overlay, 5.1.2 Craters₁, Underfill, 1/8" Incomplete Fusion - Ref Table 1: Common Types of Discontinuities₄.

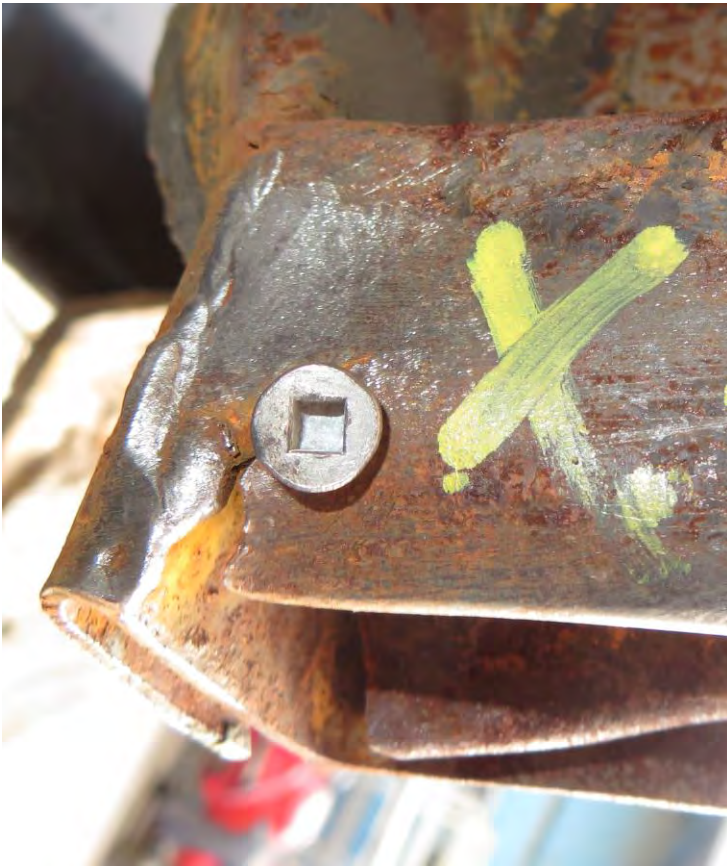
X-5: Weld became detached in 5.1.2 Craters₁ and 5.1.10 Overlap₂.

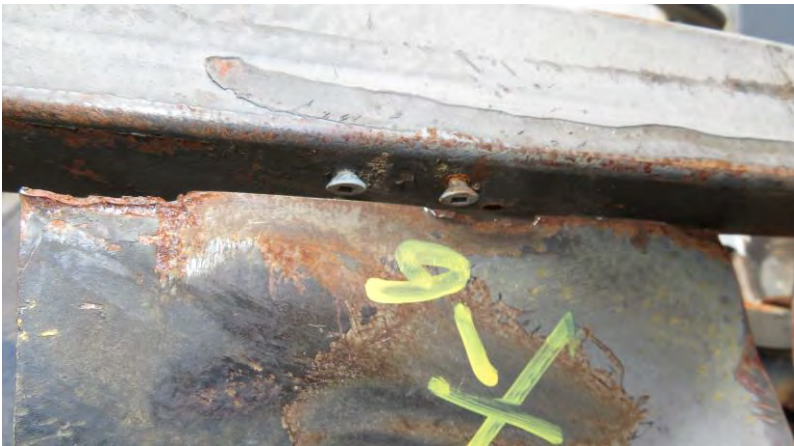
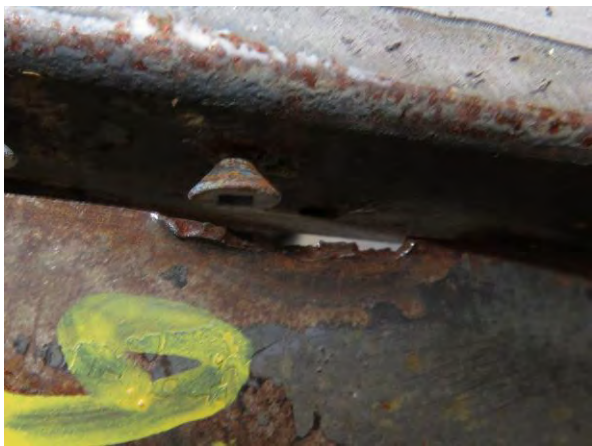
X-6: Pulled apart from weld toes

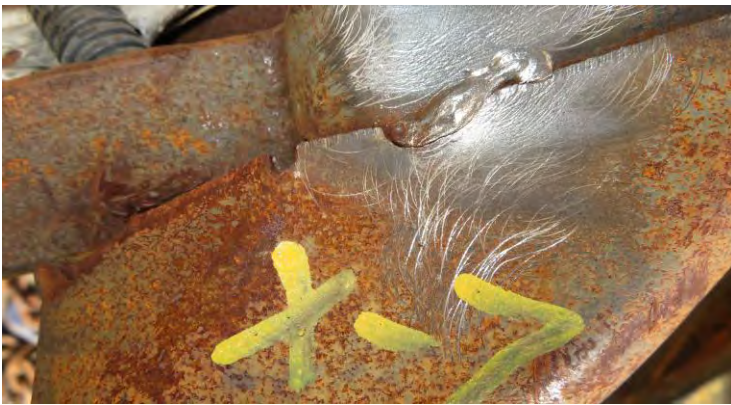
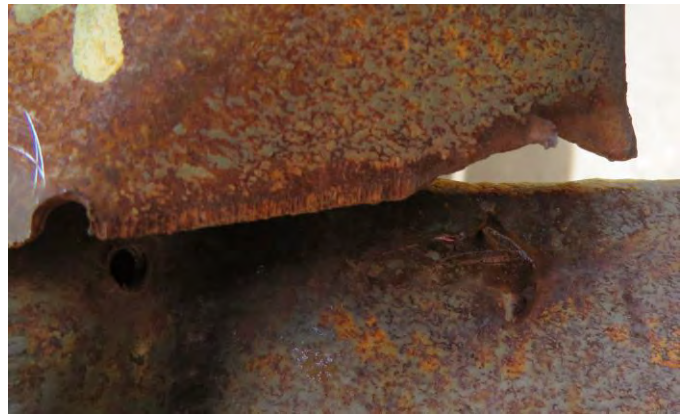
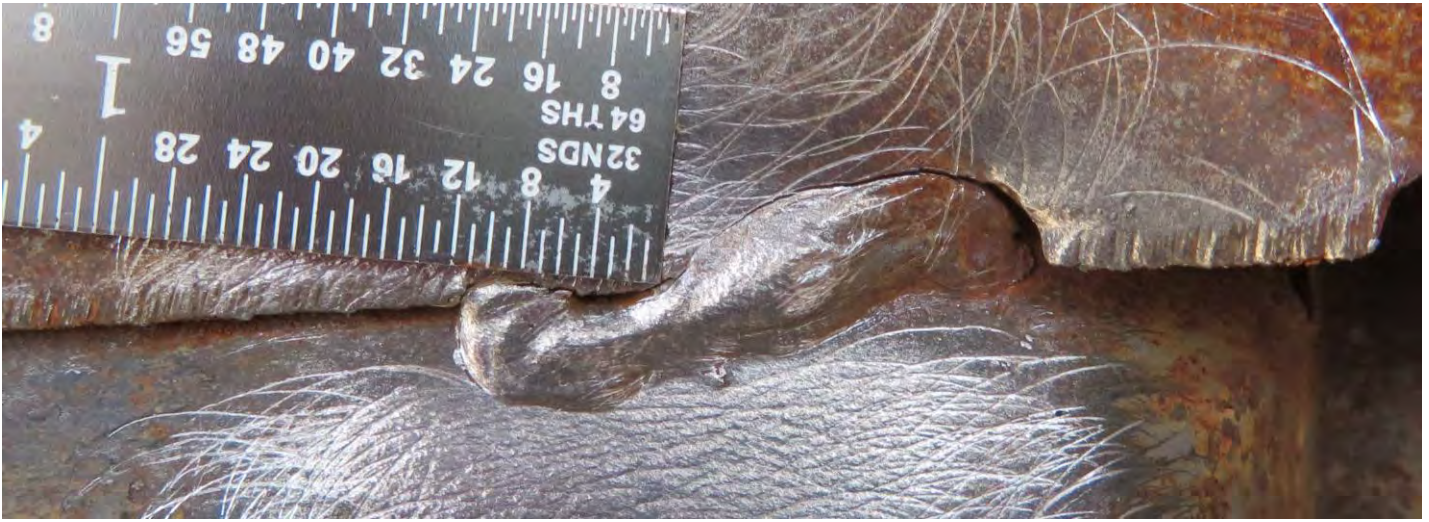
X-7: 3/16" Incomplete Fusion - Ref Table 1: Common Types of Discontinuities₄, HAZ (Heat Affected Zone) / toe of weld tearing.

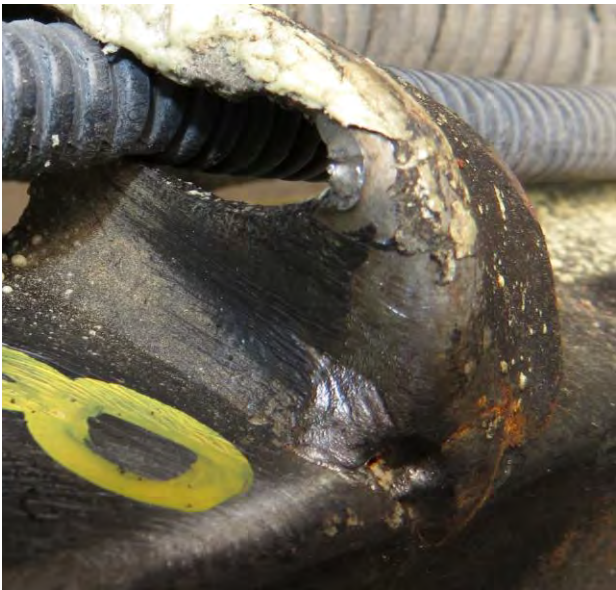
X-8: 1/8" Incomplete Fusion - Ref Table 1: Common Types of Discontinuities₄, most of weld inaccessible for cleaning & visual inspection.

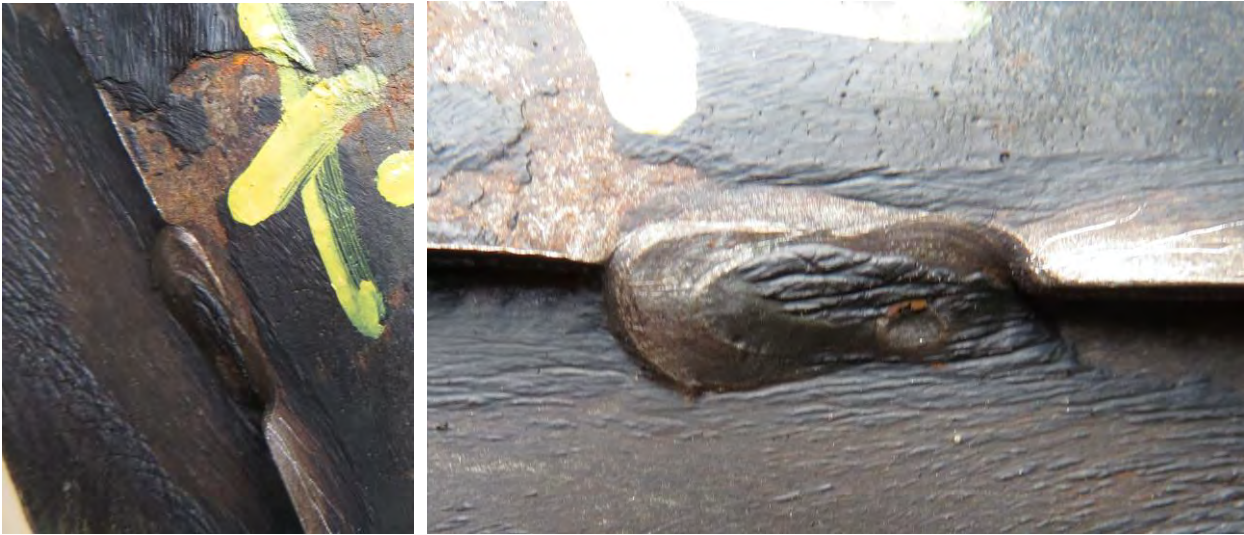
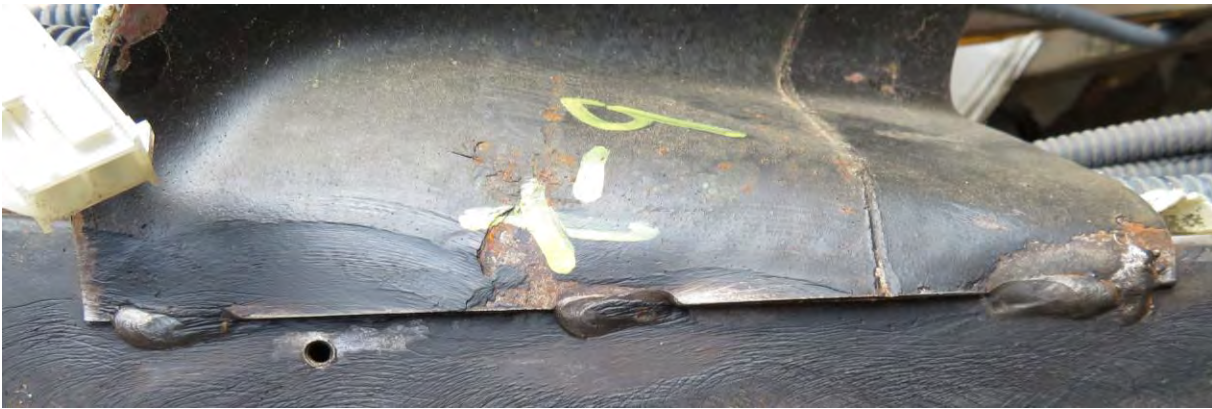
X-9: 5.1.2 Craters₁, 5.1.10 Overlap₂.

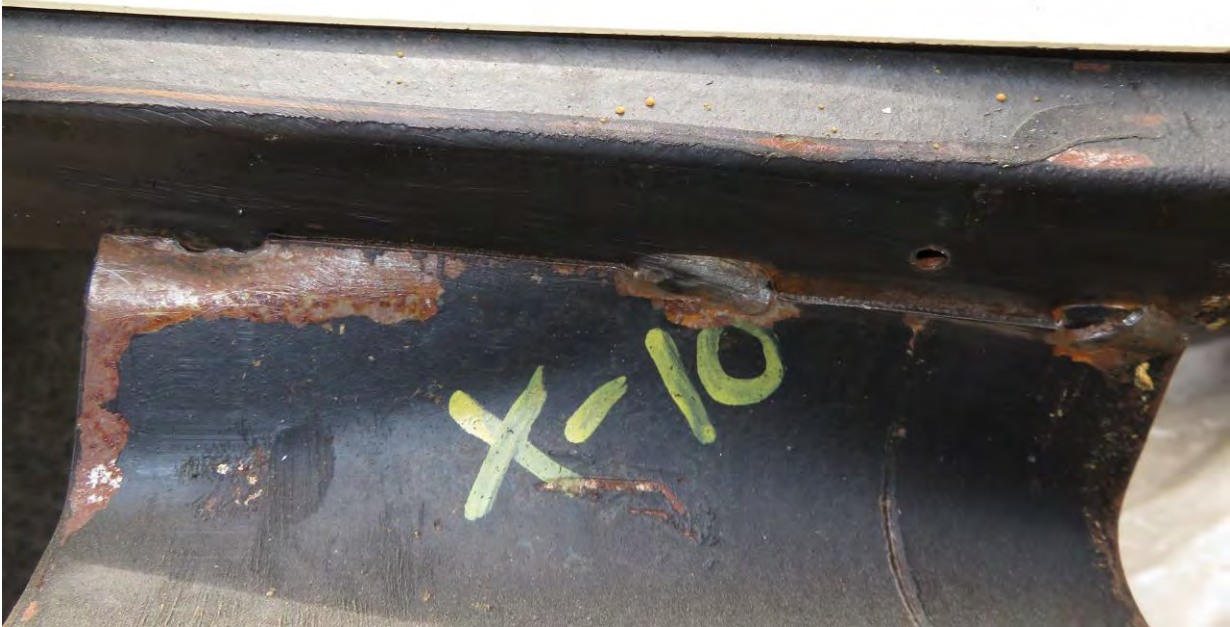
X-10: 5.1.2 Craters₁,

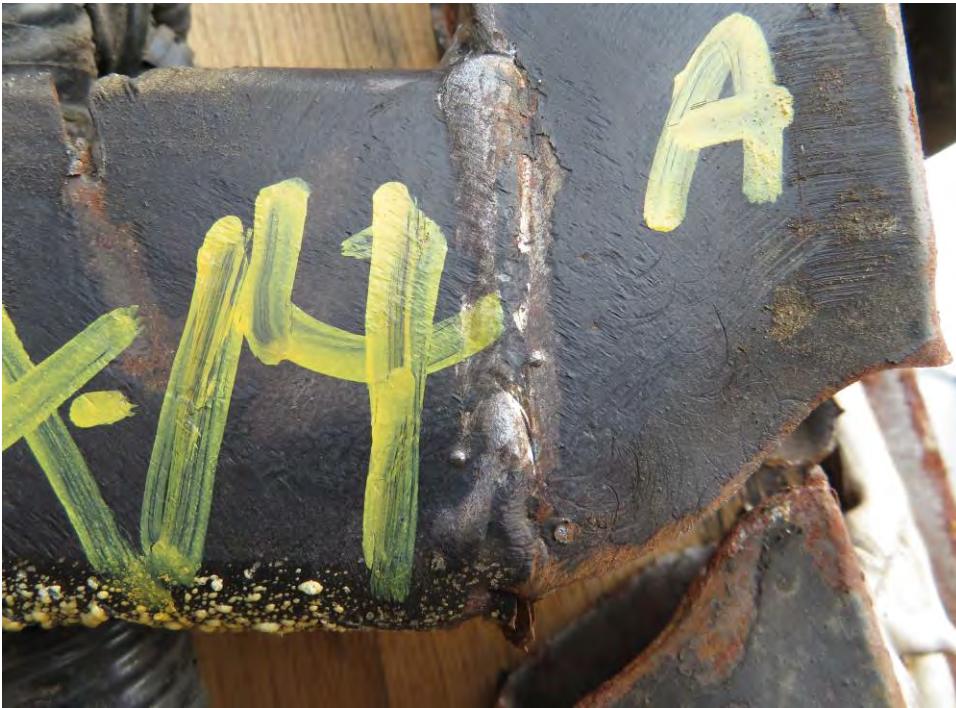
X-14A: 5.1.2 Craters₁ 5.1.10 Overlap₂.

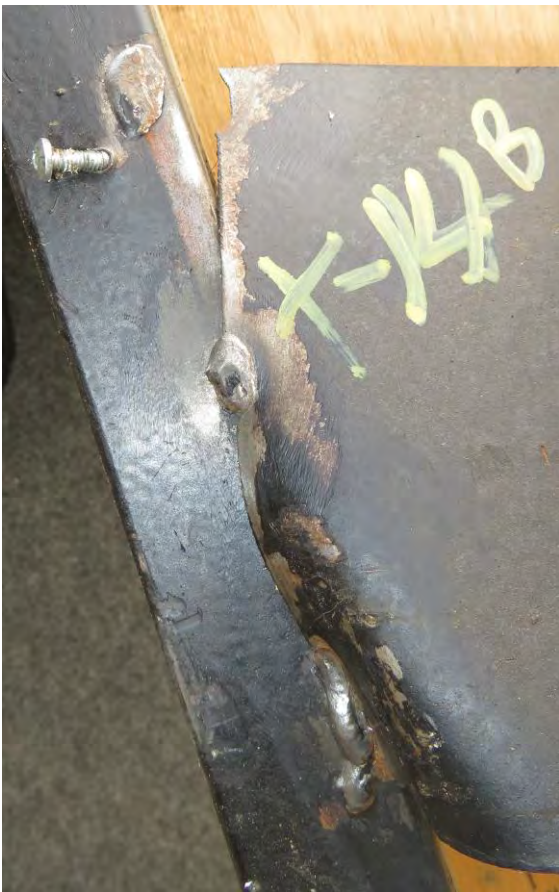
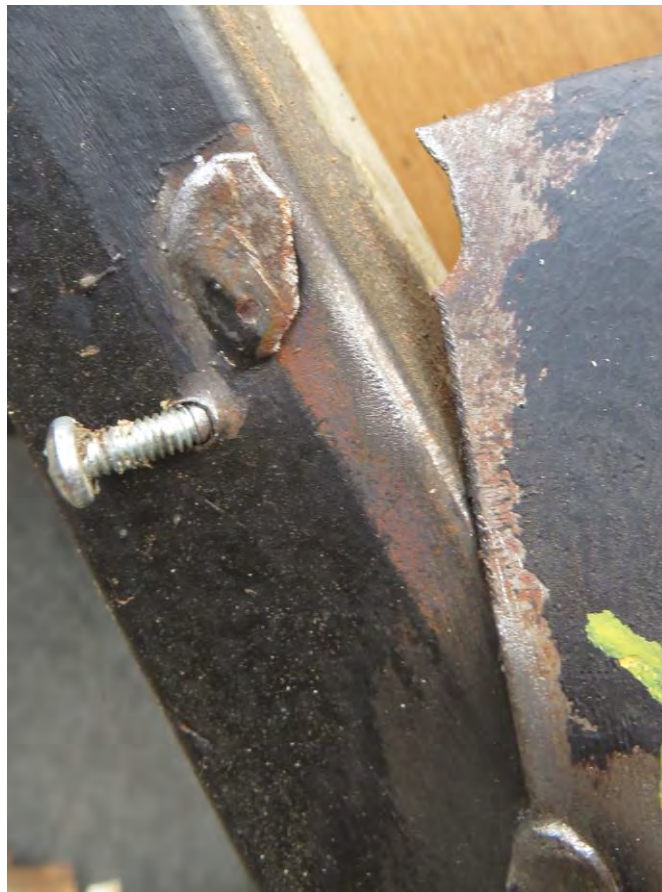
X-14B: 5.1.2 Craters₁ 5.1.10 Overlap₂, Pull away in toes and HAZ (Heat Affected Zone).

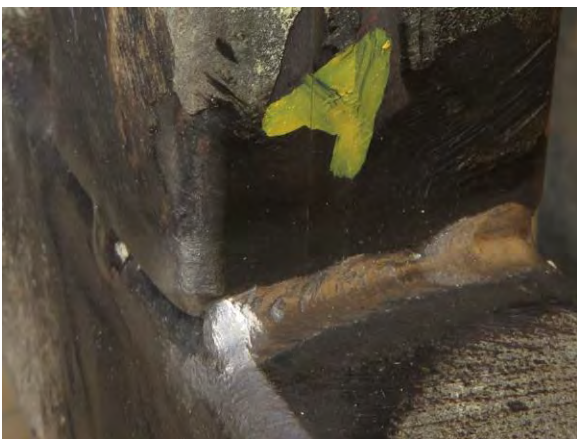
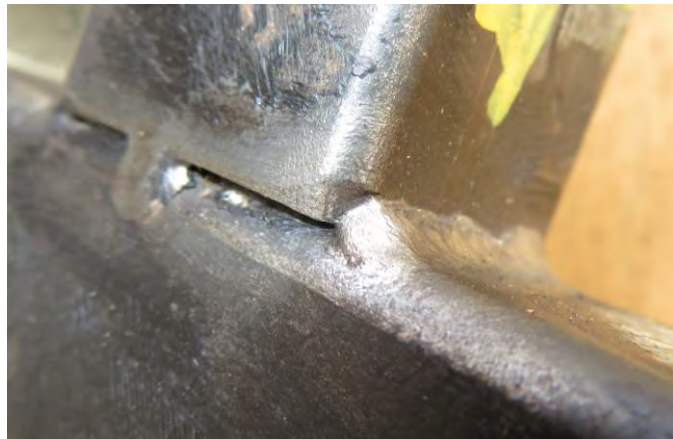
X-15A: 5.1.2 Craters₁, Incomplete Fusion - Ref Table 1: Common Types of Discontinuities₄, shear in HAZ & B: 5.1.2 Craters₁, 5.1.10 Overlap₂.

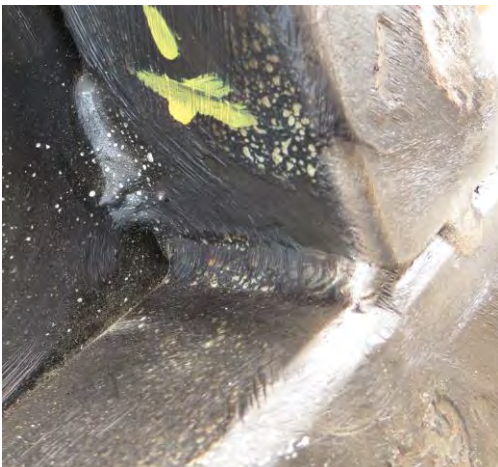
X-16A: 5.1.2 Craters₁.

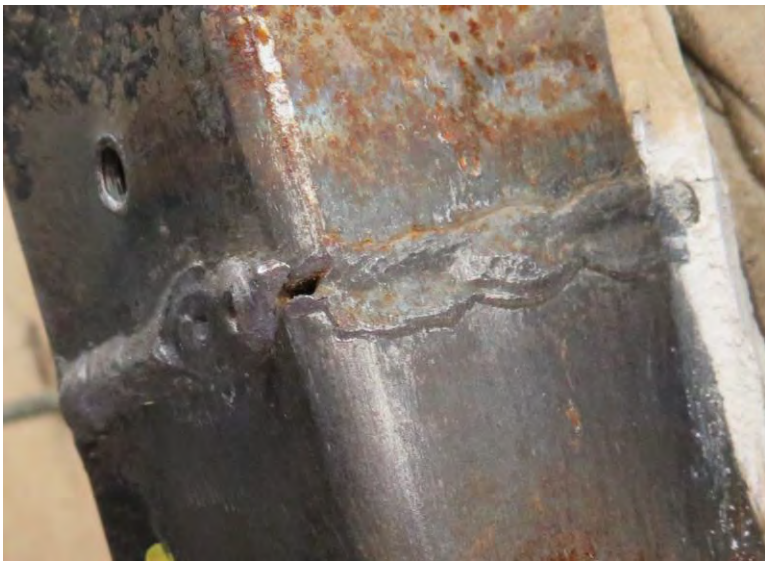
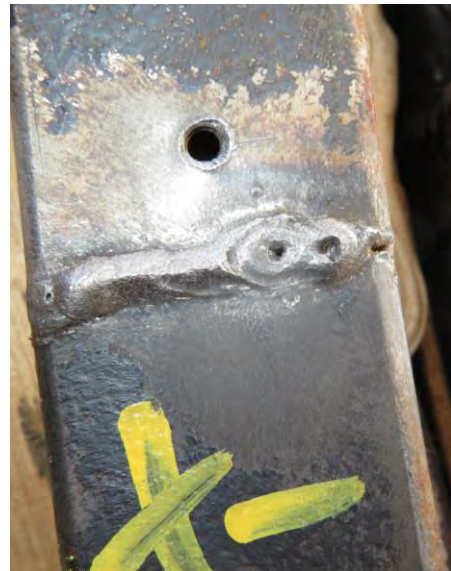
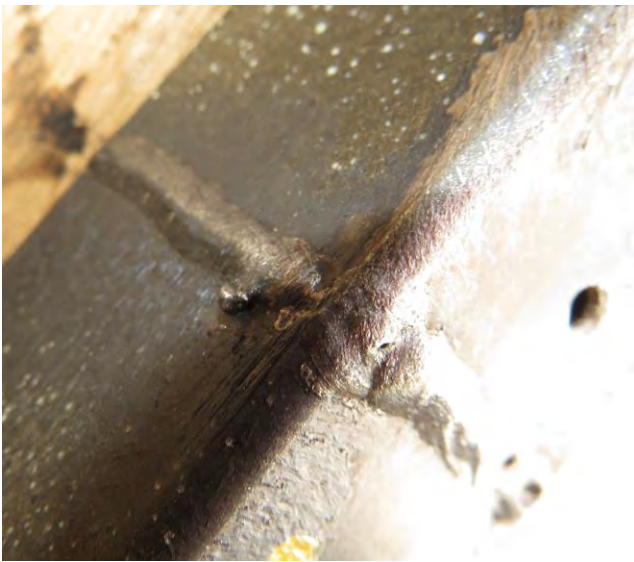
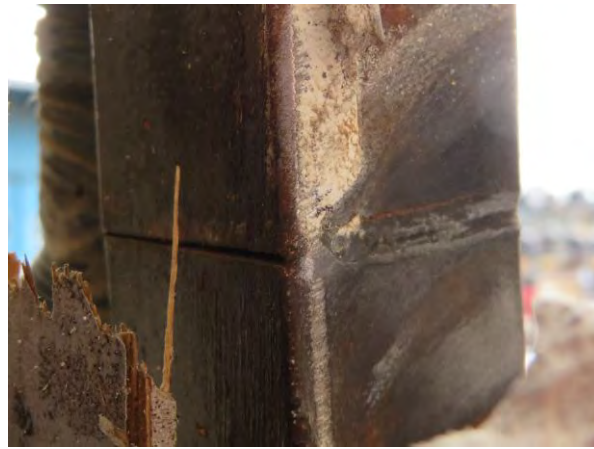
16-B: Unable to clean, no visual inspection

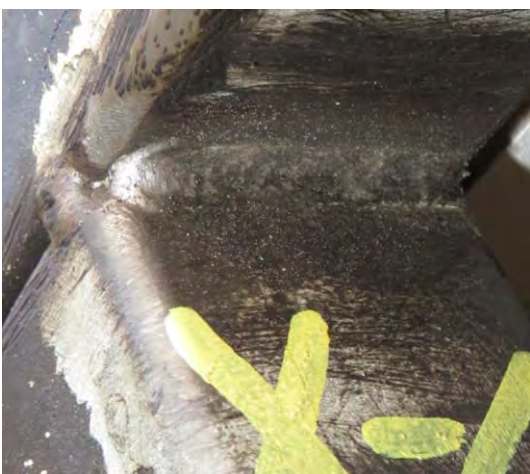
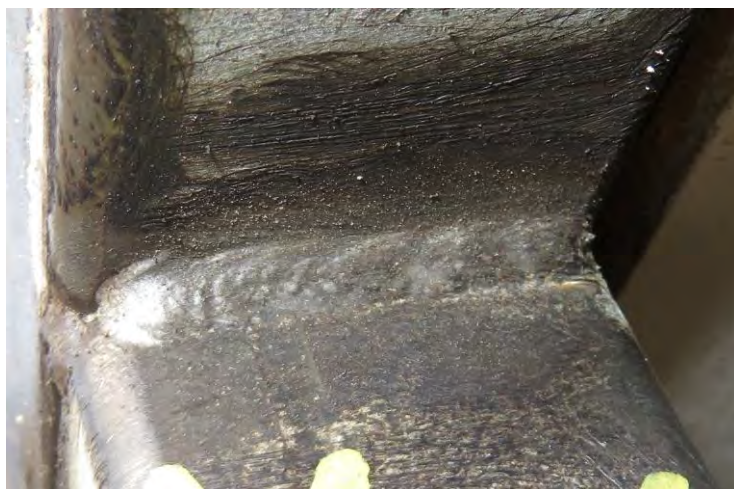
X-17A: 5.1.2 Craters₁, 5.1.10 Overlap₂; A&B: 1/8" Incomplete Fusion - Ref Table 1: Common Types of Discontinuities₄; B: 5.1.2 Craters₁; B&C: 5.1.2 Craters₁ on corner; C: 5.1.10 Overlap₂; D: No weld

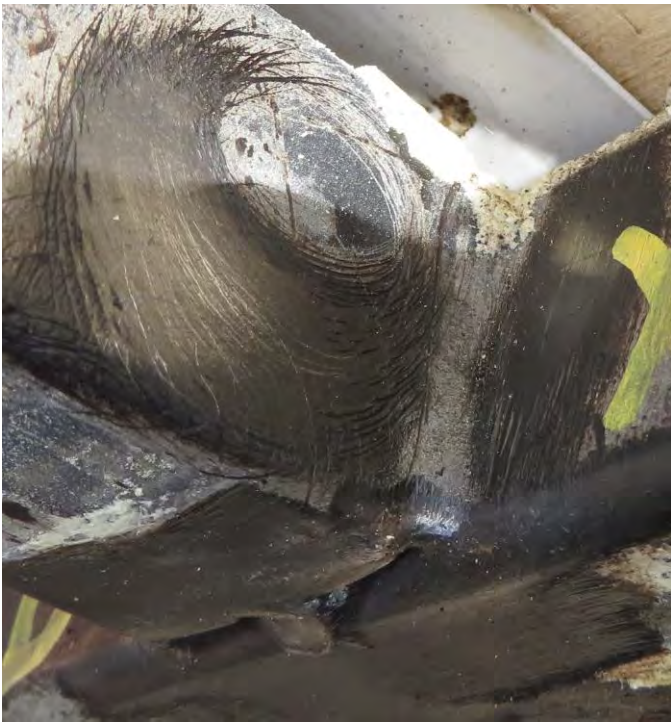
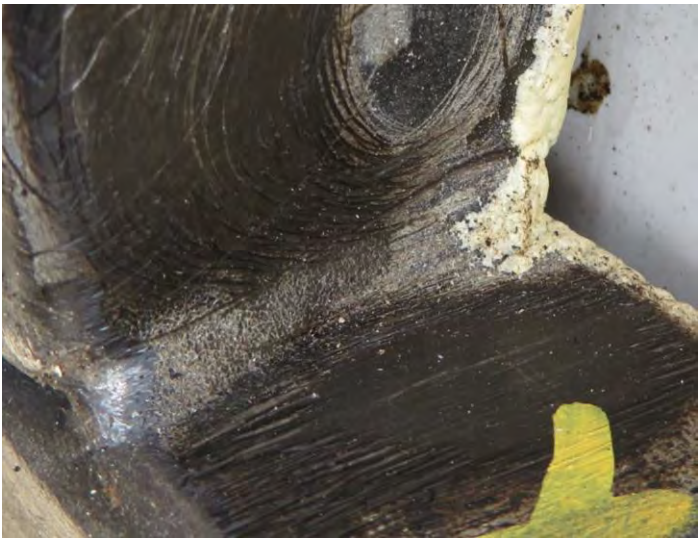
X-18B: 5.1.2 Craters, 5.1.10 Overlap₂.

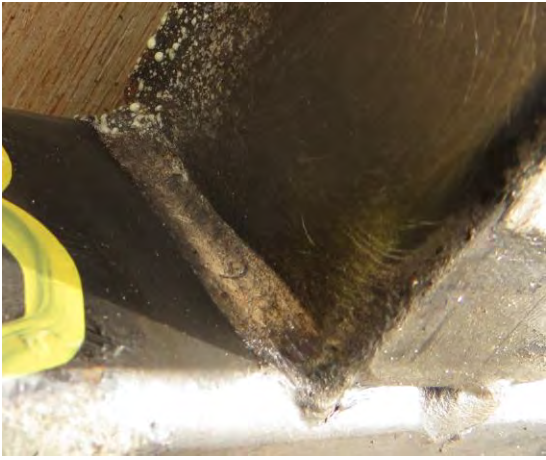
X-19A: OK

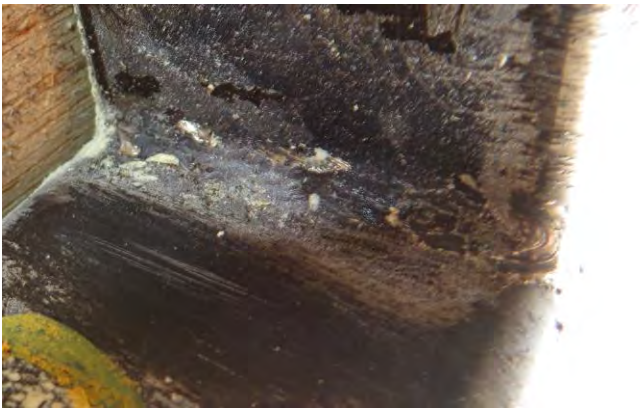
X-19B: OK

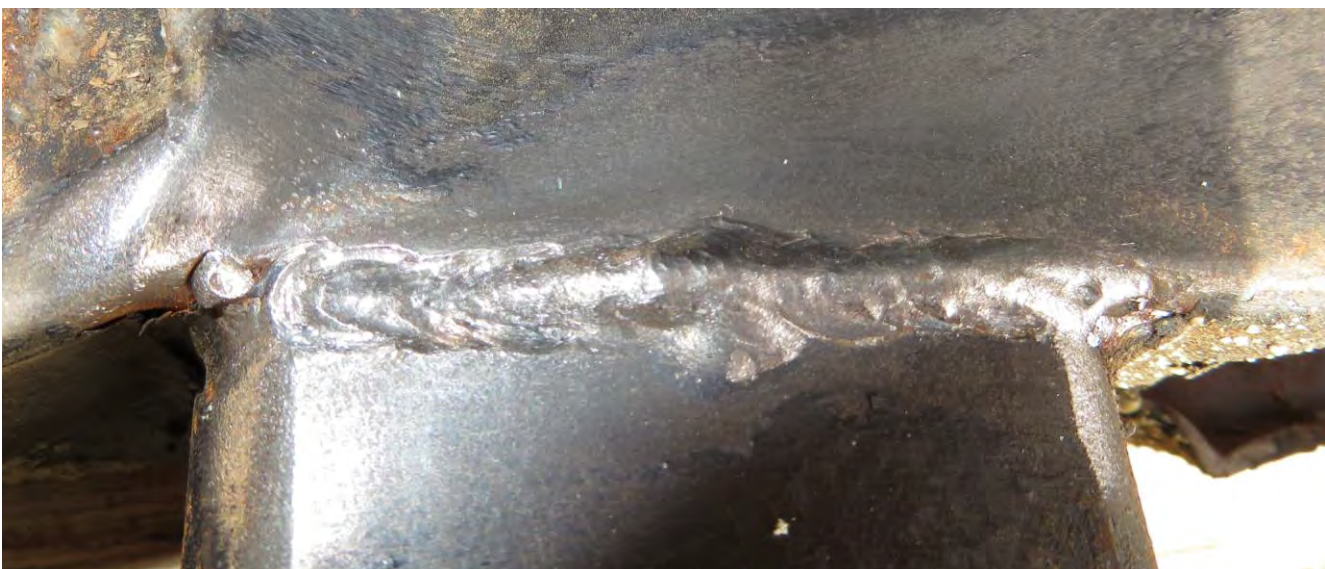
X-20B: OK

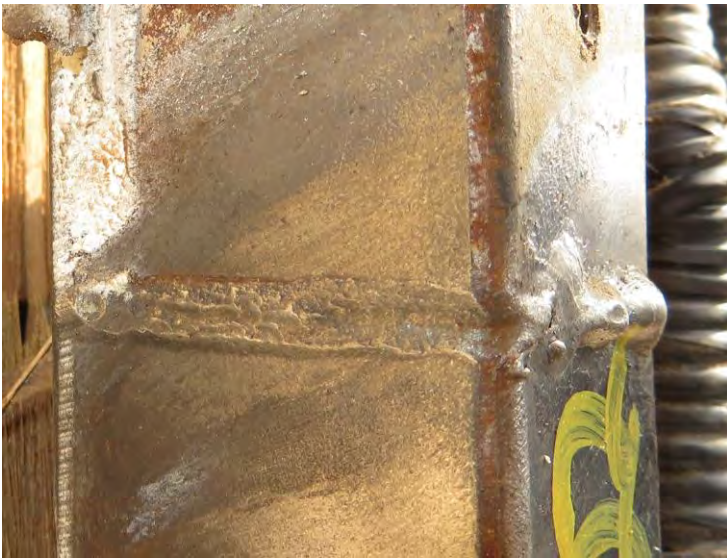
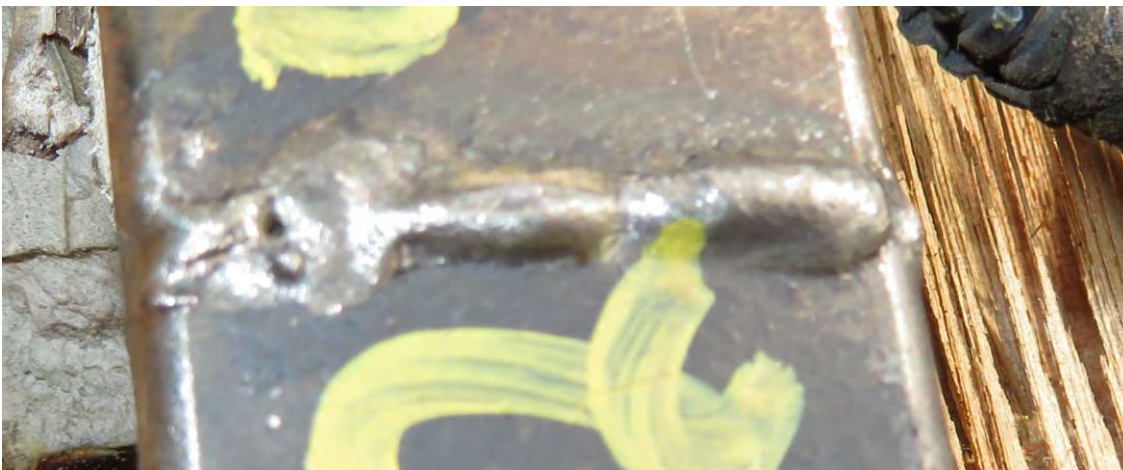
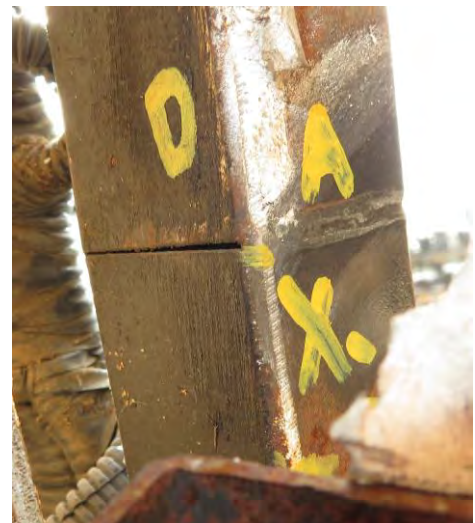
X-21: 5.1.2 Craters₁, 5.1.10 Overlap₂, Undersized weld (5.3.2.2 Welds in Butt & Groove Joints₁₂).

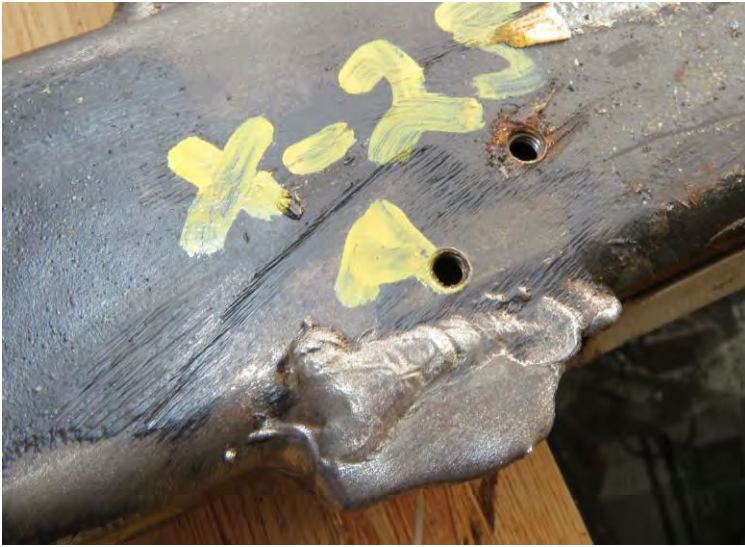
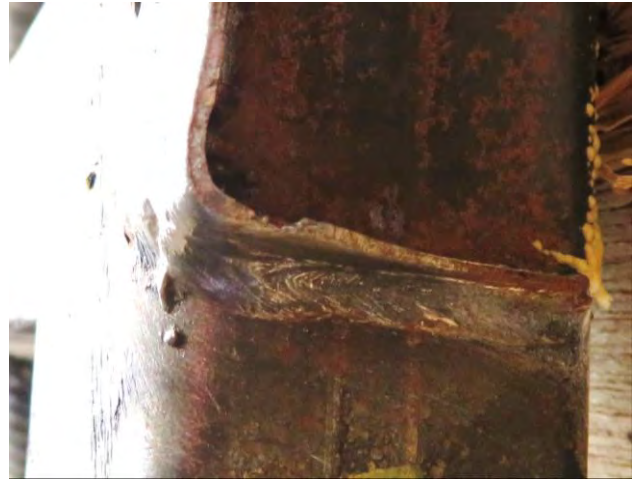
X-22 A: Undersized weld (5.3.2.2 Welds in Butt & Groove Joints₁₂);

B: 5.1.2 Craters₁, 5.1.10 Overlap₂;

C: Undersized weld (5.3.2.2 Welds in Butt & Groove Joints₁₂);

D: No weld

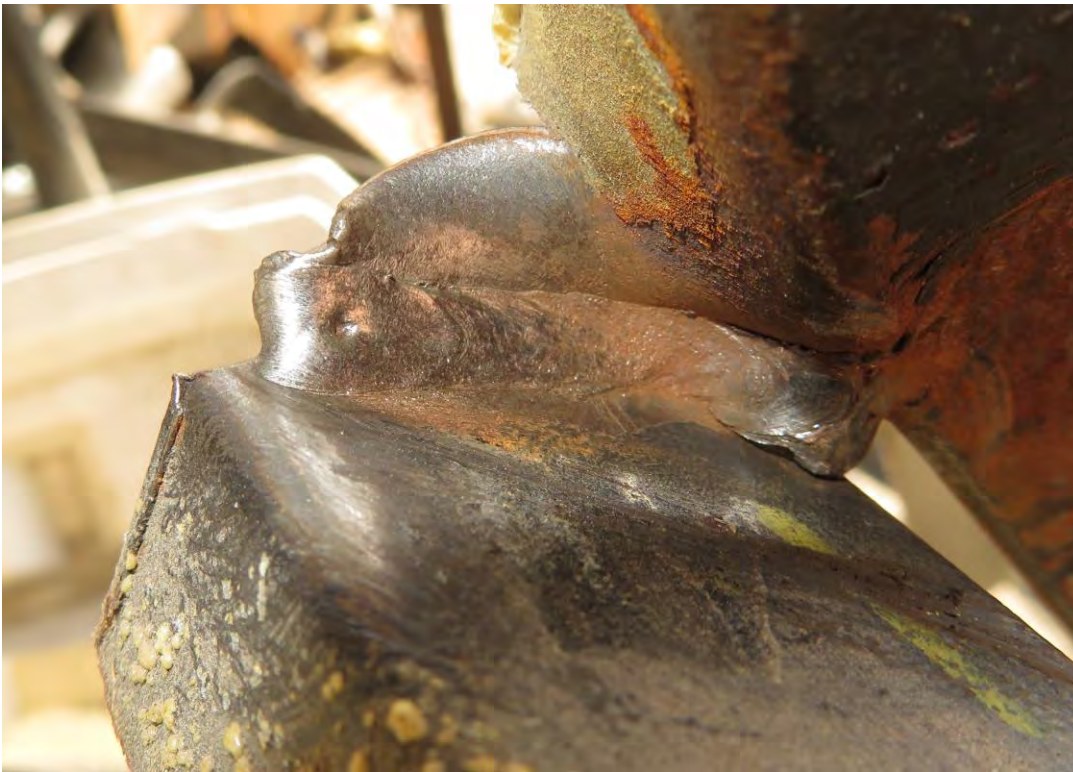
X-23A: 5.1.2 Craters₁, 5.1.10 Overlap₂; B: 5.1.2 Craters₁,
